EXPERIMENTAL SEISMIC ANALYSIS OF MONUMENTS FOR RISK MITIGATION

L. Cavaleri¹, F. Cristina² and G. Zingone²

ABSTRACT :

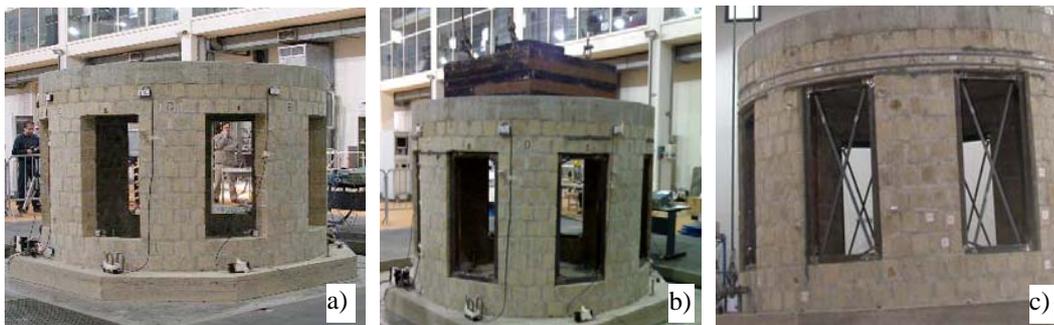
The model was submitted to seismic input using the vibrating table of the ENEA Experimental Centre in Casaccia. The three following configurations were analyzed: a) model in the absence of reinforcement -Fig. 6a; b) model strengthened with frames -Fig. 6b; c) model strengthened with braced frames (Fig. 6c). The reinforcing frames were made of steel profiles with a section of 70x50x4 mm, while the bracing elements were constituted of flat steel profiles with a section of 18x0.8 mm.

Figure 6 Model in the absence of reinforcement (a), model strengthened with frames (b) and with braced frames (c).

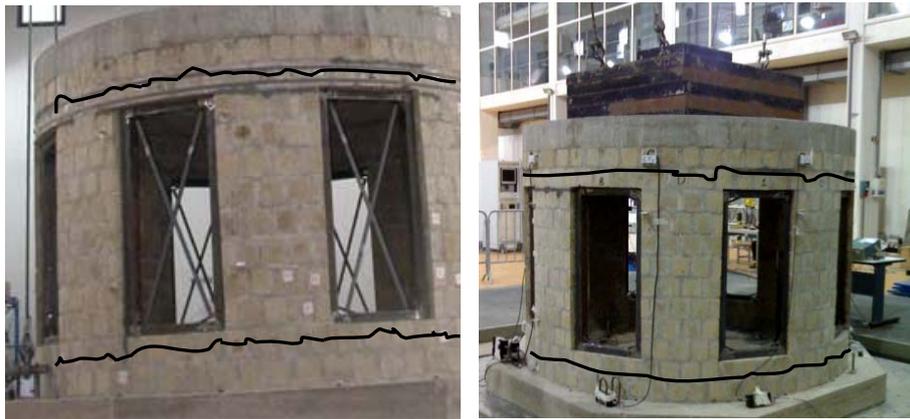
The models (b) and (c) were submitted to a history of horizontal accelerations, recorded at Colfiorito (Marche-Umbria), appropriately scaled, with an increase in the maximum peak acceleration in each test. The increasing of the peak acceleration was interrupted as soon as an abrupt reduction in the dominant frequencies of the system was recorded. Also in these two cases, cracks were detected involving the masonry rings placed above and below the delimitation planes of the masonry shear walls of the drum (Fig. 7).

Figure 7 Location of the cracks for the model reinforced with frames and braced frames
