## FIELD TEST OF RC SCHOOL BUILDING RETROFITTED BY POST-TENSIONED RODS

Field Test; Retrofit; Reinforced Concrete; School Building; Post-Tensioned Rod

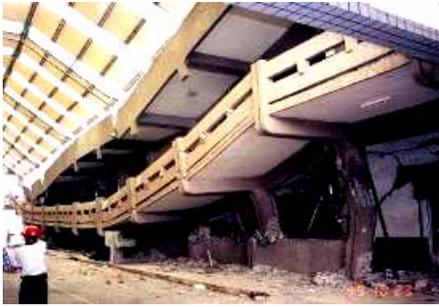
Figure 1 School building was damaged along the longitudinal direction in the 1999 Chi-Chi Earthquake in Taiwan.

Numerous school buildings in Taiwan were damaged in the 1999 Chi-Chi Earthquake. Because of their standard plan layout, characterized with openings in the longitudinal direction and partition walls in the transverse direction, common failure patterns, such as failure in the longitudinal direction due to lack of walls, short-column damages due to constraint by windowsills, and strong-beam-weak-column behavior due to weak columns were found as shown in Figure 1 (Loh et al. 1999). Likewise, on September 19, 1985, an 8.1-Richter magnitude earthquake occurred in Michoacan, Mexico, which caused severe damages of school buildings. In the aftermath of the earthquake, researches on the repair and upgrading of those damaged and vulnerable buildings have been the focus of seismic retrofitting design. The application of high-strength post-tensioned (PT) steel cables was developed in Mexico, and further investigated at the University of California and at the University of Texas (Guh 1989, Teran-Gilmore et al. 1995, Pincheira et al. 1992). These studies indicated that the PT cable technique is very effective for enhancing strength and stiffness of moment resisting frames. Moreover, because of the small diameter of PT cable braces, the PT technique does not interfere with lighting and views. This is also advantageous for the architect to have more freedom in exterior architecture. Therefore, a large number of school buildings were retrofitted with PT in Mexico (Figure 2).

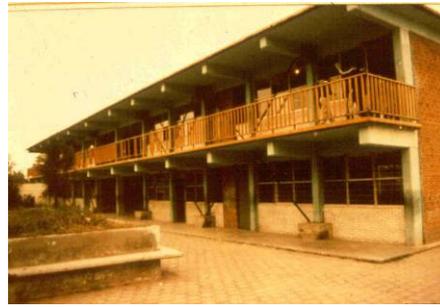
Figure 2 School building retrofitted with PT tendons along the longitudinal direction in Mexico.

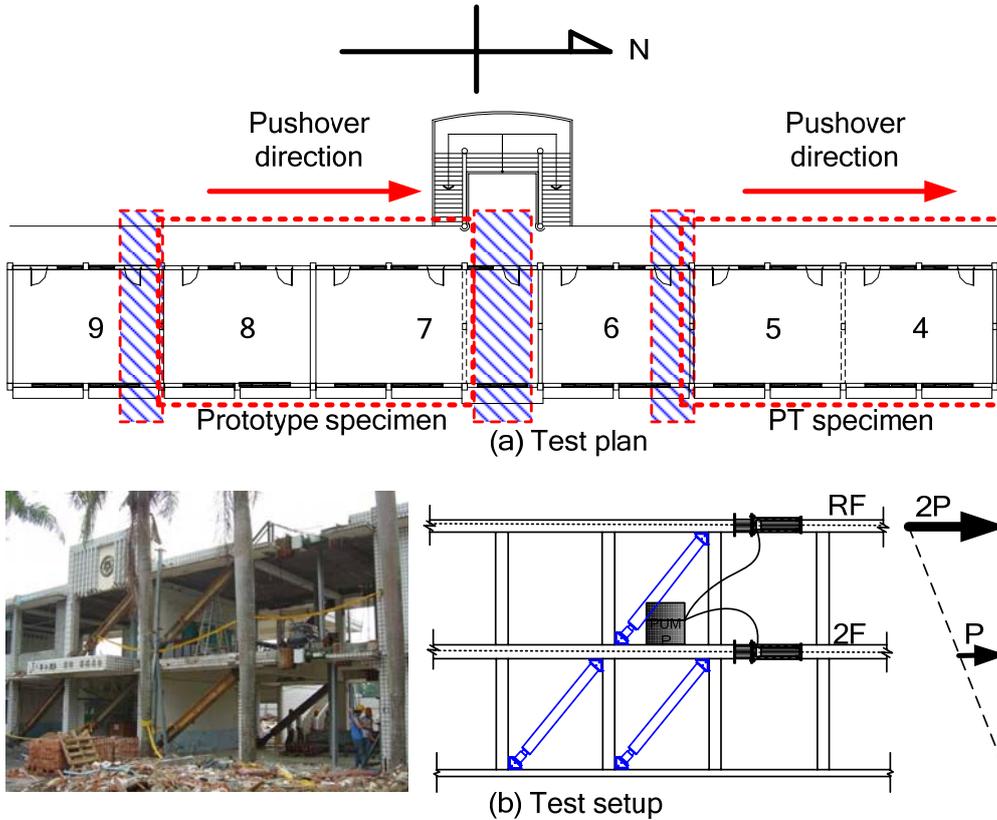
Figure 3 Test plan and test setup.

The tested school building contains 14 classrooms distributed in 2 floors and with a cantilever corridor on one side. Two specimens, a prototype of two classrooms and a retrofitted specimen using PT rods (Figure 3a), were tested under monotonic static lateral load along the longitudinal direction. The remainder part of the building was reinforced with large steel braces to serve as reaction wall. Four hydraulic actuators were installed at roof and floor to apply the lateral loading. Loading was manually controlled to maintain a 2:1 ratio during the test to simulate the earthquake loading for the fundamental mode of vibration of typical low-rise RC buildings (Figure 3b). First, the building was cut between classrooms 5 and 6; the PT specimen was pushed to north by using classrooms 6, 7, 8 and 9 as reaction wall. Afterward, the corridor between classrooms 6 and 7 was removed to allow lateral displacement of Specimen 4 (see Figure 3), which was pushed from classroom 9 to north.

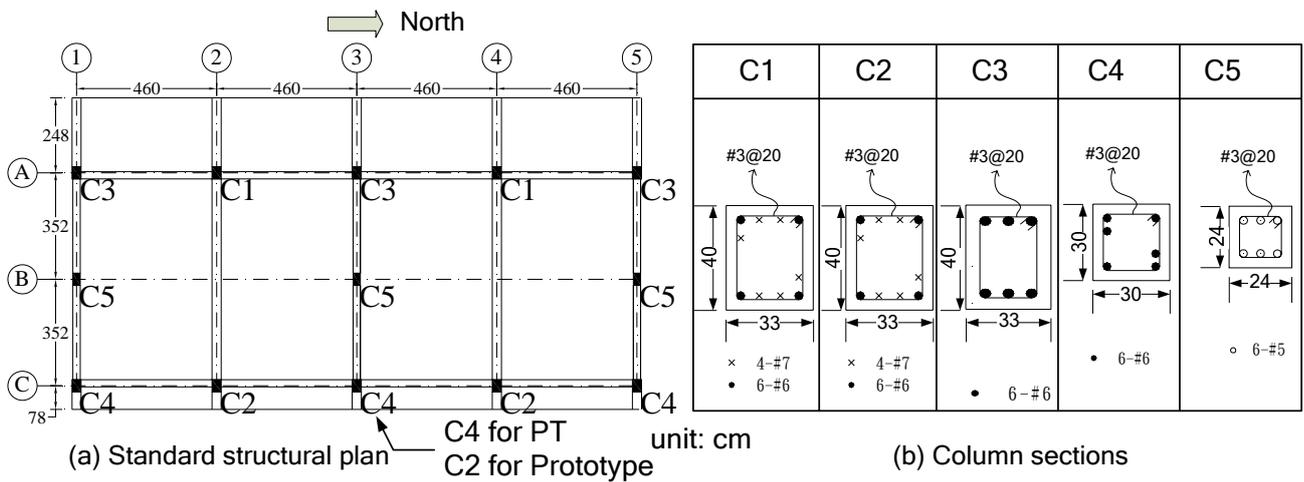
Figure 4 Standard structural plan and column sections

Figure 4 shows the standard structural plan and column sections. Column steel ratio is about 2.5% and the hoop spacing is 20 cm. One of the differences between Specimens 3 and 4 is in column type C4 for PT and C2 for prototype specimen at location C-3, respectively. As shown in Figure 5a, 8 sets of 22-mm high strength rods were added forming an angle of 57 degrees from the horizontal spanning column lines 2 and 3, and 3 and 4 in each frame. Two rods per set were placed at both sides of each frame. The location and amount of brick infills with 1B width of the prototype and PT specimens are shown in Figure 5. Material strengths and details of

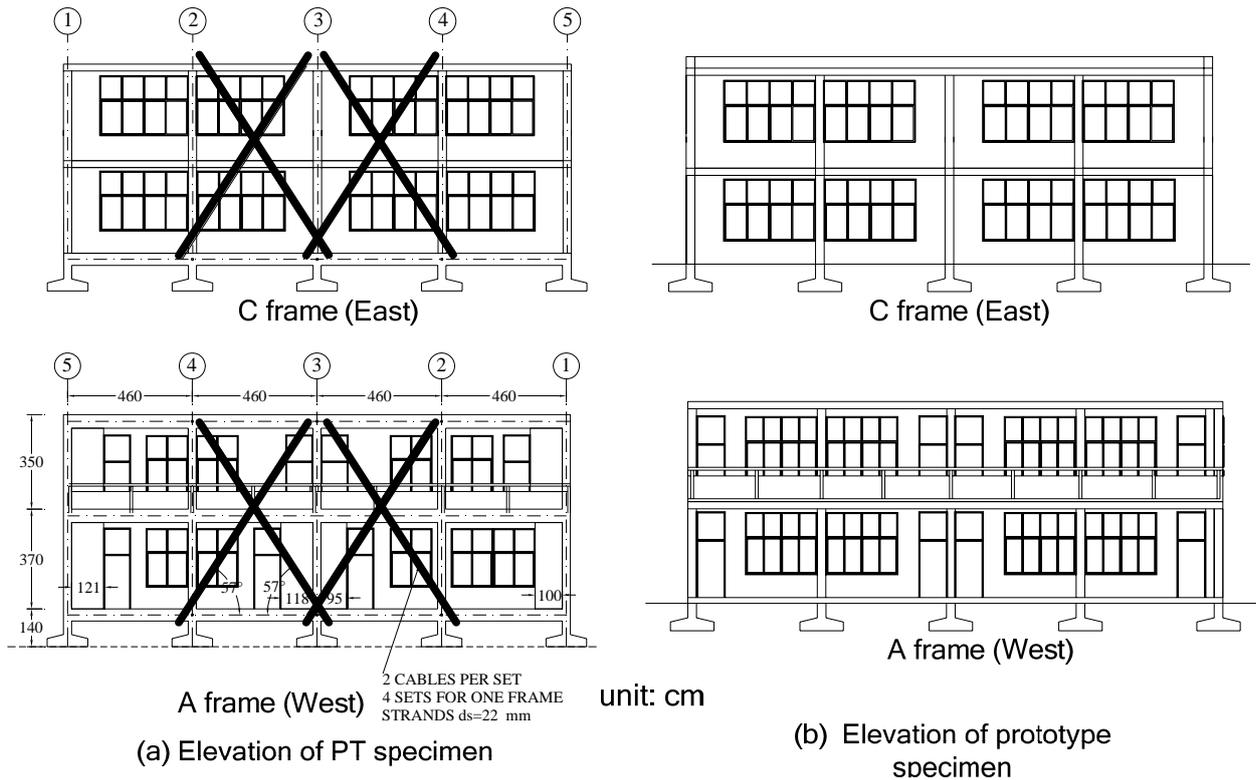
Figure 5 Elevation of specimens

According to the PT retrofitting scheme (Figure 5a), a single pair of PT rods was anchored at the ends of columns 2 and 4, whereas in column 3, two pairs of PT rods were anchored at both ends of the column for each frame. Thus two types of anchorage blocks were designed to support biaxial moment and shear forces due to PT systems. Besides, shear-friction between the new and the existing concrete interfaces was considered as well. This section illustrates the design concept considering shear friction.

Assuming an elastic perfectly-plastic material for the tendon, the ultimate strength can be estimated as the yield strength. As shown in the plan of the retrofitted specimen in Figure 5a, four sets of PT were tensioned during the monotonic push over test. Because there were two rods per set, the total horizontal component of the yield strength of 8 rods can be calculated as

Moreover, the axial load upon column members due to the vertical component of PT force would increase both the flexural moment and the shear strength of the column. According to the retrofitting design used herein (Figure 5a), the increment in axial load of each column with PT was

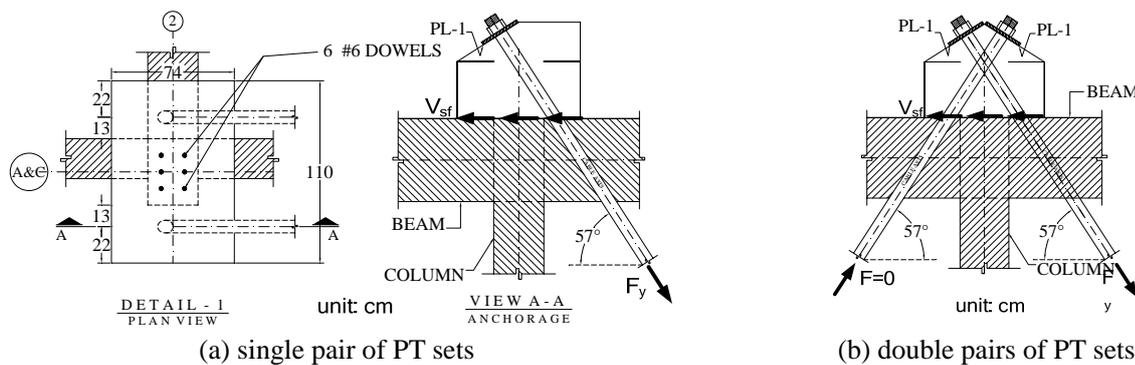
Figure 6 Roof anchorage.

First, consider the single pair of PT rods (columns 2 & 4) and assume that the rods are tensioned to yield (Figure 6a). The demand on shear-friction may be evaluated by

Secondly, as shown in Figure 6b, the anchorage for the two pairs of PT rods was designed to resist tension forces from the two diagonals. Initially, each rod was post-tensioned to  $0.5 f_y$ . Because of the monotonic nature of the pushover test, the force in the tension side will reach the yield strength, while the force in the compression side will decrease near zero. Therefore, the demand on shear-friction for the double pair of rods was the same as that for the single pair. Six D19 dowels with 180° standard hooks were used for anchorage in column 3.

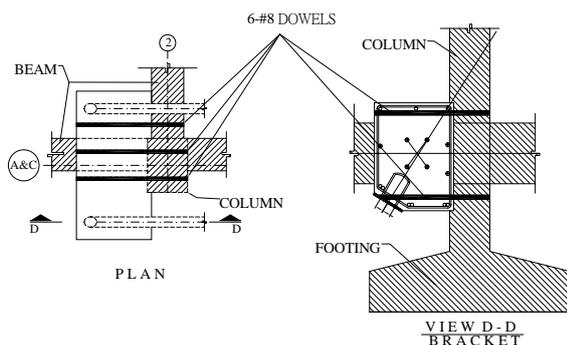
Figure 7 Detailing of foundation anchorage

Following the same reasoning, as shown in Figure 7, the anchorage of foundation block was designed by using six D25 anchor bars doweled into the footing and was combined with foundation beam in the longitudinal direction. Figure 8 shows the photo of anchorage block.

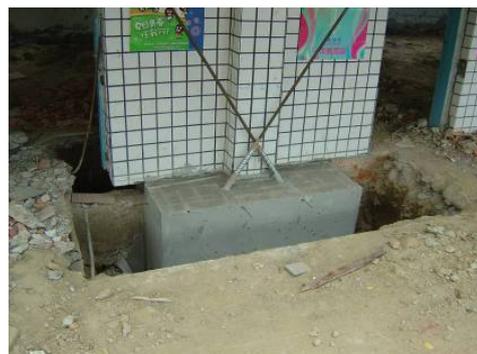
Figure 8 Anchorage block of foundation

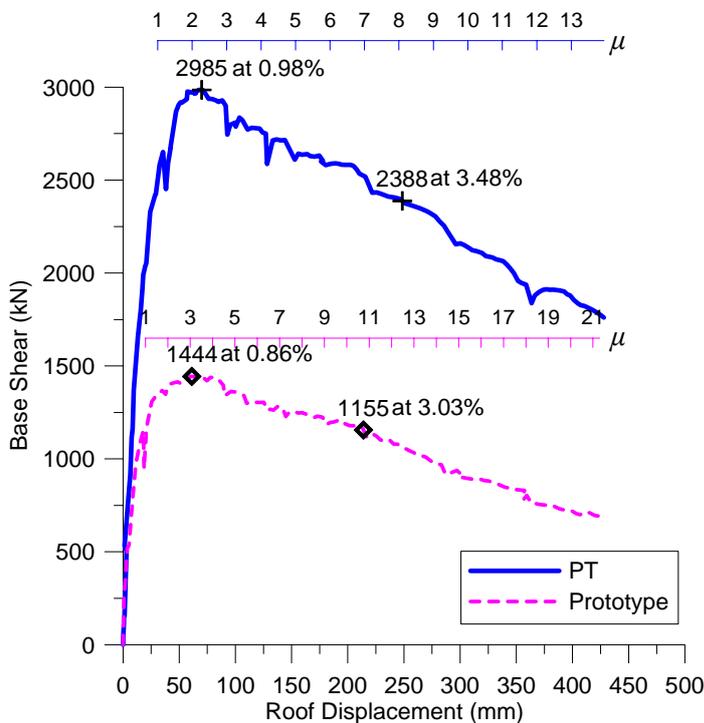
Figure 9 Comparison of pushover curves

The test results of the PT and prototype specimens are illustrated with solid and dashed lines, respectively, in Figure 9. The maximum base shear for the PT specimen was 2985kN when the roof drift ratio was 0.98%. The base shear was reduced to 80% of the maximum strength of 2388kN at the roof ratio of 3.48%. Likewise, the maximum lateral force for the prototype specimen was 1444kN at the roof ratio of 0.86% and the reduced

However, the ductility defined as the ratio of the displacement at 80% of the maximum strength to that measured at yield was 10.7 and 8.1, respectively, for the prototype and PT specimens (Figure 9 and Table 2). This means that the increase in axial loads in the existing columns due to the post-tensioned forces will decrease the ductility of structure.

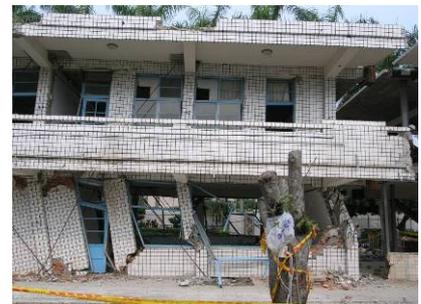
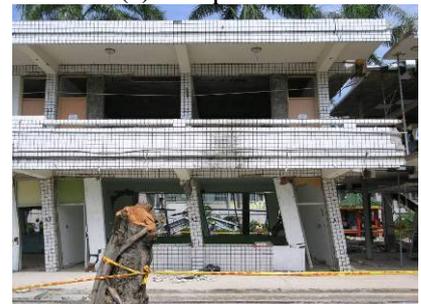
(a) PT specimen

(b) Prototype specimen

Figure 10 Pictures of the specimens at nearly collapse

Figure 10 shows pictures of the specimens at nearly collapse. Usually, the first story of school building possesses the severe damages. It is because that the school building carries the uniform floor plan and that the first story exerts the largest shear force. As may be observed, the strong-beam-weak-column behavior is apparent in both specimens. Beams and slabs remained almost undamaged when the columns and wing walls had failed to nearly collapse. As shown in Figure 10, the captive columns exhibited diagonal shear cracks because of the constraint of windowsills induced larger shear force. However, the flexural failures were observed in longer columns without constraint of windowsills.

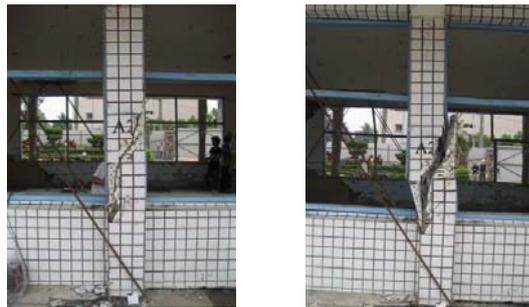
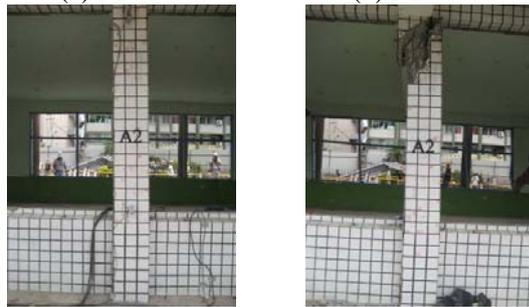
(a) PT: 1%

(b) PT: 3%

(c) Prototype: 1%

(d) Prototype: 3%

Figure 11 Comparison of damage patterns for A2 columns

As it was mentioned before, the PT rods enhanced not only the lateral strength due to the contribution of the horizontal component, but also increased the axial loading on the column due to the vertical component. Because of the larger axial load of the columns, the less ductility was observed. As shown in Figure 11, for the PT specimen, column A2 exhibited earlier shear cracks than those in the prototype. In addition, if Figures 11 and 12 are compared, side column C2, with low axial loading, showed fewer cracks than the inner column A2 because the latter supported higher axial loading at the same displacement. It means that the decrease in ductility of vertical members due to the increase in axial loading cannot be overlooked in design.
