EARTHQUAKE SIMULATION TESTS OF BRIDGE COLUMN MODELS DAMAGED DURING 1995 KOBE EARTHQUAKE

J. Sakai¹, S. Unjoh² and H. Ukon³

ABSTRACT :

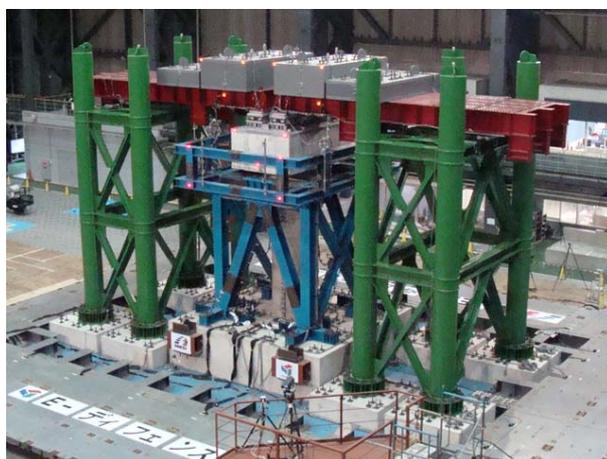
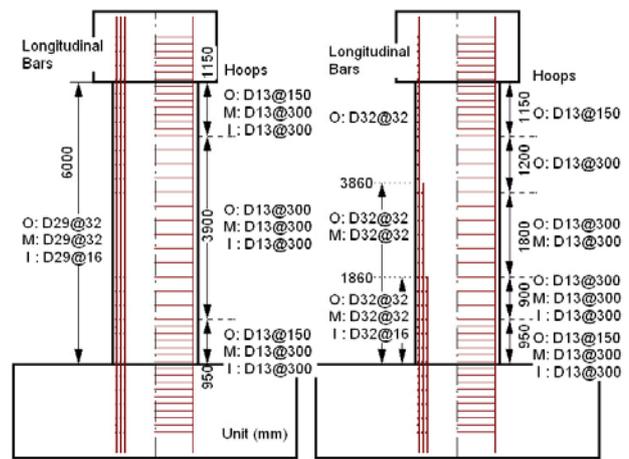
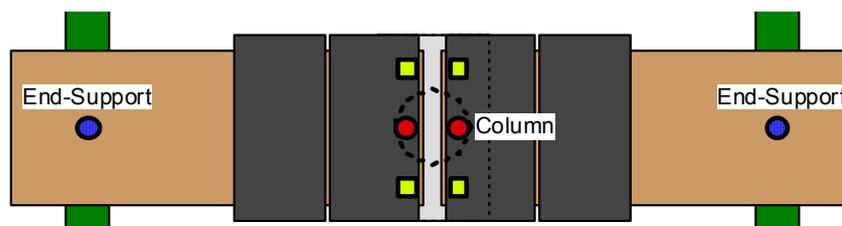
Figure 1 Test setup and specimens of full-scaled bridge column models

Figure 1 shows the test setup, reinforcement details of the specimens and bearing conditions. Two girders, which steel blocks as weights of a superstructure are fixed to, are supported by fixed bearings on the top of the specimen and a longitudinal-movable/ transverse-fixed bearing at each end. Two sliding bearing are placed on each side of the fixed bearing on the specimen to prevent overturning of the decks. Due to this setup, the inertia force of the girder-block assembly is applied to the top of the specimen (7.5 m from the bottom of the column) in the longitudinal direction, and to the center of the gravity of the girder-block assembly (9.14 m from the bottom) in the transverse direction. The inertia mass of each girder-block assembly excluding mass of the load cells and bearings on the specimen is 145 ton. Since all the inertia force is applied to the specimen due to the boundary condition, the inertia mass in the longitudinal direction is 289 ton. In the transverse direction, on the other hand, not only the specimen but also the end supports carry the inertia force. Thus, the inertia mass in the transverse direction is 199 ton.

The diameter of the column is 1.8 m, and the height of the column is 7.5 m. 80 of SD345, 29-mm-diameter deformed bars are arranged in the flexural failure model as the longitudinal reinforcement without cut-off. On the other hand, two cut-off points are designed for the shear failure model. The inner rebar is anchored at 1.95 m from the bottom of the column, and the middle rebar is anchored at 3.95 m. At the bottom, 80 of SD345, 32-mm-diameter deformed bar are arranged. As transverse reinforcement, SD345, 13-mm-diameter deformed bars are provided for both the columns. The pitch of the transverse hoops is set at 300 mm excluding the both ends of the column. In the region of about 1 m from the bottom and the top of the column, the outer transverse reinforcement is arranged at 150-mm-pitch. The transverse reinforcement is anchored with lap splices, and the anchorage length is 300 mm.

(a) Test setup

(b) Flexural failure model

(c) Shear failure model

- : Fixed for LG & TR; Free for Rotation
- : Fixed for TR; Free for LG and Rotation
- : Sliding Bearings

(d) Boundary conditions of girder-block assembly

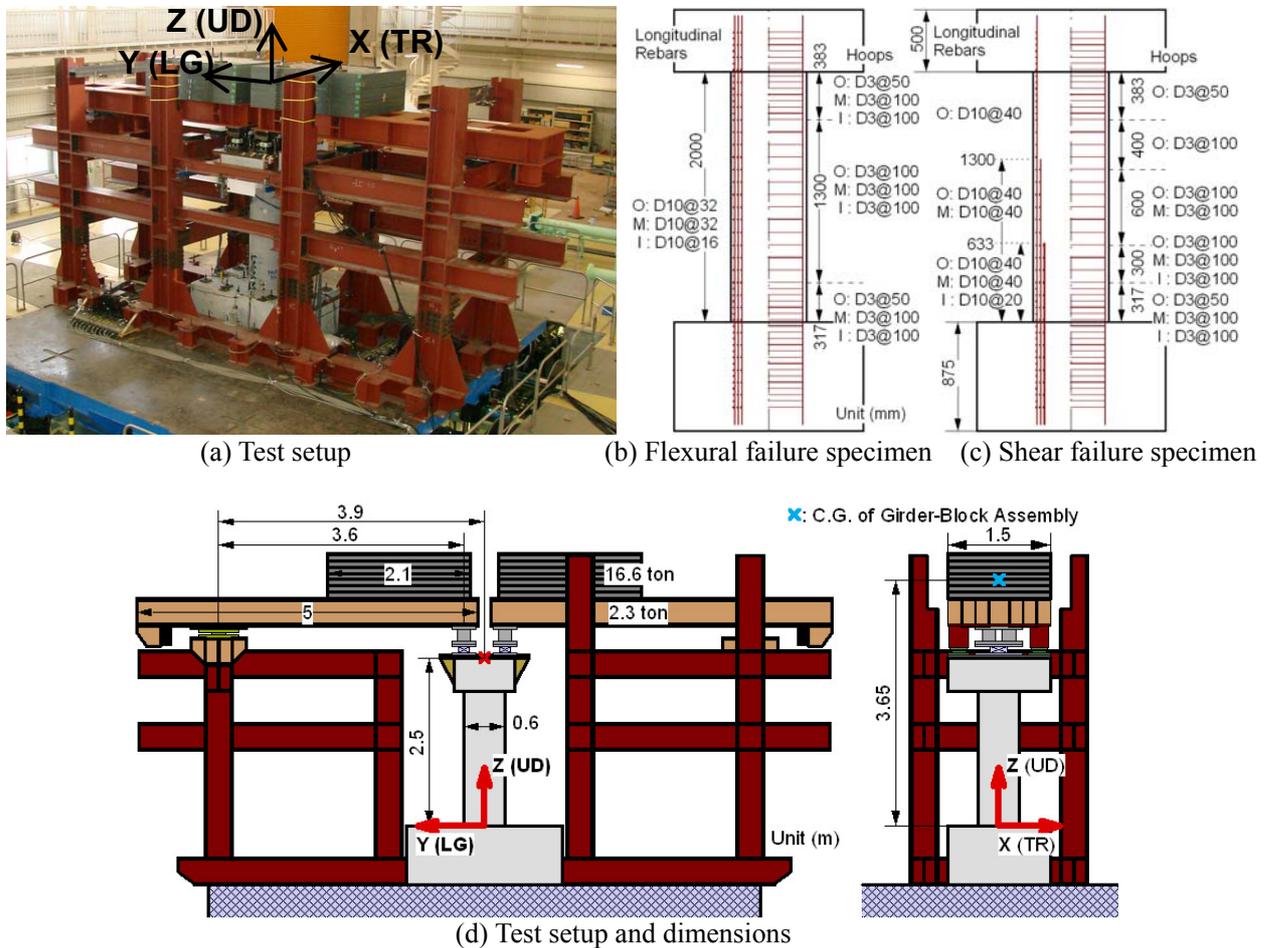
Figure 2 Test setup and specimens of 1/3-scaled bridge column models

Figure 2 shows the test setup and specimens of one-third scaled models. The specimens are designed considering the similitude requirements (Krawinkler and Moncarz, 1982). Because the plan, specimen details, setup, etc, of the full-scaled models had been minor changed since the test plan of the small-scaled test had been decided, however, some conditions such as the design material strength, the transverse reinforcement ratio, etc, do not satisfy the similitude requirements.

A similar setup and the same bearing conditions with the full-scaled model test were used. In this test program, the longitudinal and transverse directions are defined as the Y and X directions, and the sides face the X positive and the X negative directions are defined as the Xp and Xn faces, respectively. Likewise, the Yp and Yn faces are defined. Due to the setup, the points inertia force applied to are 2.5 m and 3.65 m from the bottom of the column for the longitudinal (Y) and transverse (X) directions, respectively. Inertia mass in the longitudinal and transverse directions are 37.8 ton and 26.6 ton, respectively.

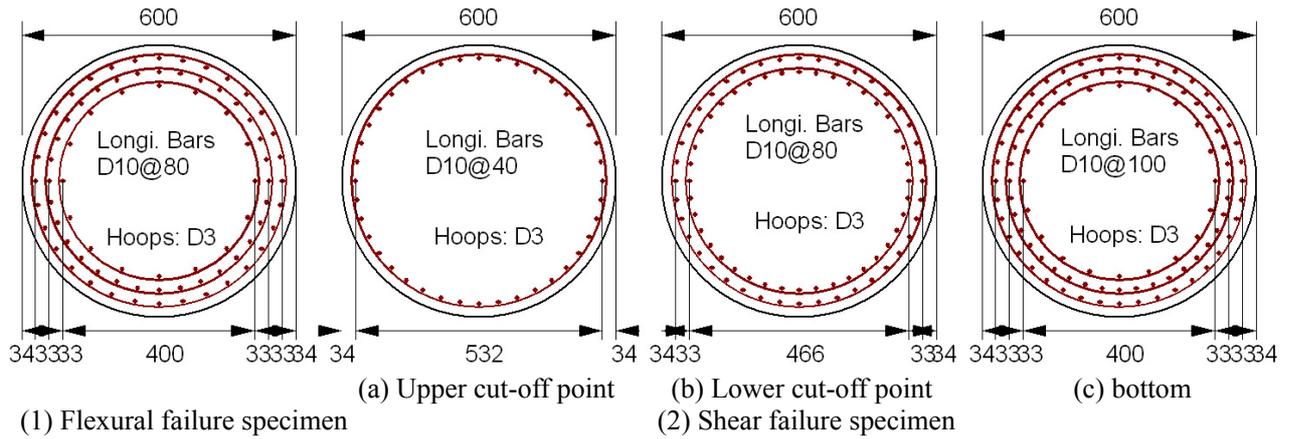
Figure 3 Cross sections of 1/3-scaled bridge column models

Figure 3 shows the cross sections. The diameter of the column is 0.6 m, and the height of the column is 2.5 m. 80 of SD295A, 10-mm-diameter deformed bars are arranged for the flexural failure specimen as the longitudinal reinforcement without cut-off. The longitudinal reinforcement ratio is 2.02%. On the other hand, two cut-off points are designed for the shear failure specimen. The inner rebar is anchored at 0.63 m from the bottom of the column, and the middle rebar is anchored at 1.3 m. At the bottom, 100 of SD345, 10-mm-diameter deformed bar are provided. The longitudinal reinforcement ratios at the bottom, lower cut-off

point, and the upper cut-off point are 2.52%, 2.02% and 1.01%, respectively. As transverse reinforcement, SD295, 3-mm-diameter deformed bars are provided for both the specimens. The pitch of the transverse hoops is set at 100 mm excluding the both ends of the column. In the region of about 0.3 m from the bottom and the top of the column, the outer transverse reinforcement is arranged at 50-mm-pitch. The transverse reinforcement ratio at the bottom of the column is 0.1%. The transverse reinforcement is anchored with lap splices, and the anchorage length is 100 mm. The design concrete strength is 27 N/mm². Table 1 shows the material properties, which were obtained from the material tests.

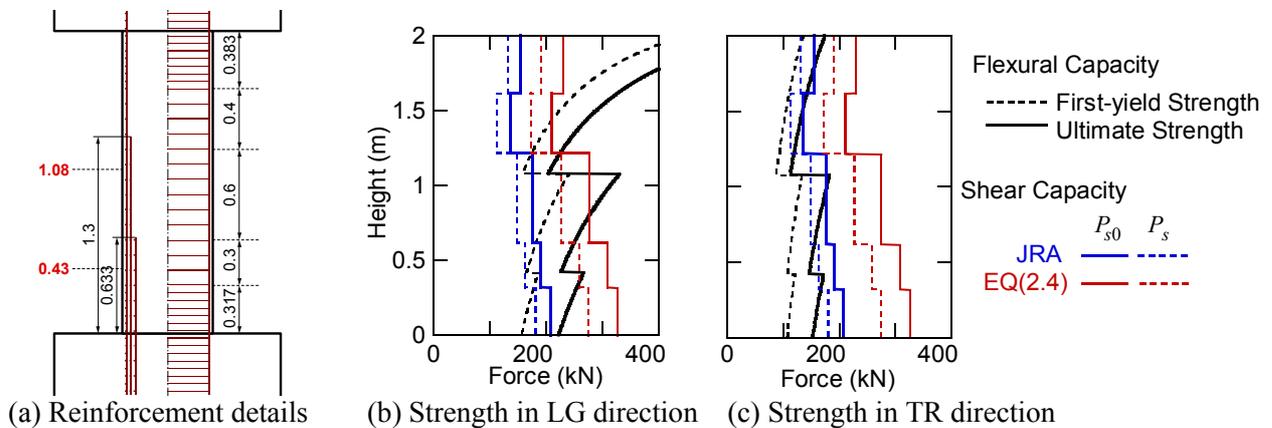
Figure 4 Evaluated failure mode of shear failure column

Figure 4 compares the flexural strength and shear strength along the column height of the shear failure specimen. Flexural strength at each section was computed based on the moment-curvature analysis with consideration of cut-off of the longitudinal reinforcement. The anchorage length of the longitudinal bars is assumed to be about 0.21 m according to the JSCE standard specification (JSCE 2002).

where d is the effective depth (m), f_{c0} is the concrete strength (N/mm²), and ρ_l is the longitudinal reinforcement ratio (%). τ_c is determined to be 0.731 N/mm² for the critical section, where is the region of 1.2 m to 1.6 m from the bottom. In Figure 4, the shear strength of the specimen obtained based on the averaged shear stress ($= 0.366$ N/mm²; $c_e c_{\rho_l} \tau_c = 0.446$ N/mm²) according to the JRA specification is also shown. The averaged shear stress is determined as the values that is equal to the mean minus twice of the standard deviation of Eq. (2.4) because of safety consideration for the design.

To predict the actual failure mode of the shear failure column, the shear strength of the column based on Eq. (2.4) was considered. According to Figure 4, flexural yielding first occurs at the bottom and the upper cut-off point because the flexural first-yield strengths are the smallest. The smallest shear strength along the column is 210 kN as P_{s0} and 172 kN as P_s in the region of 1.2 m to 1.6 m from the bottom. This P_{s0} is 35% larger than the flexural first-yield strength at the bottom and the upper cut-off point and 3% larger than the flexural ultimate strength of these points. If the deterioration of the shear strength due to cyclic flexural damage is considered, the shear strength decreases and becomes smaller than the flexural ultimate strength. Thus, the shear failure specimen was expected to be damaged in flexure around the upper cut-off point, and then shear failure to occur around the upper cut-off point.

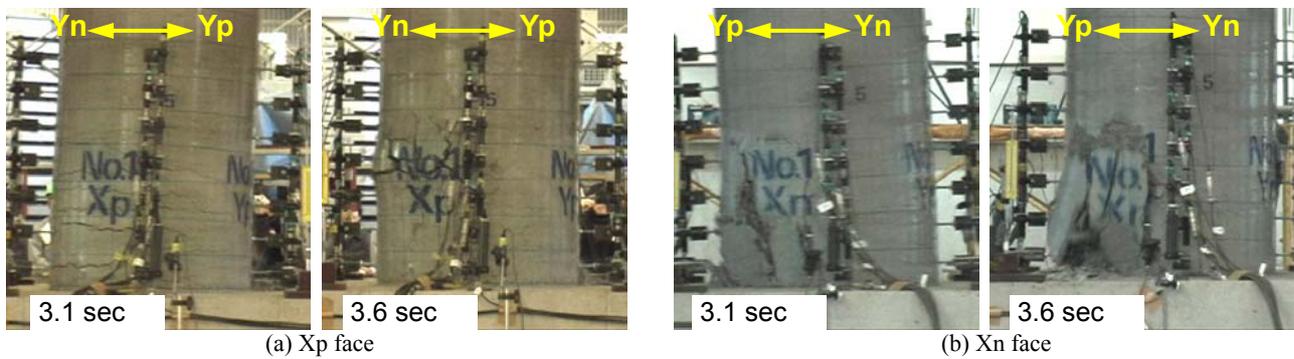
Figure 5 Damage progress of flexural failure specimen

Figure 5 shows the damage progress of the specimen during the nonlinear level test, and Figure 6 shows response displacement and lateral force versus lateral displacement hysteresses during the nonlinear level test. Several flexural cracks were observed up to 3 seconds around the bottom of the column, when the response displacement was about the computed ultimate displacement. The maximum response displacement occurred at 3.1 seconds, which were 123 mm and 115 mm in the longitudinal and transverse directions. As a distance from the origin, the maximum response was 168 mm, which was 6 times larger than the ultimate displacement of the specimen. Spalling of cover concrete and buckling of longitudinal reinforcing bars were observed. The lateral forces observed were smaller to the values that the current design specification predicts, indicating the bilateral flexural loading effects.

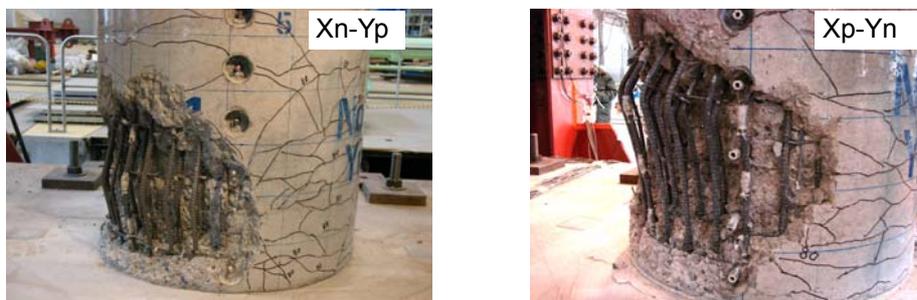
Figure 7 Failure mode of flexural failure specimen

As shown in Figure 7, flexural damage occurred in the region of 0.2 m ~ 0.4 m from the bottom of the column,

and longitudinal reinforcing bars in the middle and outer layers were buckled at the Xn-Yp face where was the compression region when the maximum displacement occurred at 3.1 seconds. On the other hand, damage occurred in the region of 0.2 m ~ 0.45 m from the bottom at the Xp-Yn face. Reinforcing bars in all three layers were buckled. The pitch of the transverse reinforcement changes at 0.317 m from the bottom, resulting in the rebar buckling in the Xp-Yn face. The failure mode is similar to one of the typical failure modes observed during the 1995 Kobe earthquake.

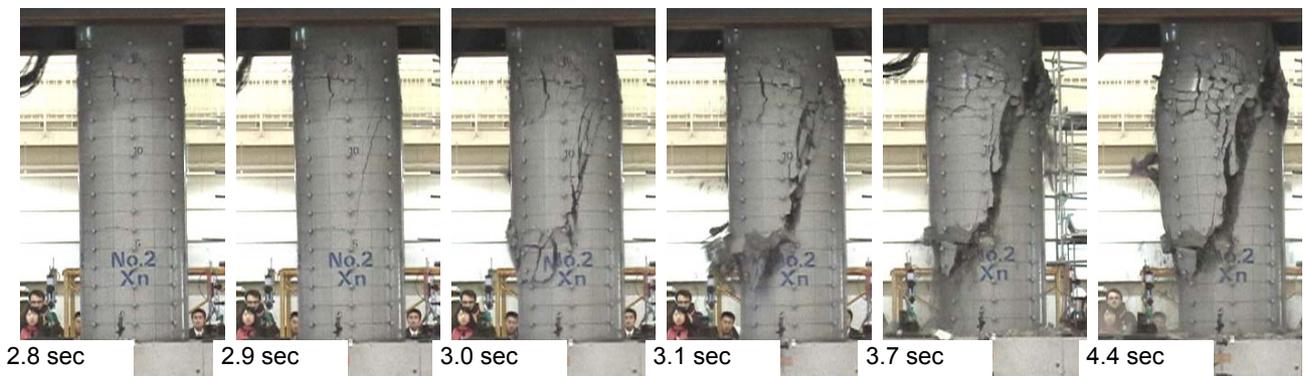
Figure 8 Damage progress of shear failure specimen

Figures 8 and 9 show damage progress, response displacement and lateral force versus lateral displacement hysteresses of the shear failure specimen during the nonlinear level test. In Figure 9, the response after 3.1 seconds shows dotted lines because the top slab of the column contacted to the safety frame and thus the results included this effect after 3.1 seconds. At about 2 seconds of the nonlinear level test, flexural cracks were observed at 1.2 m from the bottom, and then slight shear cracks initiated around the same location. The lateral displacement at this point was about 40 mm. When the lateral displacement increased up to 175 mm from 2.8 to 3.1 seconds, first flexural damage occurred around 1.4 m from the bottom, which was around the upper cut-off point, and then the shear cracks extended from 1.4 m to 0.6 m, causing the destructive shear failure, which was one of the major causes of the destructive damage during the 1995 Kobe earthquake.

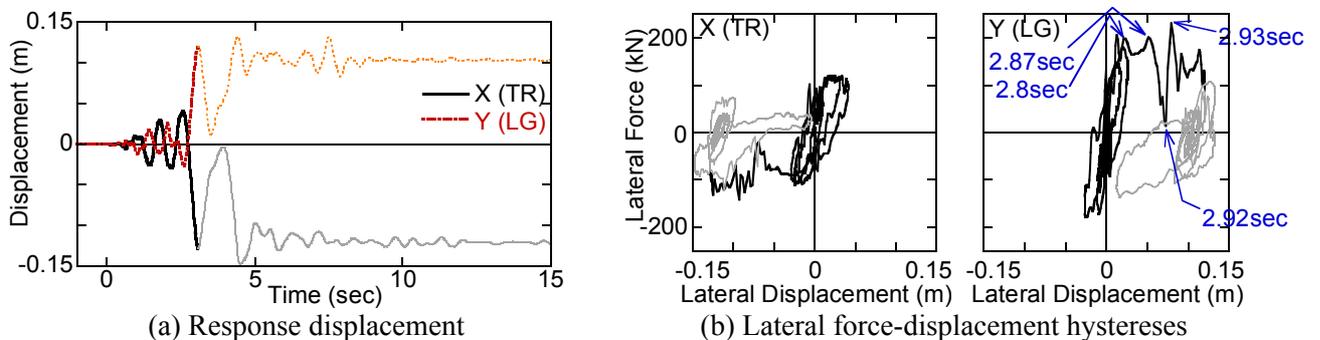
Figure 9 Response of shear failure specimen at top of column

The lateral force in the longitudinal direction reached 200 kN at 2.87 seconds, and then the force decreased to 16 kN due to the shear failure. Thus, the shear capacity of the specimen was estimated to be 200 kN. Because

the P_{s0} computed using Eq (2.4) for the averaged stress of concrete was 221 kN, the shear capacity obtained from the test was about 90% of the computed shear capacity.
