NON STRUCTURAL MATERIALS RELATED FOR DISASTER RESISTANT MUSEUMS

Alpaslan Hamdi KUZUCUOGLU¹

Non structural materials for seismic safety, disaster mitigation of museums, historical museum buildings, vulnerability risk analysis.

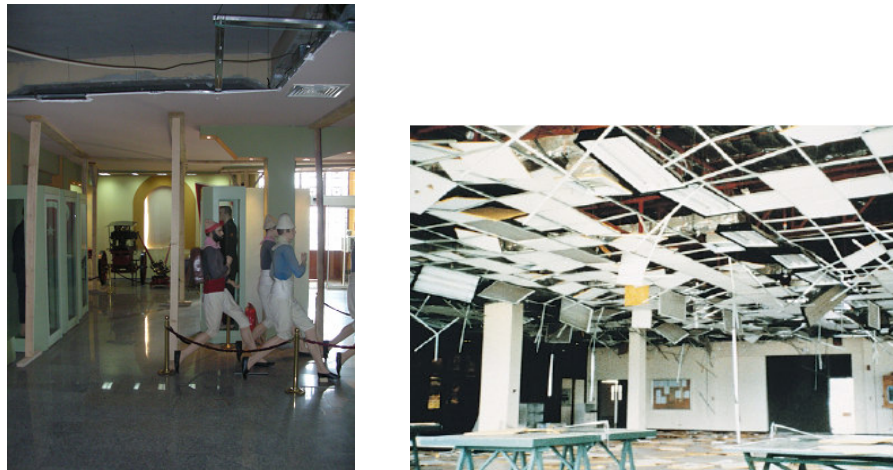
Figure 1 Removing suspended ceiling components for pre-risk analyse of restoration project , fixtures by pillars to protect artifacts at Istanbul Fire Brigade Museum. (left) and Damage to suspended ceiling and recessed ceiling lights, Philippines, Earthquake Engineering Research Institute (right)

If these defines apply to museum buildings, key areas come to fore in view of non structural components. Principally, life safety and secondly artifact safety are considered. Failure of fixed ceiling components (suspended ceiling panels, piping systems for fire, HVAC, lighting etc.) effect life safety as well as non compensable events of artefacts. Some of nonstructural risks as follows: Collapsing heavy case and exhibited artifacts, breaking case and building glasses, collapsing ceiling components falling into place, artifacts which suspended on walls, inadequate fire systems, using non fire resistant materials, collapsing precast concrete panels, collapsing walls, parapets, fences (stairs and entrance-exits doors), Falling components which anchore to interior surfaces.

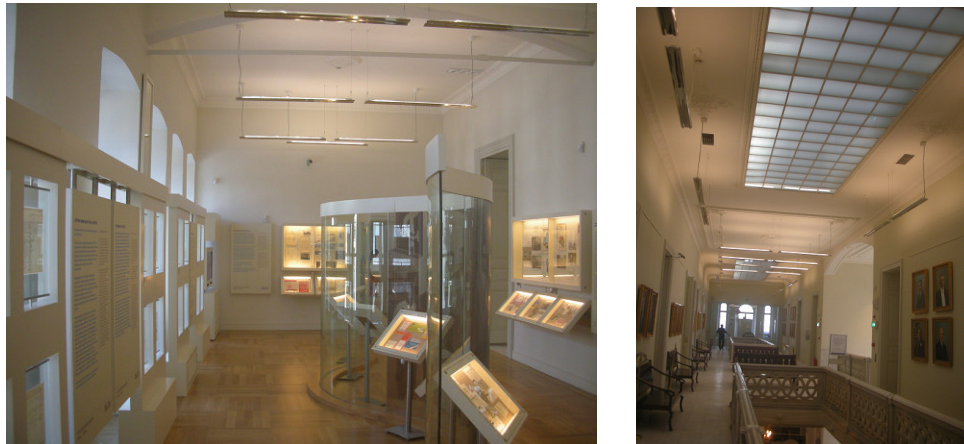
Figure 2 Using nonstructural materials at Is Bank Museum, Istanbul

All museum buildings which serve at Eminonu district are historical buildings. Nonstructural materials are installed afterward. Among these buildings most modern non structural materials are used at Is bank Museum and Islamic Science and Technology Museum which is renewed initiated by Istanbul Metropolitan Municipality and Culture and Tourism Ministry. Topkapi Palace Museum “Holy Relics” section is modified with modern nonstructural materials and exhibition techniques at recent days. Is Bank Museum is designed disaster resistant non structural materials such as windows, doors, glasses, light fixtures, anchoring control panels and electronic devices, piping fixtures, ceiling, intallation of heating, ventilation and air conditioning systems, wall, floor materials and finishes
