RECONNAISSANCE REPORT OF 0512 CHINA WENCHUAN EARTHQUAKE ON SCHOOLS, HOSPITALS AND RESIDENTIAL BUILDINGS

KEYWORDS: Wenchuan earthquake, reconnaissance, building damages

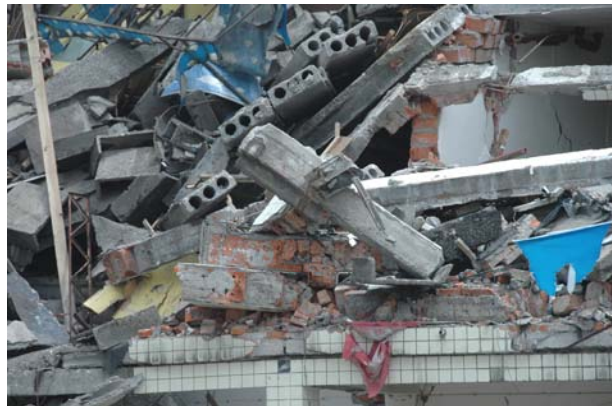
Figure 1 Photographical close-up view of the collapsed Employee Dormitory of the 3rd People's Hospital at Hanwang township, Mianzhu County after earthquake.

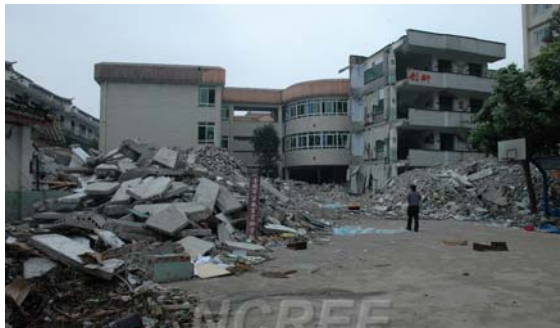
A significant number of casualties and injuries in the rural areas were associated with the total collapse of the URM and masonry buildings. Figures 2-3 show the collapsed buildings of an elementary school at Dujiangyan. Photographs also show failure and damage of commercial-residential buildings at Dujiangyan (Figures 4-9), Yingxiu (Figures 10-11), and traditional houses at Mianzhu township (Figures 12-13). Since there are no ductile structural elements in the URM and masonry buildings to resist the lateral force caused by earthquakes, it seems that structural collapse and undesirable consequences of human life losses and injuries are inevitable during a severe seismic event.

Figure 2 Collapse of elementary school buildings at Dujiangyan.

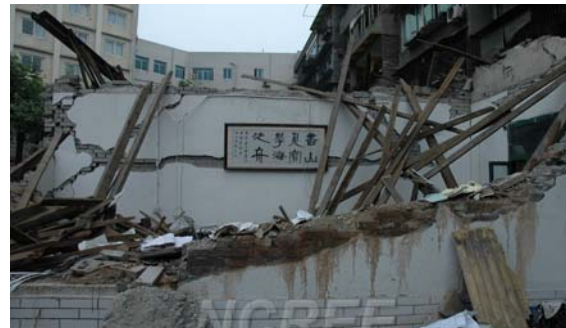
Figure 3 Collapse of elementary school building at Dujiangyan.

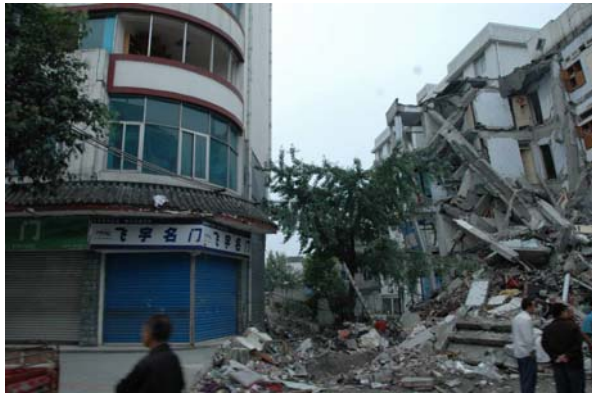
Figure 8 Collapse of commercial-residential buildings at Dujiangyan.

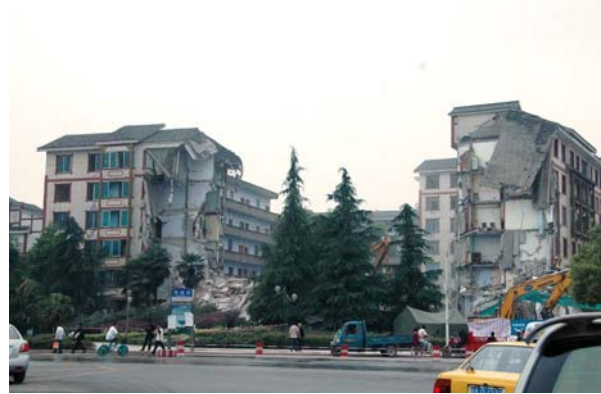
Figure 9 Partial collapse of commercial-residential buildings at Dujiangyan.

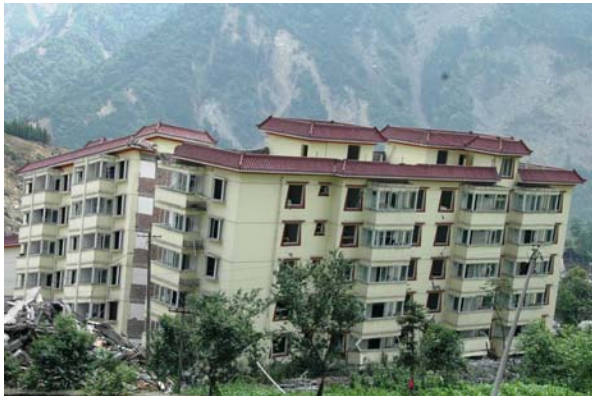
Figure 10 Soft story collapse of residential buildings at Yingxiu.

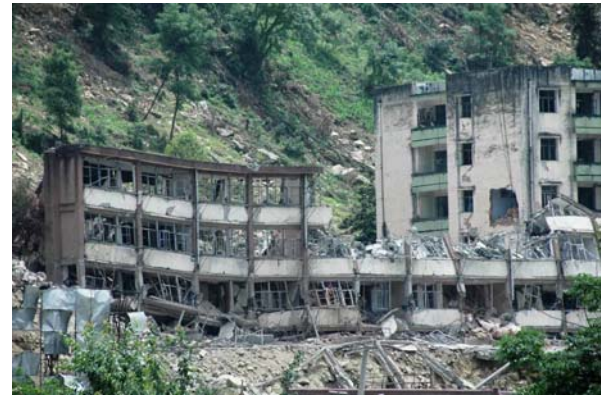
Figure 11 Collapse of residential buildings at Yingxiu.

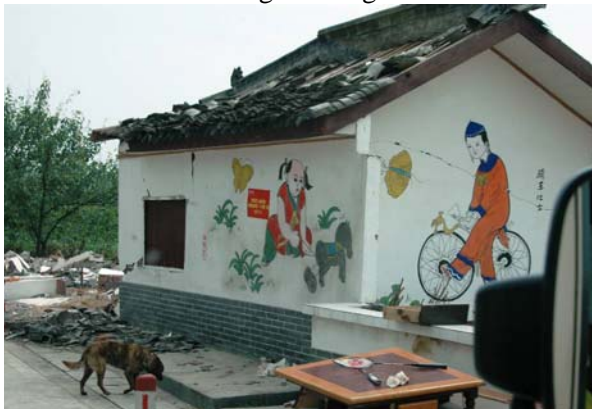
Figure 12 The black clay roof damage and wall cracking of a traditional house at Mianzhu.

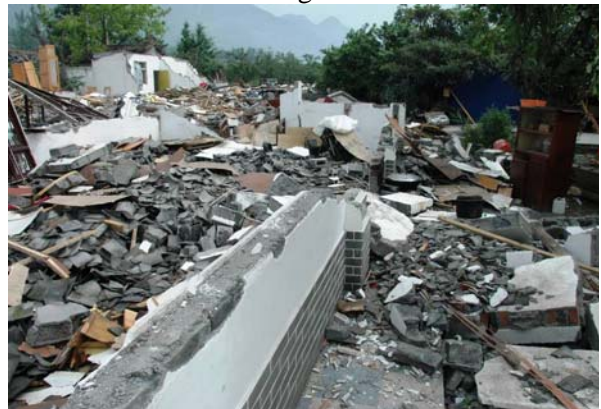
Figure 13 Collapse of traditional houses at Mianzhu.

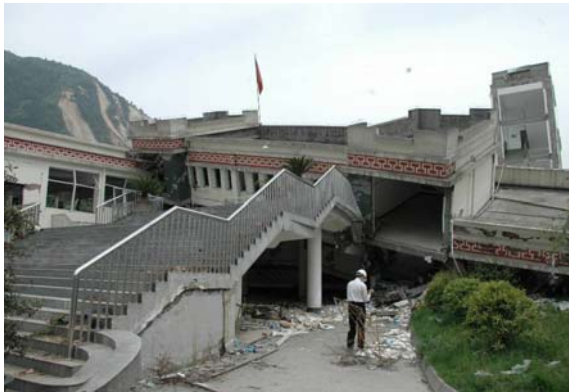
There are also engineered RC buildings that sustained severe damage or collapse, e.g., buildings of Hsuanko High School at Yingxiu Township, Wenchuan county near the earthquake epicenter as shown in Figures 14-23.

Figure 14 Total collapse of school building.

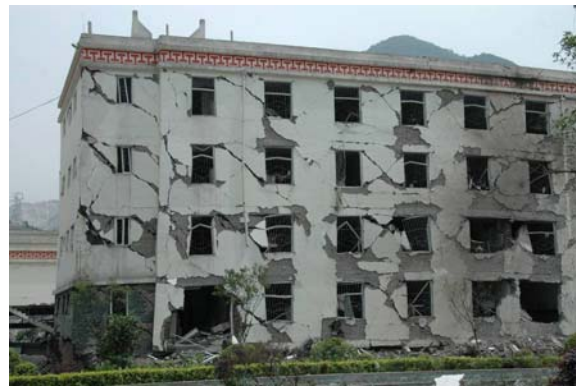
Figure 15 Severe diagonal shear cracks on the gravity wall between window openings.

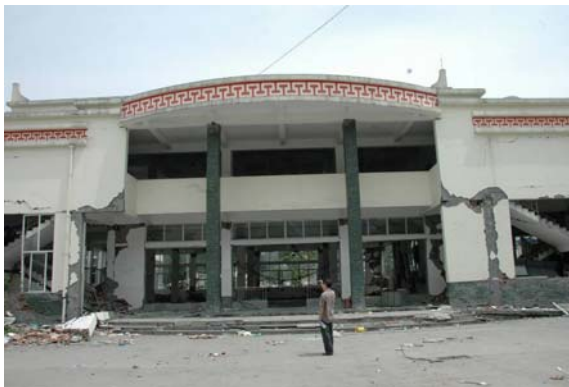
Figure 16 Severe damage of school building.

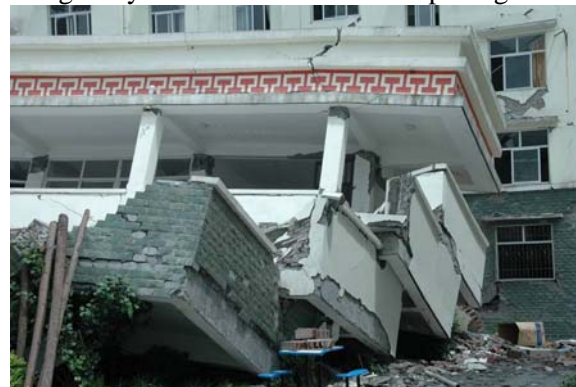
Figure 17 Pancake type of failure due to weak columns.

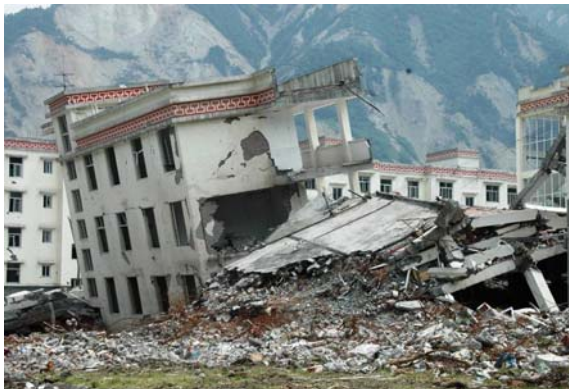
Figure 18 Collapse of school buildings.

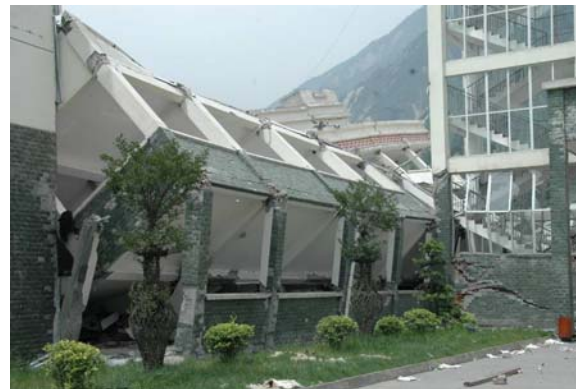
Figure 19 Building collapse due to joint failure.

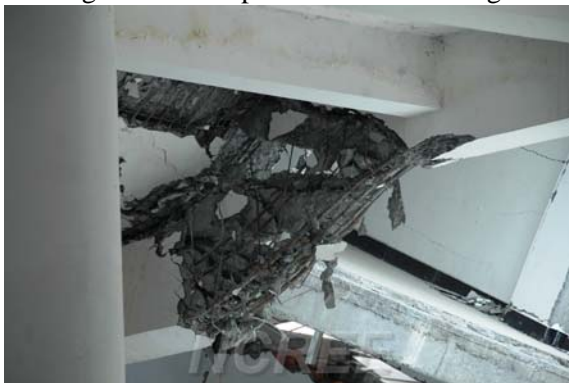
Figure 20 Column failure due to insufficient transverse reinforcement.

- (3) The design and construction practice in the earthquake affected areas indicates a lack of seismic detail, which should be avoided in the future.
- (4) Earthquake awareness and preparedness in the general public, especially schools, should be raised to a new level after the earthquake.

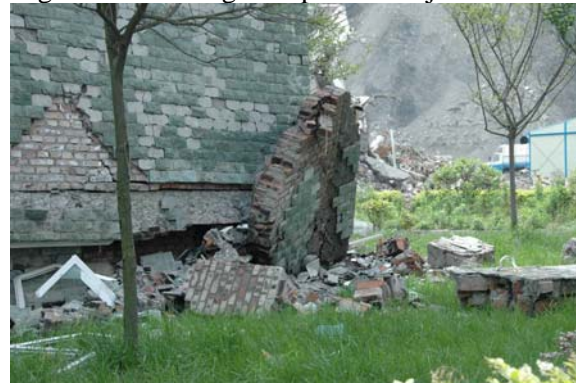
Figure 21 Soft story collapse.

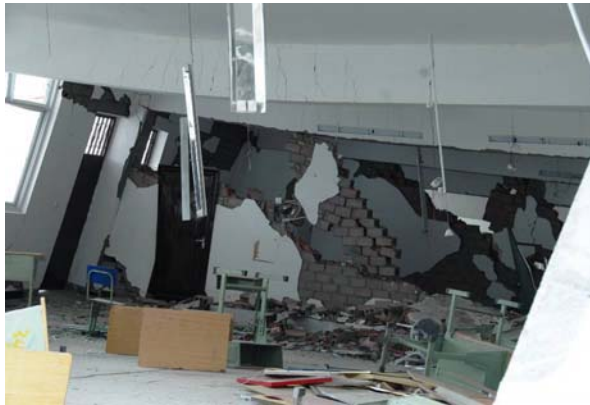
Figure 22 RC beam and nonstructural partition wall failure in the classroom.

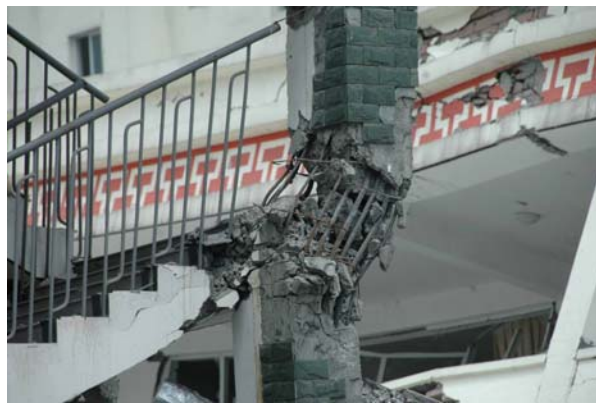
Figure 23 Column failure due to insufficient transverse reinforcement.

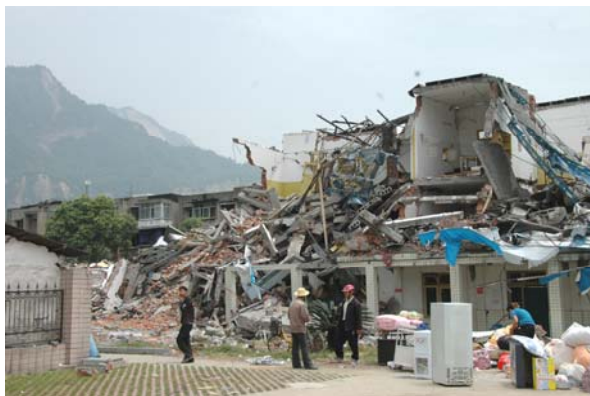
Figures 24-25 show the collapsed buildings of the 3rd People's Hospital at Hanwang township, Mianzhu County. Unfortunately, these four-story URM buildings collapsed during the earthquake hit, and they were not able to operate with normal function to rescue the injured and save lives right after this natural catastrophe.

Figure 24 Collapsed Employee Dormitory of the 3rd People's Hospital at Hanwang township, Mianzhu County after major aftershocks.

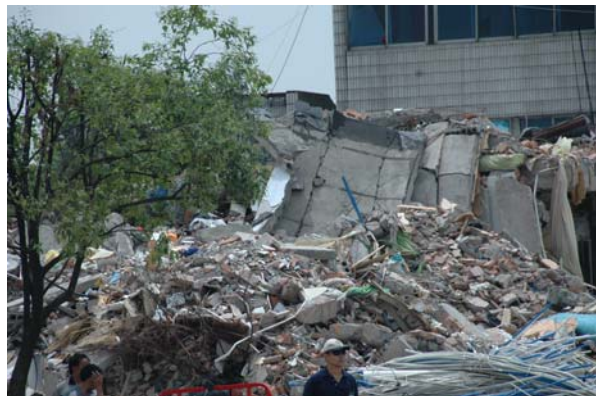
Figure 25 Building collapse of the 3rd People's Hospital at Hanwang township, Mianzhu County.

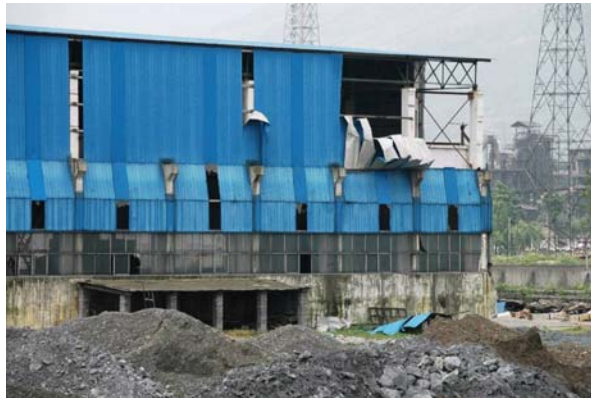
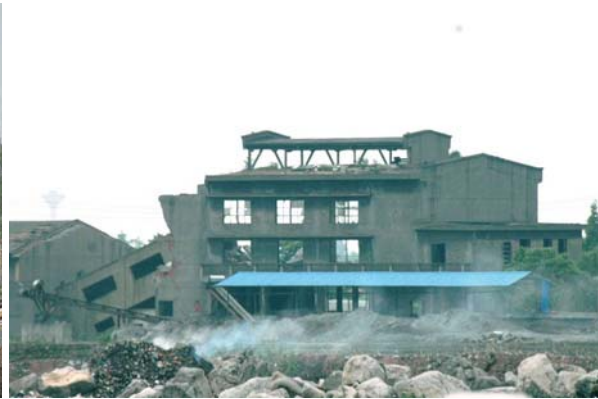
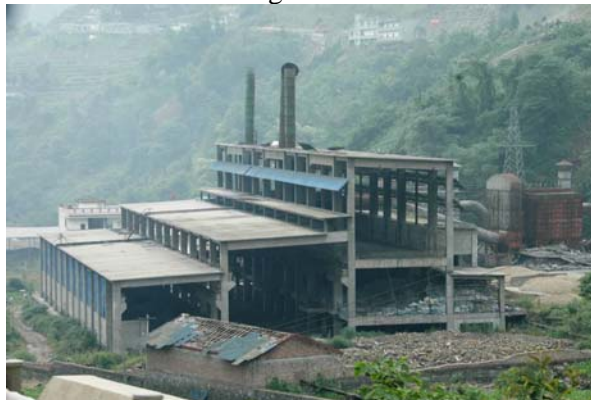
Figure 26

Figures 26-28 show the damaged factories and Figures 29-32 show the undamaged towers and chimneys in the earthquake affected region. The towers and chimneys may have a lower natural frequency than dominant frequency content of the seismic waveforms, which may have helped survive high accelerations. Figure 33 shows a clock tower, on which the time stopped at 14:28pm when the earthquake hit Hanwang township.
