WENCHUAN EARTHQUAKE (MW 7.9, 12 MAY 2008) SICHUAN, CHINA. GEOTECTONIC REGIME AND DAMAGE MACRO-DISTRIBUTION

E.L. Lekkas¹

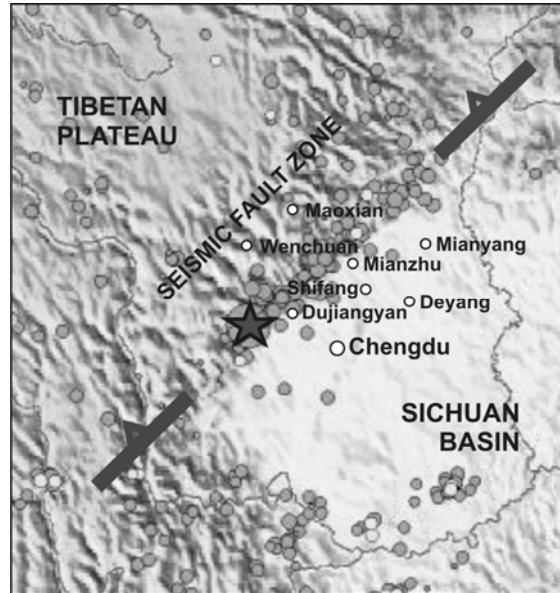
Figure 3: Geographical map of the affected region with the epicenter location (USGS, 2008) and the seismic zone location.

By the research carried out throughout the earthquake affected area which is of the order of 40.000 Km², the following damages were recorded for every urban centre or region (**Figure 3**):

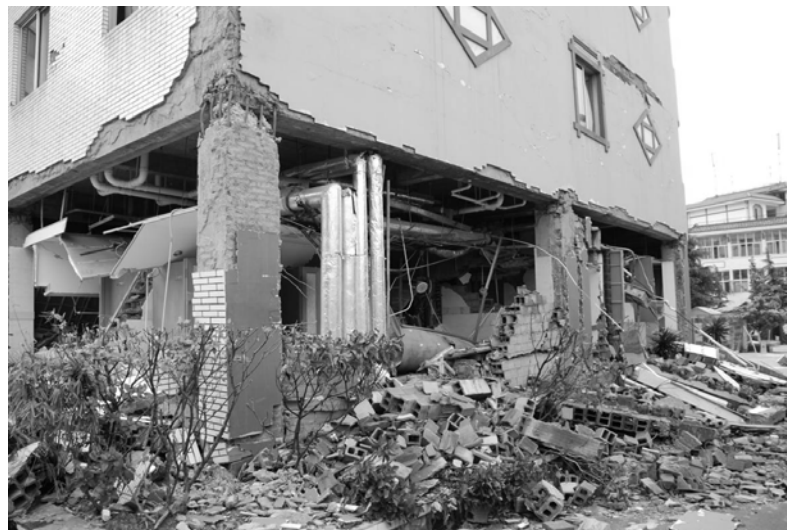
Figure 4: View of a building in Dujiangyan founded on river deposits with serious structural damages on the ground floor props. (type of building D, damage degree 4).

In the town, approximately 300 constructions collapsed while 25% of the buildings suffered serious construction damages. Mainly multistory buildings collapsed, modern or older, constructed of reinforced concrete. Most collapses are located on the foothills of the mountainous region towards the west and the morphologically higher areas and less on the lowlands. Especially interesting are the new buildings that are under construction of modern antiseismic design at the higher elevations of the town that collapsed or underwent serious foundation damages. In

these areas, it seems that the nature of the founding ground which is composed of remnants of river deposits and debris of limited thickness on the rocky background played a determinant role. It is estimated that 50% of the building collapses observed in this town were founded on similar deposits and are located in the same morphological unit, (**Figure 4**).

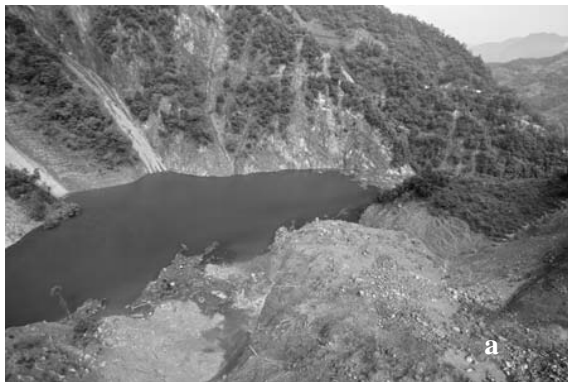
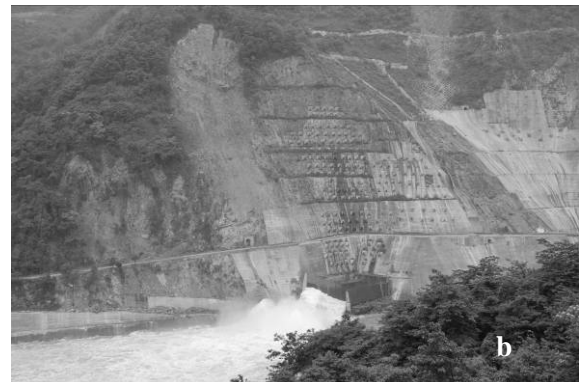
Figure 5: View of large-scale landslides that formed natural dams and lakes along the river course (a) and view of a landslide triggered above the exit of the Zipingpu dam's emergency spillway causing considerable damages (b).

As a result of this morphological, geological – geotechnical frame, were the general damages that old and new constructions suffered. It is characteristic that in the Wenchuan region, 85% of the constructions collapsed partially or totally while the rest suffered significant structural damages. It is indicative that only a few buildings did not collapse. Furthermore, all the bridges and road network collapsed while in general, the infrastructure suffered considerable damages within and beyond the urban centre. In addition, in many locations, large scale landslides were triggered that completed the frame of total destruction (**Figure 5**).

An unusual behaviour was exhibited by the existing dams in the mountainous region. More specifically, according to official data, from the 450 dams (large or small) in the region, 300 of them suffered considerable damages while some caused serious problems downstream due to the incontrollable water flow. In a great number of dams, the crown was destroyed and the connection between the two sides of the dam was not possible, blocking the road network for large areas. It is estimated that 30% of the dams in the mountainous region have been completely destroyed and their repairing is not possible. The estimated intensity for this region is $XI_{EMS-1998}$ while in some locations approached $XII_{EMS-1998}$.
