## EXPERIMENTAL TESTS ON MASONRY STRUCTURES PROVIDED WITH SHAPE MEMORY ALLOY ANTISEISMIC DEVICES

### SUMMARY

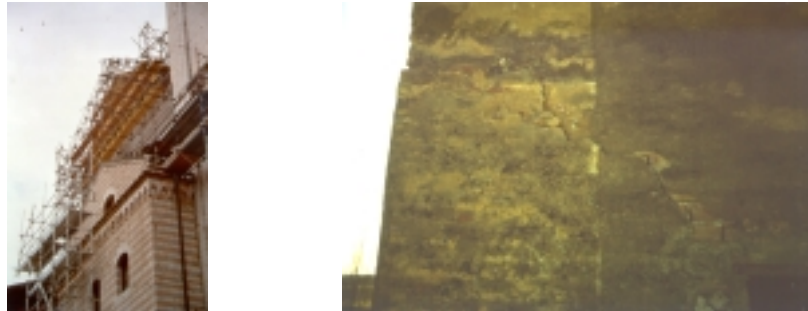
**Figure 1: the Bell-Tower of the S. Giorgio in Trignano Church in S. Martino in Rio, damaged during the October 1996 earthquake (right), and the transept tympanum of the Basilica of S. Francesco in Assisi, damaged during the September 1997 earthquake (left).**

The use of SMADs has proved very effective in improving the seismic resistance of the aforesaid structures. The successful results of the research led to two restoration applications now under way in Italy: the Bell-Tower of the S. Giorgio in Trignano Church in S. Martino in Rio, damaged during the October 1996 earthquake [Forni *et al.*, 1997], and the transept tympana of the Basilica of S. Francesco in Assisi, damaged during the September 1997 earthquake [Crocì 1998, a-c].

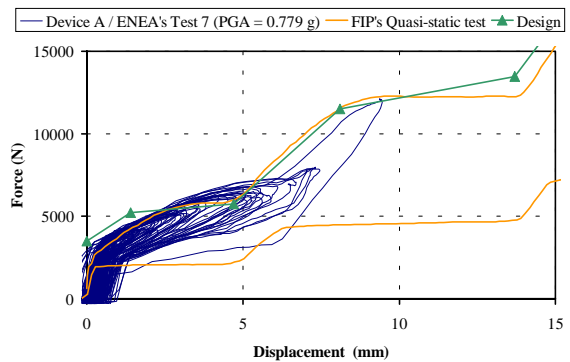
**Figure 4b: Comparison between SMA design, quasi-static and dynamic tests.**

The devices remain in their first plateau (*cf.* Figure 4 § 2) up to test n° 6 (PGA=0.65 g). In test n° 7, it is worth noting a stiffness increase (*cf.* Figure 4b).

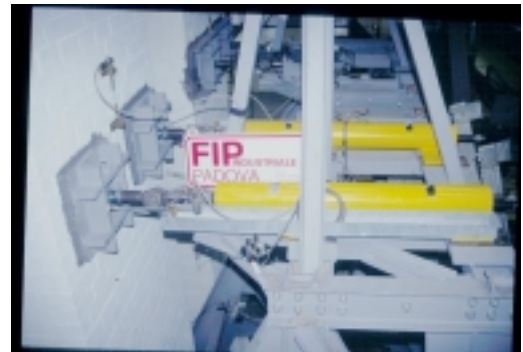
Figure 5: Mock-ups used in the shaking table tests (left) and wall connection with a steel frame through SMADs (right) with SMA connections

Two identical masonry wall mock-ups were constructed, each connected to a stiff steel frame, and placed together on the shaking table. In fact, both of the brick walls simulate a portion of a historical building façade, whilst the steel frames represent the remaining part of the structure. Their only difference is the type of connection: the first wall is linked up to the rigid frame by two conventional steel bars while the second is connected by a pair of innovative SMADs. The geometry of the testing mock-ups is shown in Figure 5-left.

The SMADs are of the multi-plateau, self-balanced type, with a design initial force of 3.5 kN, and a first plateau force equal to 5.2 kN. Both the conventional and SMA devices (Figure 5-right) were anchored to the walls using steel plates. Load cells were interposed between each device and the anchorage

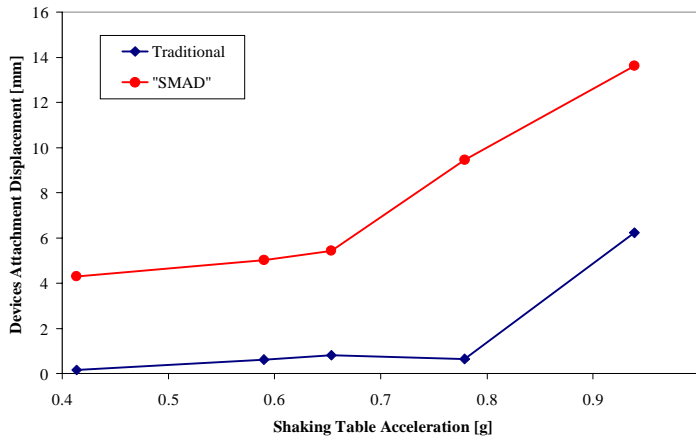
**Figure 8: Devices attachment horizontal displacement versus shaking table acceleration.**

Furthermore, Figure 8 confirms the greater SMADs horizontal "controlled displacements" (*cf.* § 2b) at the connections: in test n° 8, about 15 mm (6 mm in traditional devices), in order to reduce acceleration and avoid collapse.

The second plateau is reached only in test n° 8, where a displacement of about 15 mm was recorded (*cf.* Figure 8).

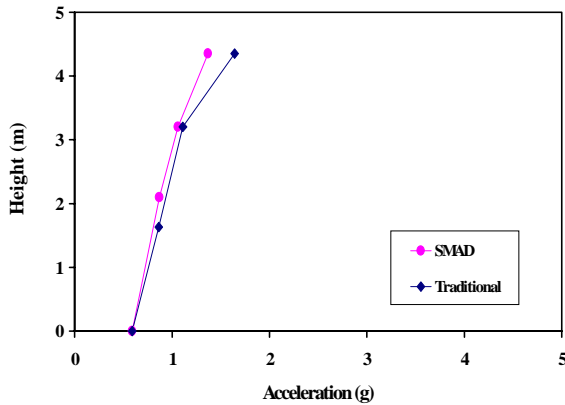
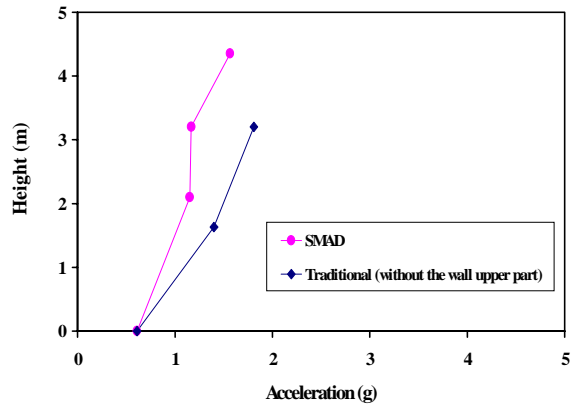
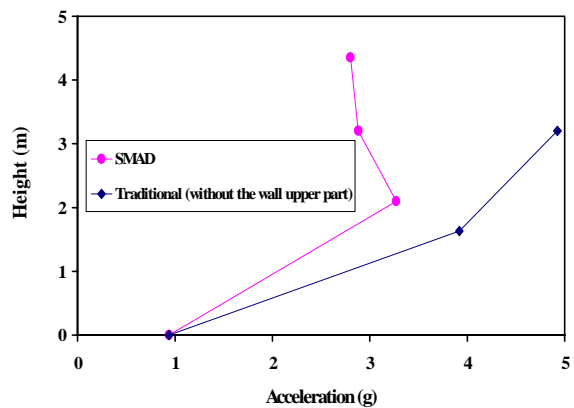
**a) PGA=0.5898 g** **b) PGA=0.6114 g**

**c) PGA=0.6535 g** **d) PGA=0.9390 g**

*collapse of the upper part of the wall with traditional steel connections*

*complete collapse of the wall with traditional steel connections*

**Figure 9: Peak acceleration values on the two walls, measured at different heights, and comparison between SMAD and traditional connections.**

The different behavior of the two walls can be understood comparing the wall top acceleration time-histories and the peak acceleration values measured at different points along the walls (*cf.* Figures 6 and 9a-d; in particular, 9c shows such a comparison in reference to the collapse of the upper part of the wall with traditional steel connections).

It is worth noting (*cf.* Figure 9c) that the top maximum acceleration reached in the wall with traditional connections in test n° 6 (2.9 g) is even higher than the one reached (2.8 g) in the SMADs wall subjected to a PGA 1.4 times higher (test n° 8, *cf.* Figure 9d).

Amplification values between the shaking table and the wall top are 4.4 (traditional devices) and 2.3 (SMADs); instead, at the connections level (always test n° 6), the table acceleration is amplified by 3.6 and 1.4 (traditional devices and SMADs respectively). This shows the effectiveness of the new tying technique employing SMADs in reducing the acceleration amplification, owing to the reduced stiffness, force limitation and energy dissipation offered by the superelasticity of SMA.

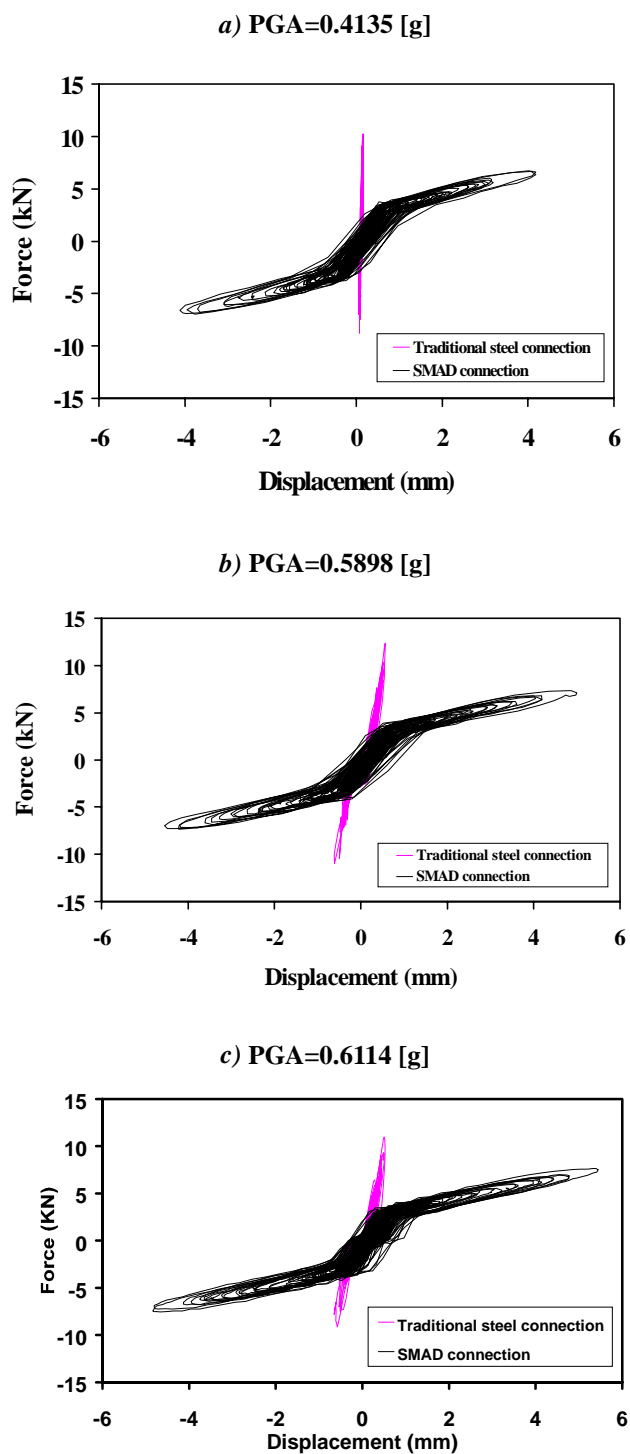
Figure 10: Force vs. displacement loops measured in the connections at increasing seismic intensity.

Figure 10 shows the force reduction and displacement increase in the SMAD connections, compared to the very stiff steel connections. The max force peak is reduced by 45 % in test n° 6, when the traditional devices wall collapsed at the connections (force=13.3 kN). Furthermore, the SMAs wall didn't show any damage till an equal force was reached in test n° 8. Figure 10 shows also the SMAD force-displacements loops at increasing earthquake intensities.
