A SHAKING TABLE TEST OF REINFORCED CONCRETE FRAMES DESIGNED UNDER OLD SEISMIC REGULATIONS IN JAPAN

Namihiko INOUE¹, Eiichi INAI², Akira WADA³, Hiroshi KURAMOTO⁴, Isao FUJIMOTO⁵ And Masanori IIBA⁶

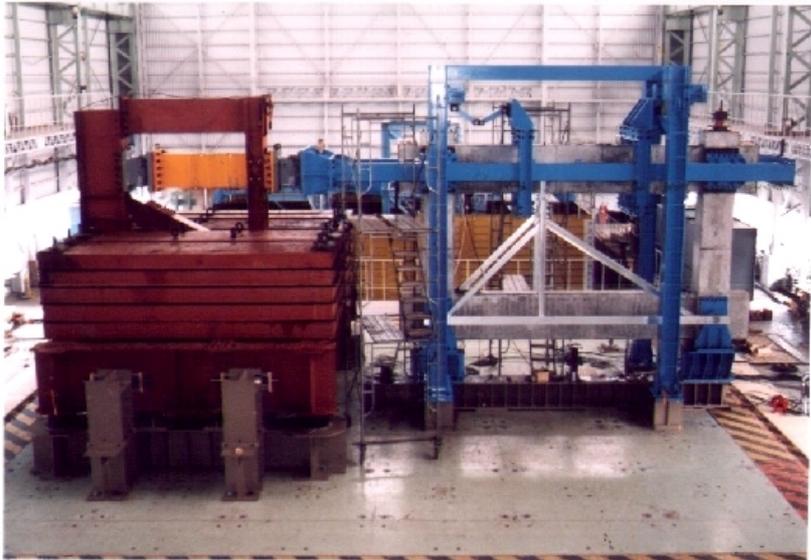
The experimental facilities on the shaking table are illustrated schematically in Figure 4 and shown in Photo 1. The RC specimen is settled on hinged supports at the bottom of columns. To adjust the natural period of the specimen to that of the prototype building with five-stories, 4 rubber bearings are installed between a load beam and an upper beam of the specimen. The resonant period of the specimen is 0.6 seconds under small excitation.

Photo 1: Experimental Facility on Shaking Table (in Science and Technology Agency)

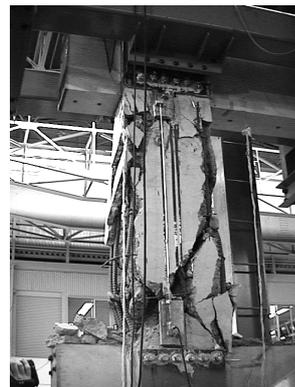
Photo 2: Damage Situation (specimen C)

There were two specimens, A and C, used for dynamic test. The specimen C was also used for the performance evaluation of energy absorbing devices (details are shown in another paper for this conference). The relationship between horizontal load and displacement are shown in Figure 8. During excitation, after 8 seconds passed, shear failure of columns occurred after flexural yielding at the beam ends and the specimens completely lost its lateral load carrying capacity. The inter story drift and observed lateral restoring force at the failure points are about 25mm and 110tonf respectively. Figure 9 shows the damage situation (tensile yielding of steel bars) of the specimen C. The yielding of main bars in beams were started at displacement about 20mm prior to that of column reinforcement bars. Finally there were shear failures with bond split failure in columns after reduction of restoring force around 25mm displacement. See Photo 2.

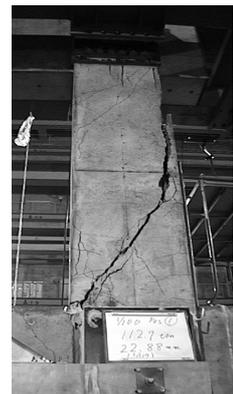
Photo 3: Damage Situation (static test)

In addition, a static test was also carried out using the same facilities except shaking table but reaction wall and oil jack (specimen B). To define the load schedule, time history of inter story drift obtained from shaking table test had used. From the time history we picked the appropriate displacement level and rearrange them in order. See Figures 10 and 11. In the static test, the shear failure of columns occurred at drift angle 1/117 (Photo 3).
