INNOVATIVE RETROFIT TECHNIQUES FOR SEISMIC RETROFIT OF CONCRETE ARCH BRIDGES OF EARLIER VINTAGE

Raj VALLUVAN¹, John STEPHENSON², Don BERGMAN³, Peter BUCKLAND⁴ And Dave PAJOUHESH⁵

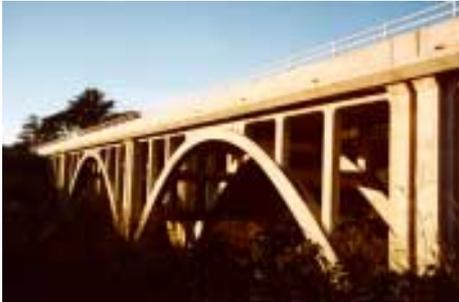
Dynamic analysis of the as-built arch bridge structure and its observed behaviour led to the development of an innovative retrofit concept. Typical seismic retrofits are reactive, in that they provide the existing structural elements with sufficient strength and ductility to withstand anticipated seismic effects. However, for this bridge, (Fig. 5) the only viable retrofit option was a proactive re-engineering of the seismic load path.

Figure 5 The Arroyo Quemado Bridge Before Seismic Retrofit

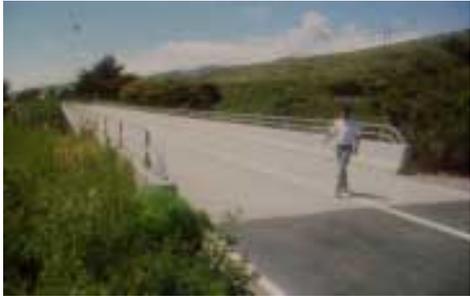
- Existing 6-inch asphalt paving was replaced by a reinforced concrete deck overlay (Fig. 6); expansion joints between the arch and approach spans and at other intermediate locations were eliminated to make the overlay continuous from the centre of the bridge back to the bridge abutments.
- Tower bases were strengthened with rock anchors, and shear walls were added between the tower legs to accommodate transverse forces (Fig. 7). Shear walls were then integrated with the new deck overlay.
- Massive reaction blocks on deep CIDH piles replaced abutments. The reaction blocks were then integrated with the new deck overlay.

Figure 6 New Reinforced Concrete Deck Overlay

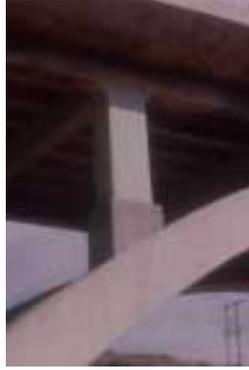
This retrofit radically altered the stiffness characteristics and dynamic behaviour of the bridge, and ensured that seismic forces would be resisted mainly by the new load path, as opposed to by the arches in the as-built bridge structure. The dynamic model of the existing bridge structure was modified to reflect the proposed retrofit. Dynamic analysis of the retrofitted bridge structure model demonstrated that the selected retrofit scheme was effective, provided that the existing bridge structure elements meet the ductility demands in the retrofitted structure. Spandrel columns and approach bent columns of the retrofitted structure undergoing substantial yield were given the necessary ductility, using reinforced concrete jacket and epoxy glass wrap (Fig. 8).

Figure 8 Column Retrofitted Using Reinforced Concrete Jacket And Epoxy Glass Wrap

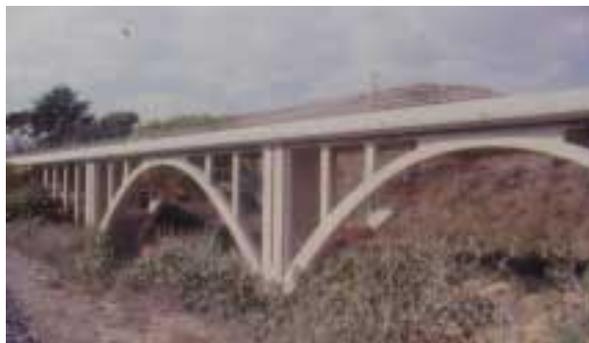
This paper discusses seismic retrofit of Arroyo Quemado Bridge, a concrete arch bridge of earlier vintage. The retrofitted bridge (Fig. 9) has already attracted two Engineering Excellence Awards, one from American Consulting Engineers Council (ACEC), and the other from Consulting Engineers and Land Surveyors of California (CELSOC). Topics discussed include seismic evaluation of existing bridge structure, dynamic analysis of existing bridge, and bridge seismic retrofit.

Figure 9 The Arroyo Quemado Bridge After Seismic Retrofit
