A VIBRATION TEST OF A LARGE MODEL STEEL FRAME
WITH PRECAST CONCRETE PANEL UNTIL FAILURE

by: R. TAMURA^(I), M. MURAKAMI^(II), Y. OSAWA^(III),
N. MIYAJIMA^(I) and Y. TANAKA^(I)

This is a paper on a vibration test carried out on a large model until failure, to study the earthquake resistance of a steel frame apartment house constructed with precast concrete wall panels.

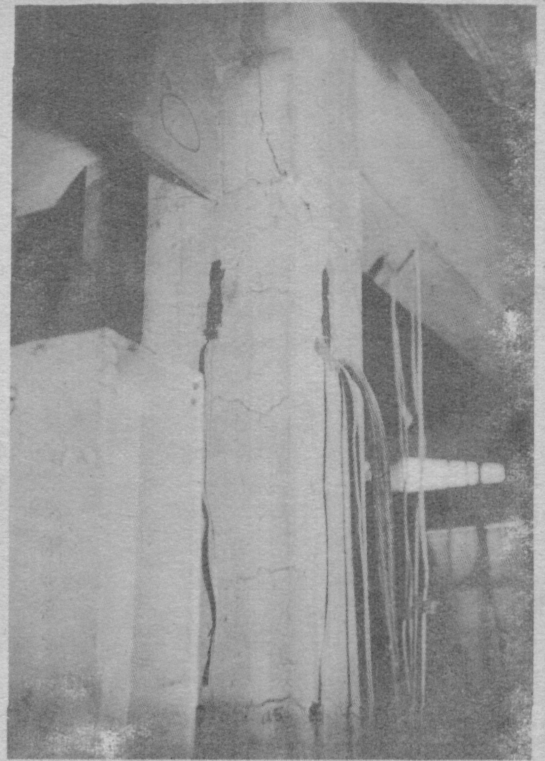
Fig 14

In the 1.5-ton constant loading test, D 60, the cracks in outer frame column concrete head became considerably and concrete fragments were observed coming off as the cracks became bigger or smaller during vibration (Fig. 14).
