LESSONS FROM SOME RECENT EARTHQUAKES IN LATIN AMERICA

by Luis Esteva* Octavio A. Rascón * and Alberto Gutiérrez**

Synopsis

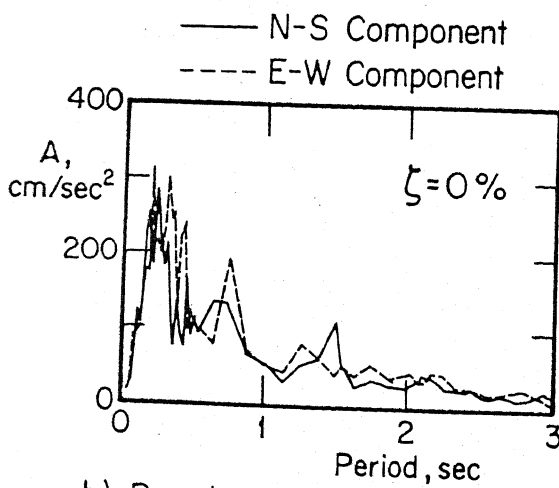
b) Pseudo-acceleration spectra on hard ground

In this study, actual spectra on rock for the earthquakes of July 1964 (fig 1a) in Mexico City are multiplied by the magnification factors in order to obtain the predicted spectra on soft soil. Fig 1b shows the properties of the layers of soft material for a zone in Mexico City for which spectra were obtained from strong motion records. These parameters were estimated by combining geophysical results³ with laboratory tests⁴. This was a necessary step, since amplification factors are very sensitive to variations in properties and thicknesses of the layers, mainly near the dominant period of the spectrum. Thus, a change in the thickness of the top layer from 15 to 14 m, of its rigidity modulus from 90 to 120 kg/m², and of its shear wave velocity from 27 to 30 m/sec, shifted the dominant period from 2.45 to 2.15 sec.

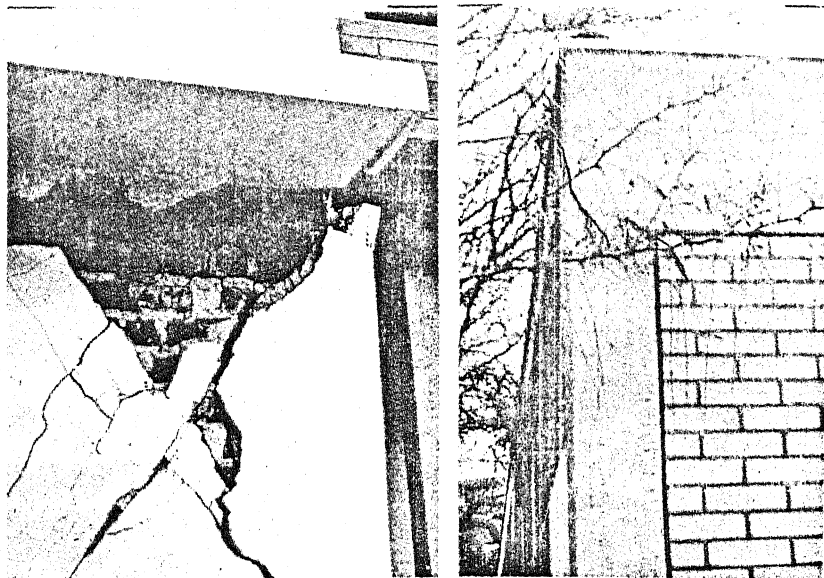
a) Thrust of wall panels on frame corners

b) Failure of frames confining wall panels

Fig 6 Unadequate reinforcement at girder-column joints

The problem depicted in fig 6a is virtually ignored by many designers. The presence of masonry wall panels filling the bays of reinforced concrete frames may produce interaction stresses at the ends of the members. Since the stiffness of the masonry panel is usually several times the one of the frame, a great portion of the seismic shears is taken by the wall. This in turn induces exceptionally high interaction stresses. The photographs in fig 6b were taken in Acapulco and Lima. They show the type of failure which may occur as a consequence of neglecting this interaction. A quantitative criterion for providing reinforcement intended to avoid this type of failure has apparently not been developed. From the behavior of laboratory specimens, diagonal cracking of the frame is known not to occur before that of the wall.¹³ Therefore, if wall failure is not expected for sufficiently strong

earthquakes, no special provisions seem necessary. However, if the wall is not sufficiently strong, it is advisable to substitute it by an even weaker panel and thus limit its interaction stresses with the frame. This recommendation stems from the advantages of the strength-plateau behavior and from the fact that it is usually more expensive repairing the frame corner than building a new wall panel. Alternate solutions comprise construction of flexible joints between wall and frame, or reinforcement of the latter's corners. Experimental information is desirable in order to accomplish economical solutions of the last type.
