RELEVANT MASONRY PROYECTS CARRIED OUT IN THE STRUCTURES  
LABORATORY AT THE CATHOLIC UNIVERSITY OF PERU

SUMMARY

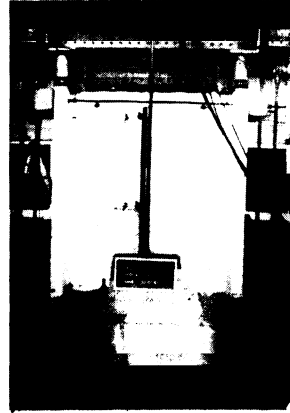
Fig.2  
Unreinforced Wall  
After Testing  
(Project I)

In Projects I vertical load was applied prior to cycling (see Fig.2). The test finished when diagonal cracking of the wall occurred. Typical displacement histories in Projects II and III are shown in Figs. 4 and 9 respectively. In Project III the first wall of each type was tested monotonically.

Unreinforced clay masonry walls behaved in an almost linear elastic fashion until fragile diagonal cracking occurred. The shear strength ( $v_R$ ) at this point was linearly correlated to the vertical stress ( $f_v$ ) as follows:
