Design of base isolated buildings built right above a fault

Takao Nishizawa & Kazuhiro Yoshihara

NIKKEN SEKKEI LTD. Structural Engineering Department, Dr.Eng., Japan

Keywords: Active fault, Base-isolated buildings, Method of structural design, Strike-slip fault, Fling step

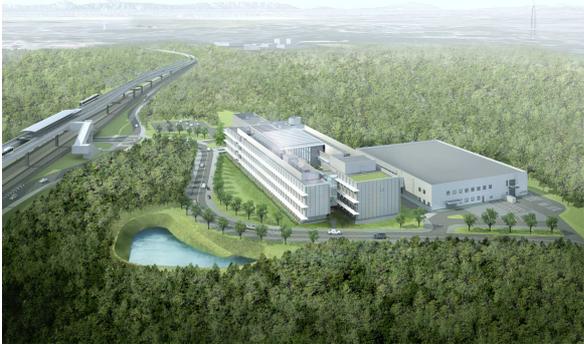
Figure 1. Appearance of the building

base-isolated building avoiding these faults, with a roof arched across the wings, which creates atrium space right above the faults and helps the building stand right above the faults. An outline of the building, the appearance of the building, the positional relationship between the layout of the building and the faults, a plan view of the building, and a cross section of the building are shown in Table 1 and Figures 1, 2, 3, and 4, respectively. Situated not only close to the faults but also in a region that must develop countermeasures against subduction-zone giant earthquakes of high incidence, the building adopts a base isolation structure, making it possible to protect human lives and research achievements.
