# EEFIT Field Observations and Lessons from the 11<sup>th</sup> March 2011 $M_w$ 9.0 Tohoku Earthquake: Ground Motion and Shaking Damage

## SUMMARY:

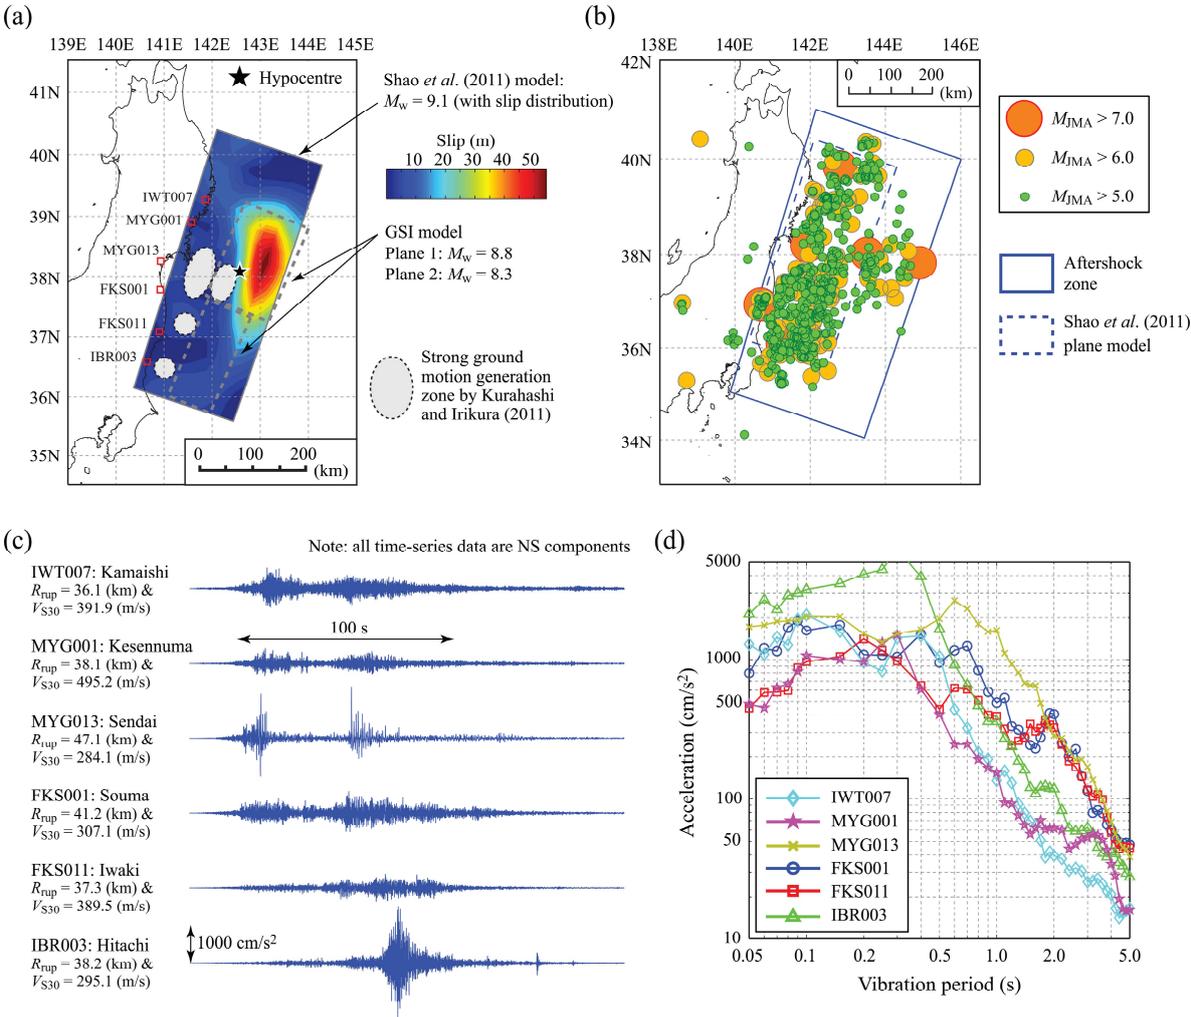
**Figure 1.** Characteristics of fault rupture and ground motions of the 2011 Tohoku earthquake: (a) fault plane, (b) aftershock activity, (c) acceleration time-history data at six K-NET stations, and (d) 5%-damped response spectra at six K-NET stations.

The estimated rupture plane of the 2011 Tohoku earthquake was 400-500 km long and 100-200 km wide. Rupture planes indicated by Shao *et al.* (2011) and by the Geo-Spatial Information Authority (GSI) of Japan (2011) are illustrated in Figure 1a, covering a wide spatial area from northern Iwate prefecture to southern Ibaraki prefecture. They were derived by focusing on macroscopic features of observed ground deformation and inversion of teleseismic data (i.e. long-period motions). The contour map of the estimated slip distribution indicates a significant amount of permanent ground deformation/slip occurred along the trench line off-shore the Tohoku region, which is responsible for the generation of massive tsunamis. The mainshock also triggered numerous aftershocks; persisting tremors and occasional major aftershocks made evacuees and residents uneasy and disrupted rescue and restoration activities in a post-disaster situation. Figure 1b shows aftershock activities following the mainshock. About 100 aftershocks with magnitudes greater than 6.0 occurred; several major aftershocks aggravated seismic damage to buildings and infrastructure (e.g.  $M_w 7.1$  inslab event on 7<sup>th</sup> April 2011 and  $M_w 6.6$  crustal event on 11<sup>th</sup> April 2011).

The complexity of the rupture process can be seen by inspecting recorded acceleration time-series data at six K-NET stations along the coast (Figure 1c). Although these acceleration time-history data were observed at similar rupture distances ( $R_{rup}$ ) from the fault plane and similar local site conditions (represented by the average shear wave velocity in the top 30 m  $V_{S30}$ ), they show very different temporal features as well as frequency content of the acceleration data. For the latter, 5%-damped response spectra of the six ground motions are compared in Figure 1d. For instance, two phases of seismic wave arrivals are present in acceleration data at IWT007, MYG001, and MYG013, while a single phase of seismic wave arrivals with very large amplitudes is featured at IBR003. Large observed ground accelerations are generated from localised strong motion generation areas or

asperities along the coast (Kurahashi and Irikura, 2011); such areas within the fault plane are indicated in Figure 1a with grey ellipses. These localised zones are associated with large stress drops (thus radiating strong short-period motions). The proximity to the southernmost asperity led to a single strong phase of seismic wave arrivals at IBR003, whereas more than two localised ruptures contributed to the two-phase arrival of seismic waves at IWT007, MYG001, and MYG013 (note: there are time gaps between the ruptures of the asperities). Figure 1d shows that the dominant frequency content varies significantly, depending on the locations. Generally, they are rich in the short-period range, whereas response spectra at MYG013, FKS001, and FKS011 have rich spectral content in the intermediate-period range (between 0.5 s and 1.5 s). It is also noteworthy that the shape of the response spectra varies significantly among the six stations (e.g. FKS011 versus IBR003), suggesting the importance of capturing local features of the rupture propagation process for improved prediction of ground motion parameters due to a large earthquake.

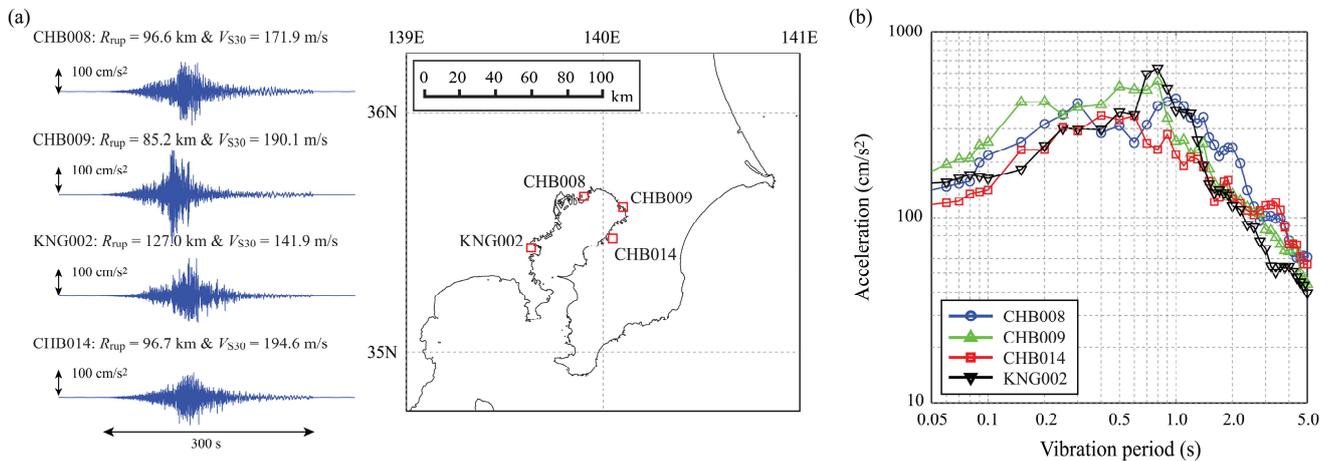
**Figure 2.** Characteristics of ground motions of the 2011 Tohoku earthquake in the Kanto region: (a) acceleration time-history data at four K-NET stations, and (b) 5%-damped response spectra at four K-NET stations

From a geotechnical viewpoint, the 2011 Tohoku earthquake caused extensive and widespread liquefaction in the Tokyo Bay area (Bhattacharya *et al.*, 2011; Tokimatsu *et al.*, 2011). The liquefied areas were mostly located at reclaimed land with low soil strength. To show typical recorded ground motions in the Tokyo Bay area, recorded acceleration time-series data at four K-NET stations are presented in Figure 2a. The selected stations are at soft soils ( $V_{S30}$  less than 200 m/s). The recorded

ground motions at the four stations are similar and have the peak ground acceleration (PGA) of about 100-200  $\text{cm/s}^2$ , and the duration of strong ground motion part is long (100 s or more). Such site and ground motion characteristics promote the occurrence of significant liquefaction. Moreover, to show the frequency content of the observed ground motion records, 5%-damped response spectra of the four records are shown in Figure 2b. The dominant period of the recorded ground motions at these sites ranges from 0.75 s and 1.25 s, and short-period content of these records is relatively low.

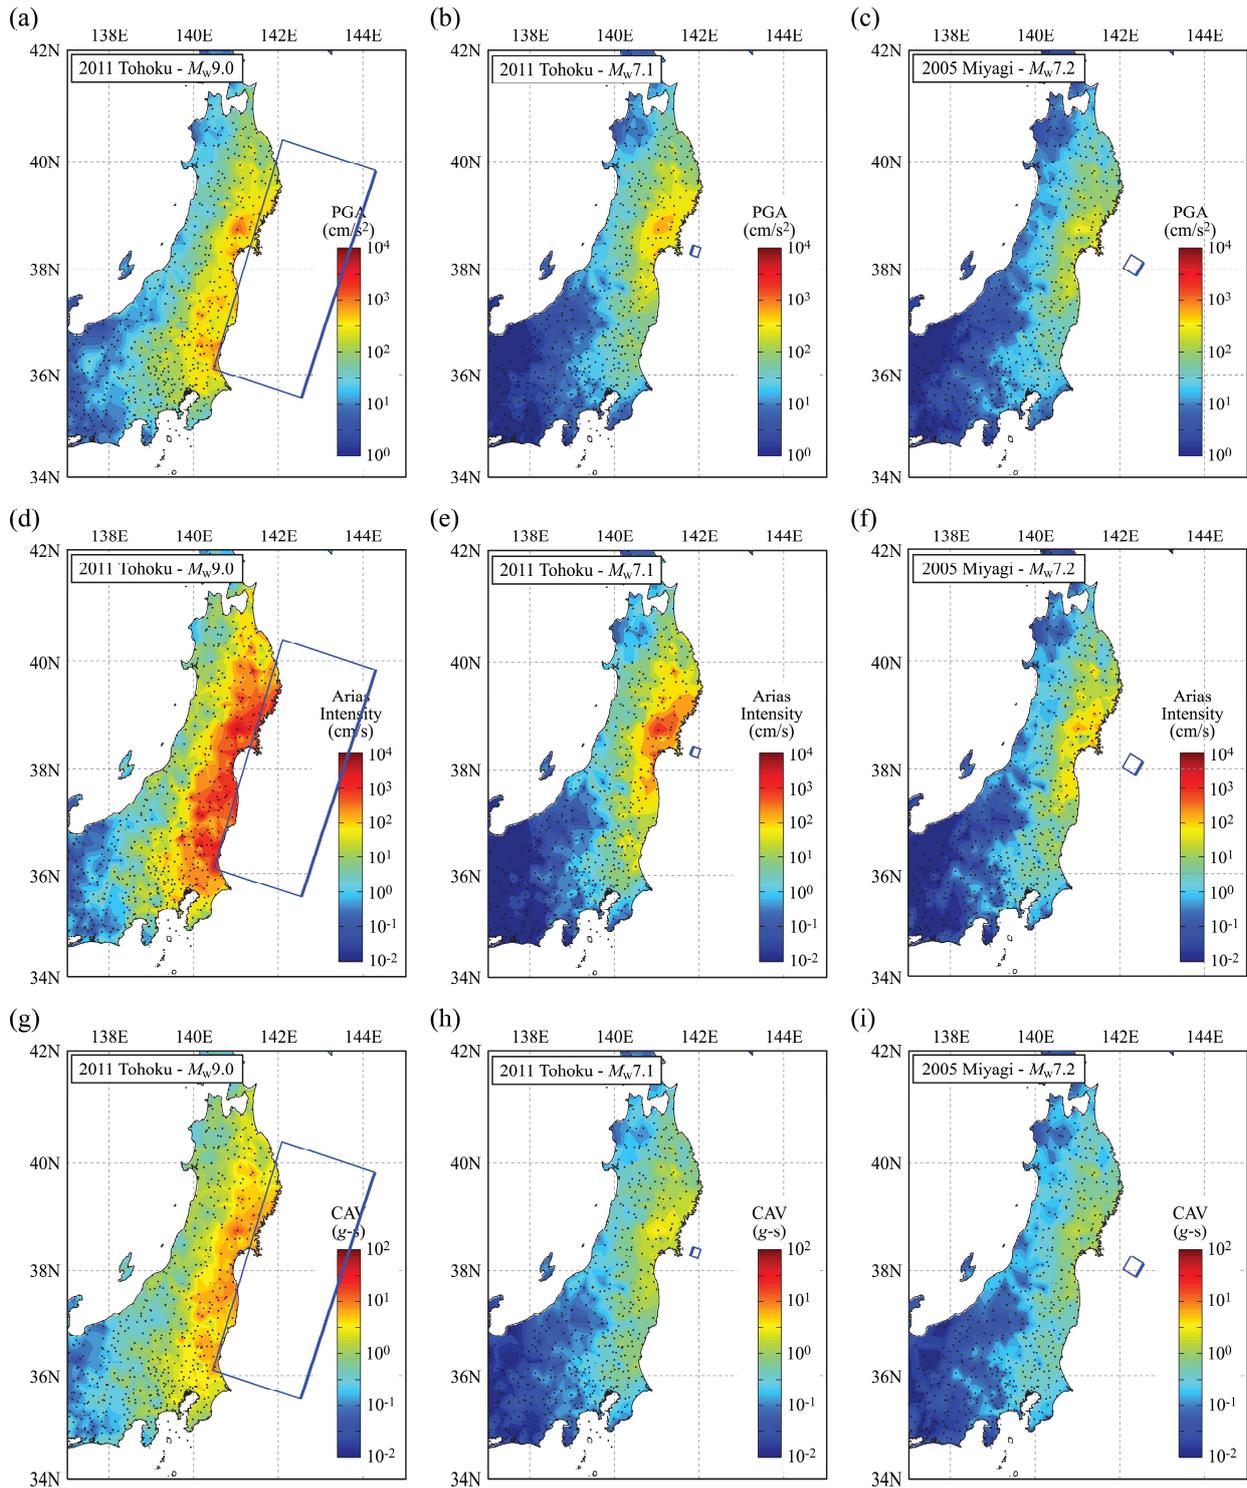
**Figure 3.** Contour maps of PGA, Arias intensity, and CAV for the 2011 Tohoku mainshock ( $M_w$ 9.0), the 2011 Tohoku aftershock ( $M_w$ 7.1), and the 2005 Miyagi-Oki earthquake ( $M_w$ 7.2): (a-c) PGA contour, (d-f) Arias intensity contour, and (g-i) CAV contour

Inspection of the results shown in Figure 3 indicates:

1. For PGA, spatial extent of the ground shaking (red/yellow-coloured areas) for the Tohoku mainshock is much larger than other events, affecting a larger population and building stock. This is important from regional/national earthquake risk management viewpoints, because seismic damage and disruption of lifelines and essential services can happen simultaneously in widespread areas.

3. The Arias intensity for the Tohoku mainshock is greater than other events. This is due to the long duration of seismic waves, and is particularly noticeable for sites at short distances, where values of Arias intensity reach 2000–4000  $\text{cm/s}$ . The magnitude scaling of Arias intensity is more significant than PGA, and this should be reflected in future ground motion prediction equations for Arias intensity.
4. Generally, the above observations for Arias intensity are applicable to CAV. Note that CAV for the Tohoku mainshock reaches 10–15  $g$ -s; this seismic intensity level has not been attained in any other events that are considered in this study. The results for Arias intensity and CAV suggest that a mega-thrust subduction earthquake with long duration can be far more destructive than smaller earthquakes.

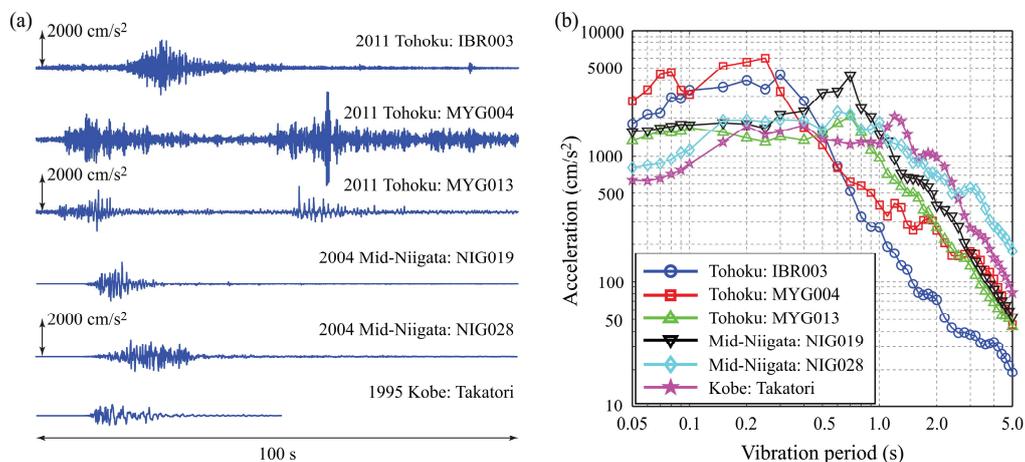
**Figure 4.** Comparison of acceleration time-history data and response spectra for very significant ground motion records from the 2011 Tohoku earthquake, 2004 Mid-Niigata earthquake, and 1995 Kobe earthquake: (a) acceleration data and (b) 5%-damped response spectra

- Overall, the Tohoku mainshock did not produce abnormally large PGA values (note: at several sites (e.g. MYG004), very large ground motions were recorded; see Figure 4). This may be explained by noting that peak ground motions are strongly affected by local features and seismic waves generated over a vast rupture area attenuate while travelling the crust. Therefore, a large earthquake size and released energy do not necessarily have significant influence on

Lastly, it is insightful to compare time-series data and response spectra of the Tohoku mainshock records, having very large PGA values, with those of significant records from past earthquakes. Figure 4 compares acceleration time-history data and response spectra for three Tohoku ground motions (IBR003, MYG004, and MYG013) with those for the 2004  $M_w$ 6.6 Mid-Niigata motions (NIG019 and NIG028) and the 1995  $M_w$ 6.9 Kobe earthquake (Takatori). Inspection of Figure 4 suggests that the Tohoku motions have larger PGA values and significantly longer duration, in comparison with those from the Mid-Niigata and Kobe earthquakes. Furthermore, the Tohoku mainshock motions have rich short-period spectral content, while the Mid-Niigata and Kobe motions have rich long-period spectral content. The latter phenomenon is due to near-fault motions (Mavroeidis and Papageorgiou, 2003), where very large velocity pulses with long vibration periods are generated due to forward directivity. The near-fault motions during the Mid-Niigata and Kobe earthquakes caused very destructive effects to structures. The above comparison explains the reason why the Tohoku motions with very large accelerations did not cause much damage/disruption to buildings and infrastructure in the Tohoku region, in comparison with the Mid-Niigata and Kobe ground motions.

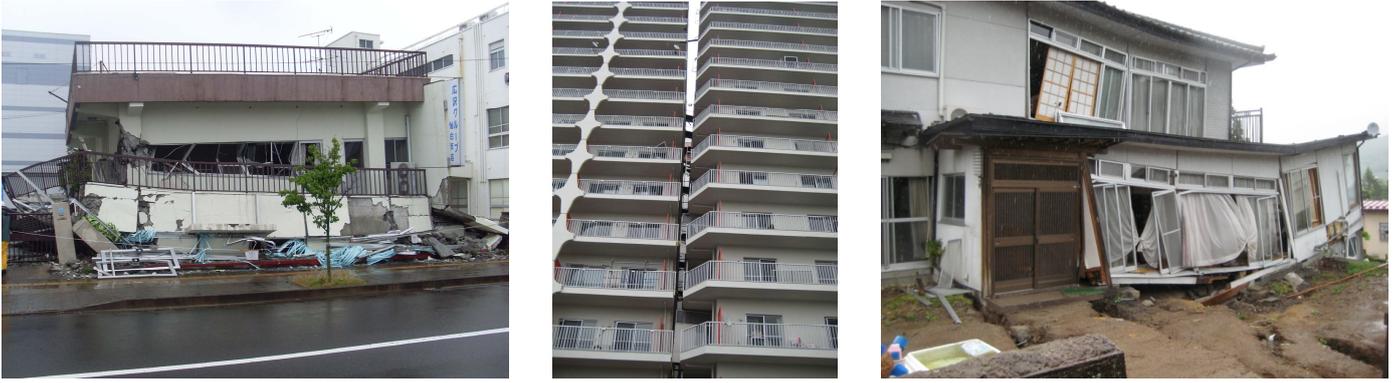
**Figure 5.** Shaking damage in Sendai

Figure 5 shows three damage cases in Sendai. The first photo is a 2-storey RC office building in Oroshi, which was completely collapsed due to soft storey mechanism. It was constructed in 1969, prior to 1981 when major improvements in seismic provisions were incorporated (Nakashima and Chusilp, 2003). In the surrounding area, several RC buildings were also collapsed or severely damaged. The second photo is a 14-storey residential apartment building, constructed in 1975. This building consists of two structures, connected by expansion joints, and forms L-shape. It suffered from damage during the 1978 Miyagi-Oki earthquake; repairs were done by replacing damaged RC walls with new ones with increased thickness (NILIM and BRI, 2011). During the 2011 Tohoku earthquake, many shear cracks on non-structural walls were observed from ground-floor to upper-floor levels. Furthermore, one of the two structures was tilted by about 2 degrees due to ground settlement (gap between two structures becomes large with height). A common factor for severely damaged structures in this area of Sendai is old RC construction in 1960s and 1970s. In the damaged buildings, several structural deficiencies were noted, such as the use of smooth reinforcement bars and insufficient reinforcement hook length. The third photo in Figure 5 shows a damaged house in Oritate, a hill-side area of Sendai, where several houses were significantly damaged due to slope instability. These houses were relatively new and were built on shallow foundation which displaced significantly due to sliding of surface soil. The affected houses were red-tagged for occupancy. The residential development was built on fill material which is less compacted and is subjected to greater seismic excitation. Houses sited at boundary areas between cut and fill suffered from significant differential strains. To prevent similar slope failure in future large earthquakes, improvements on ground, foundation, and retaining wall are necessary.

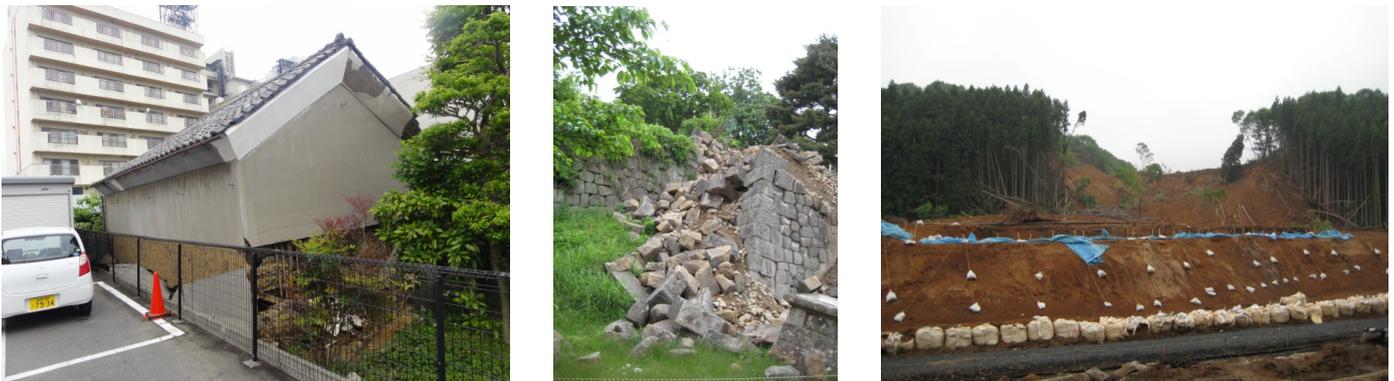
**Figure 6.** Shaking damage in Shirakawa

The first photo in Figure 6 shows the cladding and roof damage to a traditional warehouse near the Shirakawa City Office. Roof damage was seen at several sites near this location. However, there was no clear indication of significant structural damage around this area. Generally, shaking damage in downtown Shirakawa was minor. The second photo shows the collapse of a retaining stone wall at the Komine Castle due to significant out-of-plane force acting on the wall induced by large ground accelerations in Shirakawa (Table 1). In total, the collapse occurred at eight locations, north and south sides of the Castle, noting that ground shaking in the North-South direction was greater than that in the East-West direction. The third photo shows a landslide site in Hanokidaira; 13 people were killed due to this event and several houses at the foot of the slope were destroyed completely. The estimated size of the landslide was about 150 m long and 60 m wide.

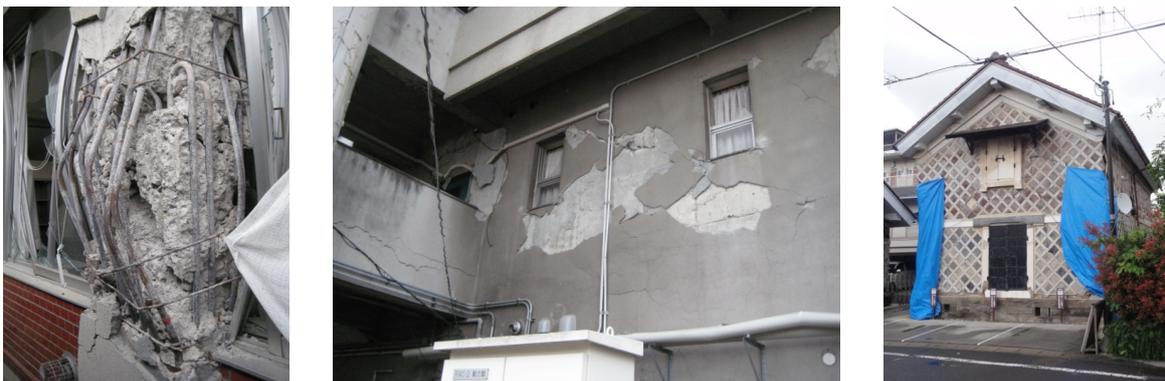
**Figure 7.** Shaking damage in Sukagawa

Figure 7 presents two damage cases in Sukagawa. The first and second photos show the damage condition of the Sukagawa City Office, a 4-storey RC building constructed in 1970 and no seismic upgrading was conducted. Many large diagonal cracks on non-structural walls and shear failures of structural walls/columns were observed. Shear failure of columns occurred at the middle height of the ground floor level. The location of the failure corresponds to the change of (amount of) reinforcement; more reinforcement was placed at joints but less reinforcement was placed in the middle of the column. A similar damage pattern was observed in the 1995 Kobe earthquake. The third photo shows the cladding damage to a traditional warehouse. A simple damage survey was conducted near the City Office; in total, 63 buildings were surveyed; 4 buildings were demolished; 4 buildings were severely damaged; and 11 buildings are partially damaged. These damage survey results are in agreement with quick inspection results in Sukagawa conducted by professional engineers and architects after the 2011 Tohoku earthquake.
