Experimental Investigation on the Effects of Steel Fibers to Reduce Steel Rebars in Beam-Column Joints of Railway Bridges

15 WCEE
LISBOA 2012

K. Shakya, K. Matsumoto & J. Niwa

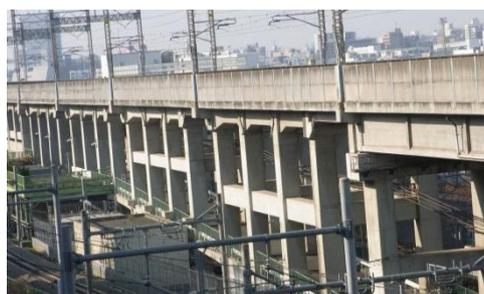
Figure 1. Rigid-framed railway bridge

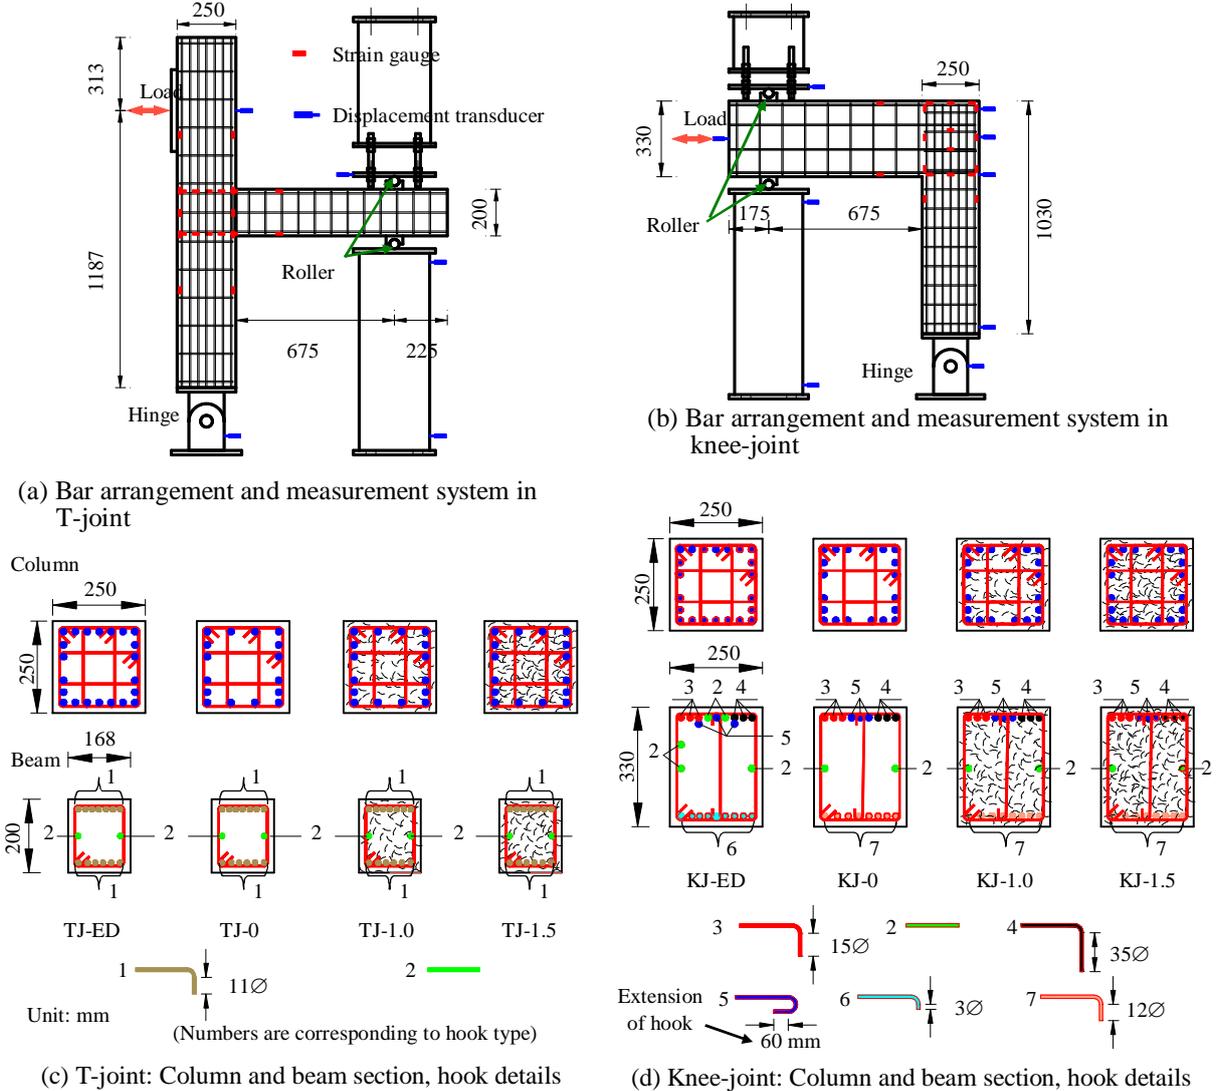
Figure 2. Specimen details

Based on the existing railway bridges in Japan, the material properties, specimen dimensions, detailing of steel rebars etc. were chosen for the test specimens. The considered existing bridge was designed following the Japanese Code, "Design Standards for Railway Structures and Commentary (Concrete Structures)" (Railway Technical Research Institute (2004)) and is referred as a prototype structure. The 1/6-scaled beam-column joint specimens are shown in Figure 2. The T-joint corresponds to half

of the column heights above and below the intermediate link beam and a half of the intermediate link beam span and the knee-joint corresponds to a half of the column height and a half of the top beam span of a rigid-framed railway bridge. The cross-sectional size of columns were 250 mm × 250 mm in both T-joint and knee-joint specimens and the cross-sectional sizes of intermediate beam in T-joint specimens and top beam in knee-joint specimens were 168 mm × 200 mm and 250 mm × 330 mm, respectively. The concrete mix was prepared according to the procedure given in JSCE (2002a) to get concrete of compressive strength 30 N/mm². The mix proportion and concrete strength are shown in **Table 1**.

In the beam and column of control specimens, TJ-ED and KJ-ED, steel rebars were provided following the structural design of the existing bridge. In the designation of the specimens TJ and KJ stand for T-joint and Knee-joint and ED stands for Existing Design. The amount of steel rebars and its properties are tabulated in **Table 1**. All the steel rebars including longitudinal and shear rebars were of size D6 (nominal diameter of 6.35 mm) having yield strength of 325 N/mm². The arrangement of steel rebars in beams and columns are shown in **Figure 2**. In all the 22 numbers of column rebars of TJ-ED and KJ-ED, 180° hook were provided at the end of rebars. In beam top and bottom rebars of TJ-ED, 90° hook with hook extension of 11 \varnothing (\varnothing is rebar diameter) were provided while in top rebars of KJ-ED, out of 11 rebars, 3 rebars with 180° hook, 3 rebars with 90° hook having hook extension 35 \varnothing , 3 rebars with 90° hook having hook extension 15 \varnothing and 2 rebars without hook were provided. All the 9 numbers of beam bottom rebars in KJ-ED were provided with 90° hook having hook extension of 3 \varnothing . No hooks were provided in the side face rebars. All the hook types and length of hook extension were decided as per reinforcement detailing of the existing railway bridge. The hoops in the columns of TJ-ED and KJ-ED were spaced at 85 mm. The stirrups in the beams of TJ-ED and KJ-ED were spaced at 70mm and 110 mm, respectively.

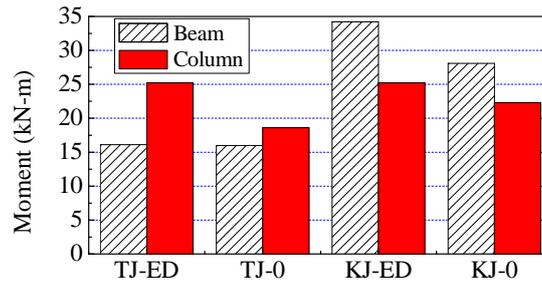
Figure 3. Calculated flexural capacities

In the specimens, TJ-0 TJ-1.0, TJ-1.5, KJ-0, KJ-1.0 and KJ-1.5, numbers of longitudinal rebars were reduced such that $M_c/M_b \approx 1.2$ in T-joints and $M_b/M_c \approx 1.2$ in knee-joints, where, M_b is the flexural strength of a beam and M_c is the flexural strength of a column. The calculated flexural capacities of beams and columns are shown in **Figure 3**. The numbers in the designation of specimens represents the percentage of provided steel fibers in the specimens. Hence, 0 refers to no steel fiber and 1.0 and 1.5 refer to 1.0% and 1.5% of hooked end steel fibers by volume had been added in concrete. In the columns of T-joints and knee-joints, the number of longitudinal rebars was reduced to

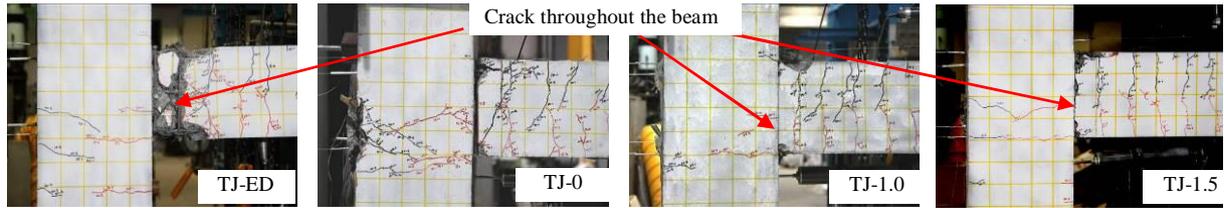
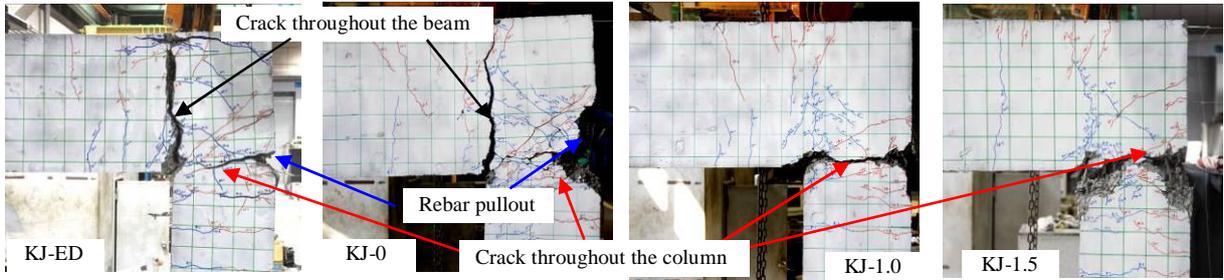
(a) Crack patterns in T-joints

(b) Crack patterns in knee-joints

Figure 4. Crack patterns after the loading test

Figure 4 illustrates the crack patterns observed in the specimens by the end of the tests. The plastic

hinges formed in the beam at the junction of a beam and a column of the specimens TJ-ED, TJ-1.0 and TJ-1.5 due to concentration of cracks in the beams and the yielding of beam rebars. However, comparatively few cracks were observed at the joint. The reduction of rebars degraded the shear strength of the joint as a result large numbers of diagonal shear cracks were generated at the joints of TJ-0. The diminished numbers of cracks in the joints of TJ-1.0 and TJ-1.5 highlighted the effectiveness of steel fibers in arresting cracks. Because of the loss of cover concrete at the junction of the beam and the column and the presence of intact bond between concrete and rebar in the beam-column joint, the beam rebars buckled at the junction of the beam and the column of TJ-ED, TJ-1.0 and TJ-1.5. The entire bottom beam rebars in TJ-0 were pulled out due to the bond deterioration and the straightening of the hooks at the end of rebars. There was no buckling of beam rebars, so the failure mode of TJ-0 was confirmed to be an anchorage failure. The addition of steel fibers also improved the bond between rebars and the surrounding concrete as a result, even after the

Significant numbers of inclined cracks were observed in the joint of knee-joint specimens which did not possess steel fibers (KJ-ED and KJ-0). After the addition of steel fibers the numbers of cracks in the joints of KJ-1.0 and KJ-1.5 highly diminished highlighting the effectiveness of steel fibers in controlling cracks. In addition, both the beam and the column of KJ-ED and KJ-0 were completely damaged, however, the complete damage was limited only to the columns of KJ-1.0 and KJ-1.5 on adding steel fibers even though the amount of rebars were reduced (**Figure 4(b)**). From the maintenance and restorability view point, the complete damage of the top beams are not desirable in the railway bridges (Ishibashi and Tsukishima (2007)). In this regard, it can be said that the performance of KJ-1.0 and KJ-1.5 were better than that of KJ-ED. Because of insufficient hook extension of 3ϕ , all the beam bottom rebars in KJ-ED were pulled out leading to the anchorage failure (**Figure 5(b)**). Although the hook extension in the beam bottom rebars were increased to 12ϕ , the anchorage failure could not be prevented once the amount of rebars were reduced in KJ-0. The failure mode changed from the anchorage failure to the flexural failure in the specimens KJ-1.0 and KJ-1.5 after implementing the combination of increased hook extension in the beam bottom rebars and the addition of steel fibers. On comparing the concrete damages in KJ-1.0 and KJ-1.5, it can be seen that excessive concrete was spalled off in KJ-1.5. In KJ-1.0, on repeating cyclic displacements, the beam slid over the column along with the joint rotation, smearing the concrete at the cracked section and shearing the column rebars. However, in KJ-1.5, cover concrete was spalled off due to buckling of column rebars and the core concrete was crushed because of high compression on the cracked section, consequently more concrete damage became apparent in the column of KJ-1.5 than that in KJ-1.0. In KJ-1.0 fourteen out of twenty and in KJ-1.5 ten out of twenty column rebars were ruptured. Hence, it can be said that the response of the specimens TJ-ED and TJ-1.5 were comparable and KJ-1.5 showed enhanced performance over KJ-ED in terms of crack patterns and damage.

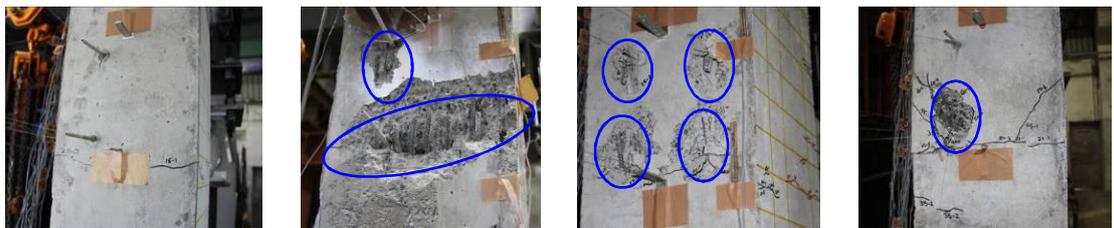
TJ-ED: No pullout

TJ-0: Rebar pullout

TJ-1.0: Rebar pullout

TJ-1.5: Rebar pullout

(a) Damage at the column external face of T-joints

○ : Exposed rebars

reduction of rebars, only four corner beam rebars and one bottom rebar were pulled out in TJ-1.0 and TJ-1.5, respectively (**Figure 5 (a)**). Three beam rebars were ruptured in TJ-ED whereas no rupture of rebars took place in TJ-0. In case of TJ-1.0, eight rebars out of fifteen rebars were ruptured and seven rebars in TJ-1.5 were ruptured. The rupture of rebars illustrated that TJ-1.0 and TJ-1.5 failed in flexure. The least amount of cracks in TJ-1.5 among all specimens and less number of ruptured rebars in TJ-1.5 compared to TJ-1.0 confirms that the response of TJ-1.5 was comparable to all other specimens.

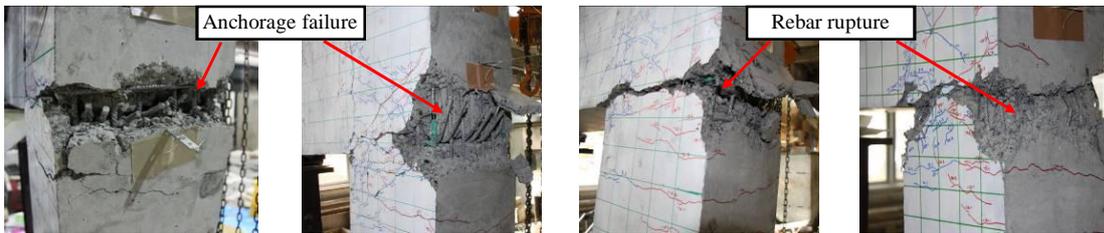
KJ-ED: Rebar pullout

KJ-0: Rebar pullout

KJ-1.0: Rebar rupture

KJ-1.5: Rebar rupture

(b) Damage at the column external face of knee-joints

Figure 5. Damage observed at the column external face of specimens by the end of tests

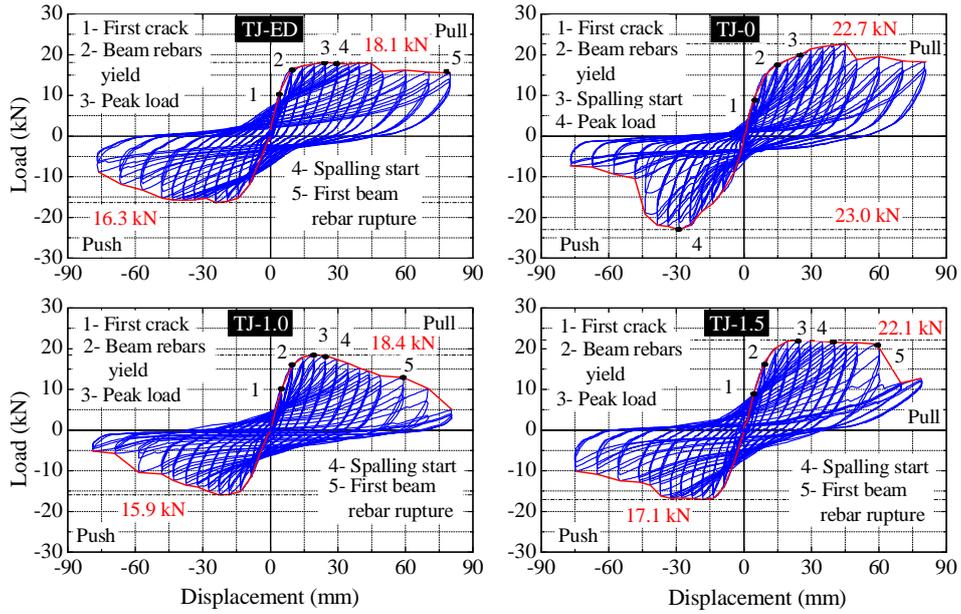
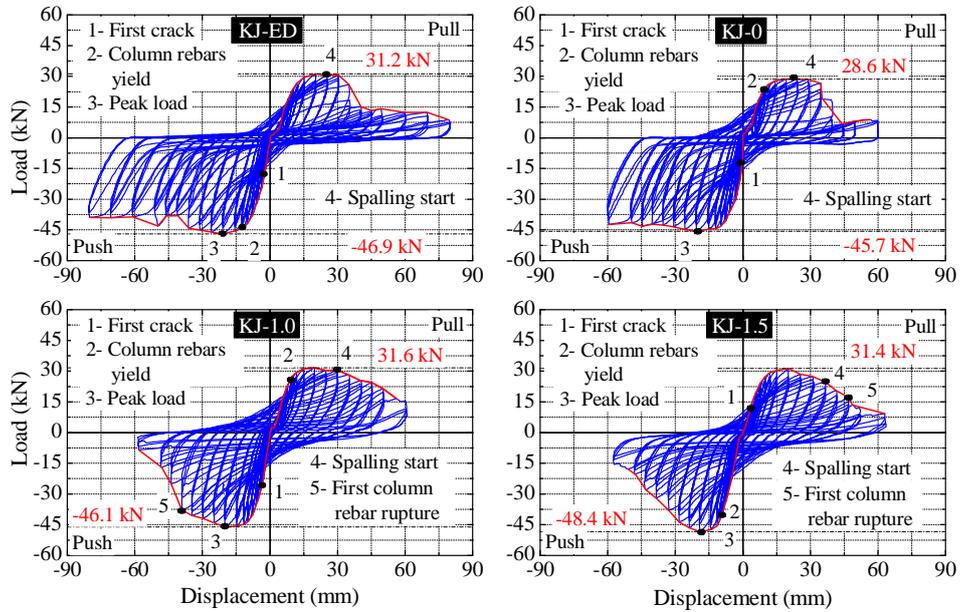
(a) T-joint

(b) Knee-joint

Figure 6. Load-displacement relationship

recorded load and corresponding applied displacement at the column of T-joints and at the end of beam of knee-joints during the cyclic loading is expressed in terms of load-displacement curve and is shown in **Figure 6**. The displacement was considered as positive when the specimen was pulled towards the actuator and vice-versa. The envelope curves along with some important points are also presented. The pinched hysteresis loops and gradual stiffness degradation was common in all the specimens as shown in **Figure 6**. The pinching effect resulted mainly because of the formation and opening of cracks, the bond deterioration along the beam and column longitudinal rebars, anchorage failure and buckling of rebars. Since TJ-0 and KJ-ED experienced premature bond and anchorage failure, the pinching effect became more severe compared to other specimens.

In contrary to the expectation, even after the reduction of amount of steel rebars in TJ-0 compared to the control specimen TJ-ED, the peak load of TJ-0 exceeded that of TJ-ED. The partial bond restoration caused by the joint distortion and the strain hardening of tensile steel rebars caused the increase in load capacity of TJ-0 and it can be explained through **Figure 7**. On applying positive load,

The knee-joint specimens without steel fibers (KJ-ED and KJ-0) exhibited the sharp decrease in load once the anchorage was failed and such sharp decrease of load are not desirable in the structures as it can be disastrous during seismic events. Despite the amount of rebars in KJ-1.0 and KJ-1.5 were lesser than that in KJ-ED, the anchorage failure was eliminated and concrete spalling was delayed in KJ-1.0 and KJ-1.5 compared to that of KJ-ED. It indicated the improvement in bond strength and anchorage of steel rebars due to addition of steel fibers. From (**Figure 6(b)**), it is clear that the peak loads of KJ-1.5 was higher both in positive and negative loading cycles than those of KJ-ED. Hence, it can be said that even if certain amount of steel rebars are reduced, the strength deficit can be restored by adding 1.5% volume fraction of steel fibers. As the peak load of KJ-1.0 was inferior to KJ-ED, the performance of KJ-1.0 was not satisfactory. The post peak behavior of KJ-ED and KJ-0 are quite similar. After the occurrence of anchorage failure, the load capacity suddenly dropped in positive loading and the load capacity became almost constant afterwards. However, similar response could not be observed in negative loading cycle.

rebars, the load decreased gradually after the peak in KJ-1.5. Gradual decrease in load is more preferable than the sudden drop in load. Hence, the performance of KJ-1.5 can be considered as satisfactory. The comparable load-displacement response of TJ-1.5 and KJ-1.5 over TJ-ED and KJ-ED illustrated the effectiveness of steel fibers to reduce over congestion at the joints through supersiding certain amount of steel rebars with 1.5% of steel fibers.

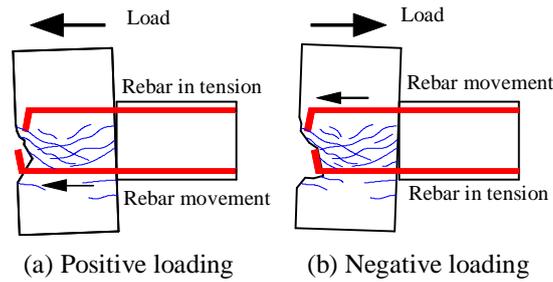
Figure 7. Sequence of rebar movement in TJ-0

the beam bottom rebars slipped away from the external face of column without offering resistance to the load and only the beam top rebars resisted the applied load. On reversing the loading direction, the compressive force induced due to the joint distortion partially restored the bond between rebars and surrounding concrete that prevented the slippage of rebars enabling the rebars to resist the load and as a result, the load capacity of TJ-0 became higher. On the other hand, the buckling of beam rebars in all other T-joint specimens inherently diminished the strength of rebars that caused the lesser load capacity than that of TJ-0. The addition of 1.0% and 1.5% of steel fibers after reduction of steel rebars enhanced the bond between rebars and surrounding concrete, in turn the anchorage failure was prevented in both TJ-1.0 and TJ-1.5. The exceedance of the peak load in both positive and negative loading cycles of TJ-1.5 to those of TJ-ED, as shown in **Figure 6(a)**, clarified that the inclusion of 1.5% of steel fibers could restore the strength deficit caused by the reduction of steel rebars in beam-column joints.

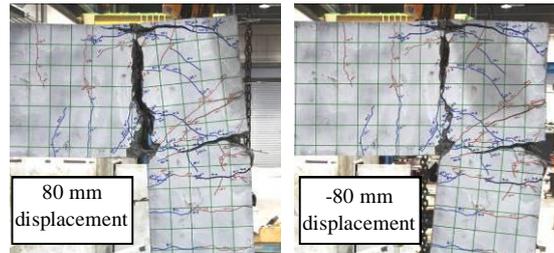
Figure 8. Opening and closing of cracks in KJ-ED

As shown in **Figure 8**, the beam bottom rebar could easily slip after the anchorage failure when positive displacement was applied. On contrary, on exerting negative loading cycle, the induced compressive force in concrete gripped the rebars enabling the restoration of the partial bond in the beam bottom rebars. As a consequence, the slippage of rebars were prevented and the rebars participated in resisting load that maintained the load capacity. The gripping of beam bottom rebars was mainly attributed by the significant plastic rotation of beam-column joint which was possible due to the formation of wider cracks along the beam and column. Due to buckling and rupture of column

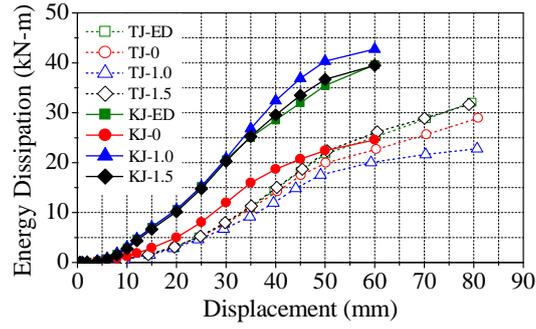
Figure 9. Energy dissipation

Figure 9 shows the relationship between cumulative energy dissipation and applied displacement in T-joint and knee-joint specimens. The energy dissipation capacity, W_e of specimen refers to the area enclosed by the load-displacement curve and is computed by;

$$W_e = \int P dx \quad (1)$$

where, P is a load, x is an applied displacement. The energy dissipation in the structures is caused by the cracking of concrete, bond deterioration and yielding and buckling of rebars. The energy dissipation capacity of both T-joint and knee-joint specimens reduced upon decreasing the amount of steel rebars. Among all the T-joint specimens, TJ-1.0 dissipated the least energy and the performance of KJ-0 was severe among knee-joints in terms of energy dissipation. The control specimens (TJ-ED and KJ-ED) and the specimens with 1.5% of steel fibers (TJ-1.5 and KJ-1.5) displayed almost identical energy dissipation capacities.

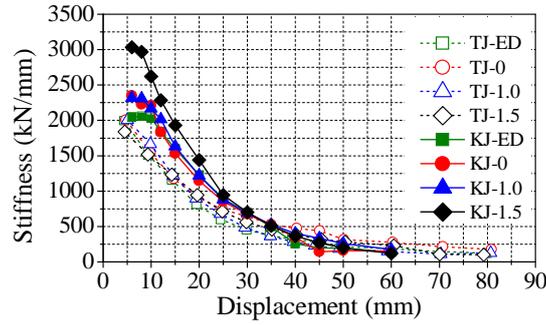
Figure 10. Stiffness degradation

The relationship between the stiffness and the applied displacement is shown in **Figure 10**. The stiffness is estimated by computing the slope of the line joining the peak load and zero load at half cycle of each displacement amplitude. It can be seen that the stiffness degradation of TJ-ED and TJ-1.5 are analogous which indicates that if 1.5% of steel fibers are added in concrete after reducing certain amount of steel rebars, there is almost no variation in the stiffness between them. Since the

numbers of cracks were comparatively less and the anchorage in KJ-1.5 was not damaged, KJ-1.5 showed the least stiffness degradation in the pre-peak region. However, in the post peak region, the stiffness impaired and manifested analogous stiffness degradation to other specimens. Resembling energy dissipation and comparable stiffness degradation observed in the control specimens (TJ-ED and KJ-ED) and the specimens with 1.5% of steel fibers (TJ-1.5 and KJ-1.5) confirmed that the use of steel fibers can be a better option to substitute steel rebars in beam-column joints and reduce the over congestion.
