Tyre Strap Seismic Reinforcement for Adobe Houses

A.W. Charleson

School of Architecture, Victoria University of Wellington, New Zealand

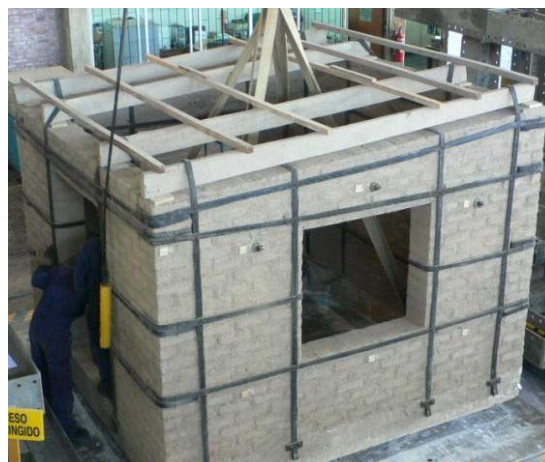
Figure 4. The adobe test module on the shaking table.

Initial load tests using the tyre straps for in-plane and out-of-plane test specimens on dry-stacked brick walls were successful. They indicated the potential of the system to provide large amounts of ductility and so the system was further developed for use in adobe construction. A small single room full-scale adobe house was built and reinforced and subjected to four phases of earthquake shaking on a uni-directional shaking table (Fig. 4).

During the first phase shaking, all the elements of the module remained in the elastic range due to the high quality of adobe materials and workmanship. The straps made no contribution to the module performance. However during the second half of Phase 2 shaking, a vertical crack formed in the middle of the rear wall due to out-of-plane response. Small areas of spalling and loss of adobe material occurred in the vicinity of the crack and many other narrow cracks appeared. Damage intensified during Phase 3. The top of the rear wall was flung vigorously to-and-fro. It fractured into large individual blocks which were restrained by the straps alone. The horizontal straps wrapping around the side walls crossed wide vertical cracks that had opened up between the side walls and the rear wall, certainly preventing it from falling outwards. Diagonal tension shear cracks formed in the vicinity of the bases of the piers but straps crossing them kept closing them up. A video clip of the test can be viewed (World Housing Encyclopedia, 2011).

Even though by this time the module was quite badly damaged, it was subject to a repeat of Phase 3 shaking for a fourth Phase. The upper-most large blocks of adobe continued to be flung about and two areas of masonry in the lower half of the wall fell out from between the horizontal straps onto the module floor. Damage increased everywhere although side wall damage remained modest. By this time the module had been subject to the unrealistic scenario of two large earthquakes. At no time did it look likely to suffer partial or full collapse.

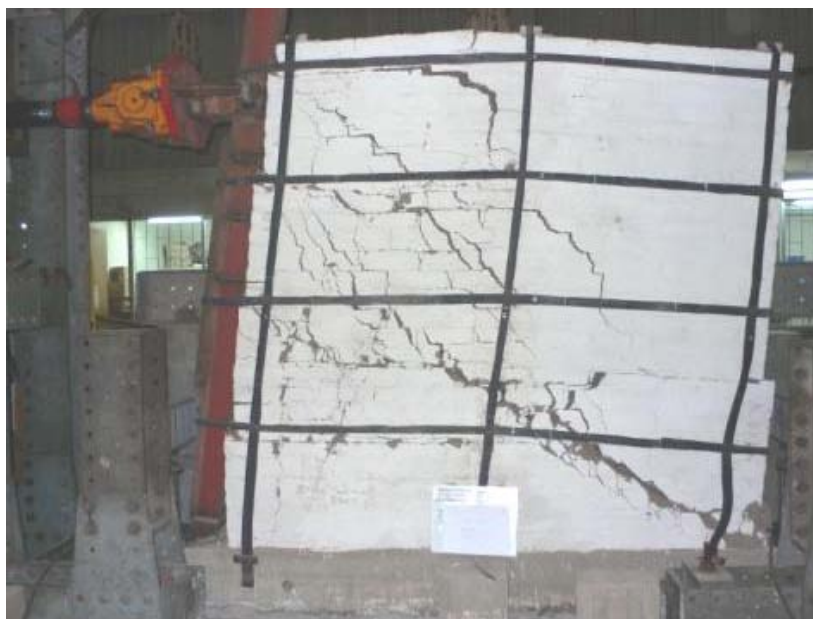
Figure 5. Even though subject to a large lateral displacement the wall was still able to resist load

As well as the dynamic tests, two static cyclic tests were conducted on adobe walls by applying in-plane lateral loads. The first test on a 1.2 m long and 2.4 m high wall was not that useful as the wall rocked on its base, experiencing very little damage. However, when the same loading configuration and cyclic sequencing was applied to a 2.4 m long wall, severe damage was observed. Although severely damaged, the wall strength peaked when the top of the wall had undergone 160 mm displacement. Most of the deterioration was due to diagonal tension cracking, but some sliding was also evident. Unlike an unreinforced adobe wall loaded at its top, the cracking was well-distributed up the height of the wall and concentrated on the left-hand side (Fig. 5).

Compared to conventional unreinforced adobe construction these walls displayed excellent structural performance. The performance of the 2.4 m long wall was especially noteworthy. Since straps crossed each of the major cracks, the wall did not fail suddenly as is the case with unreinforced adobe.
