Seismic behavior of a four-legged masonry minaret

The four-legged Minaret of Sheikh Mutahhar Mosque has been constructed in the early 16th century during the Aq Qoyunlu Period in Diyarbakır, Turkey, which is located in the second most hazardous zone of the Turkish Seismic Zones Map. This is a special structure, because the minaret body has been placed on four cylindrical stone columns. Therefore, this minaret is seemingly vulnerable though it has survived for five centuries. We use the square cross sectioned minaret as a possible large-scale seismograph to examine the possible limits of ground motion that must have affected it without causing its collapse. In order to investigate the likely seismic performance and strength of the four-legged minaret, a model, which is very close to real structure, was generated with explicit dynamic code LS-DYNA. The developed model takes into account the material nonlinearities and the interface friction and contact behavior between the masonry units. It was displayed that the amplitude of the ground motion in Diyarbakır could not be 0.15g.

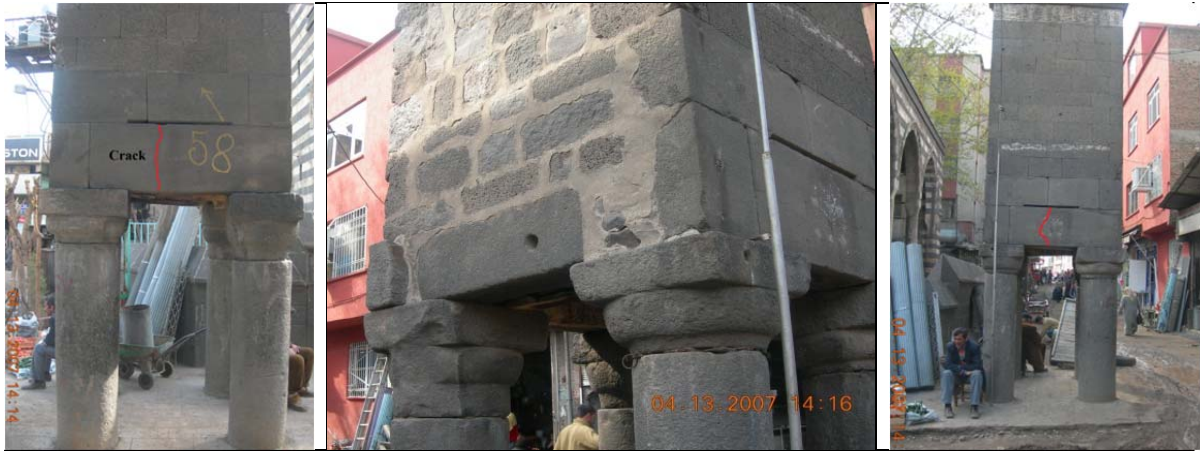
Figure 3. Details of the support at the base of the minaret and existing cracks on the main lintels

As can be understood from the inspection of Fig. 3 there is no positive connection that can be assumed to transmit tensile forces between the pillar caps and the base of the minaret. As seen in most ancient stone column construction, pillars and caps were carved with a center hole, so that they could be pegged together with melted zinc. Contribution of this metal pin to interface sliding was neglected, but it was accounted in the form of frictional resistance later in the analysis.

pillars, it is assumed the minaret deforms in the first mode. There are significant cracks in the two of the main lintels. Such a crack can occur as a result of an impact following the uplift of one side pivoting around the other corner as in the case of rocking motion. Determining the characteristics and quantifying the intensity of the ground shaking to initiate the rocking motion and causing the existing damage will be the subject of the next section.

As mentioned earlier the only visible damage are the cracks on the main lintels carrying the body of the minaret. It was reported that the beams were cracked during the September 6, 1975 earthquake of Lice. The earthquake region is at the northern part of Diyarbakır Province which is located in southeastern Anatolia. Lice earthquake happened at 12:20 hours local time and caused 2385 fatalities and 8149 houses were destroyed or were damaged beyond repair (Mitchell, 1977). The Richter magnitude of the earthquake was reported as 6.6 by Istanbul Kandilli Observatory and the epicenter was located at a few kilometers away from Lice town in the northeast direction. The shaking continued for about 20–24 seconds. The main shock was followed by aftershocks that continued for more than a month. The focal mechanism for the earthquake suggests that it was associated with

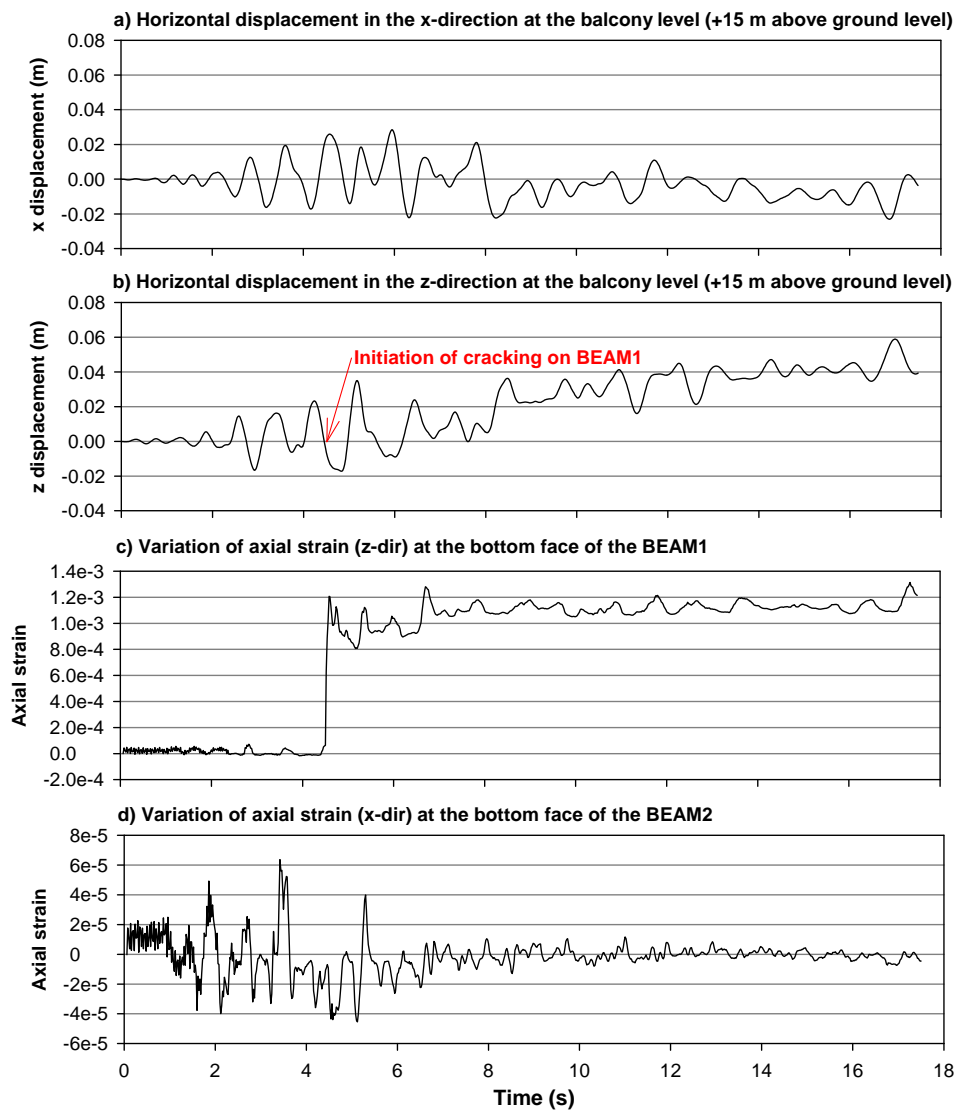
Figure 8. Time-history plots

The analysis of the model was conducted according to the seismic scenario described above. Time history plots of horizontal displacements at the balcony level and axial strains in BEAM1 and 2 are given in Fig. 8. Figs. 8(a) and (b) displays the horizontal displacement in two orthogonal directions. The sudden yielding at time 4.42 s in Fig. 8(c) is the point where the cracking commences on BEAM1 (see Figure 6). The picture depicted at that instant displaying the axial strain (z-axis) and crack propagation on BEAM1 is given Fig. 9(a). The crack develops as the oscillating minaret passing from equilibrium position, i.e. while the displacement is changing sign. After the BEAM is cracked, the minaret starts to oscillate about a line that point in the positive z-direction (east). The maximum axial strain in the BEAM2 develops at 3.5 s. Fig. 8(d) displays the variation of strain at the midpoint of the bottom face of BEAM2. Although strain intensity was raised to a critical level at this region as seen in Fig. 9(b), cracking did not develop.

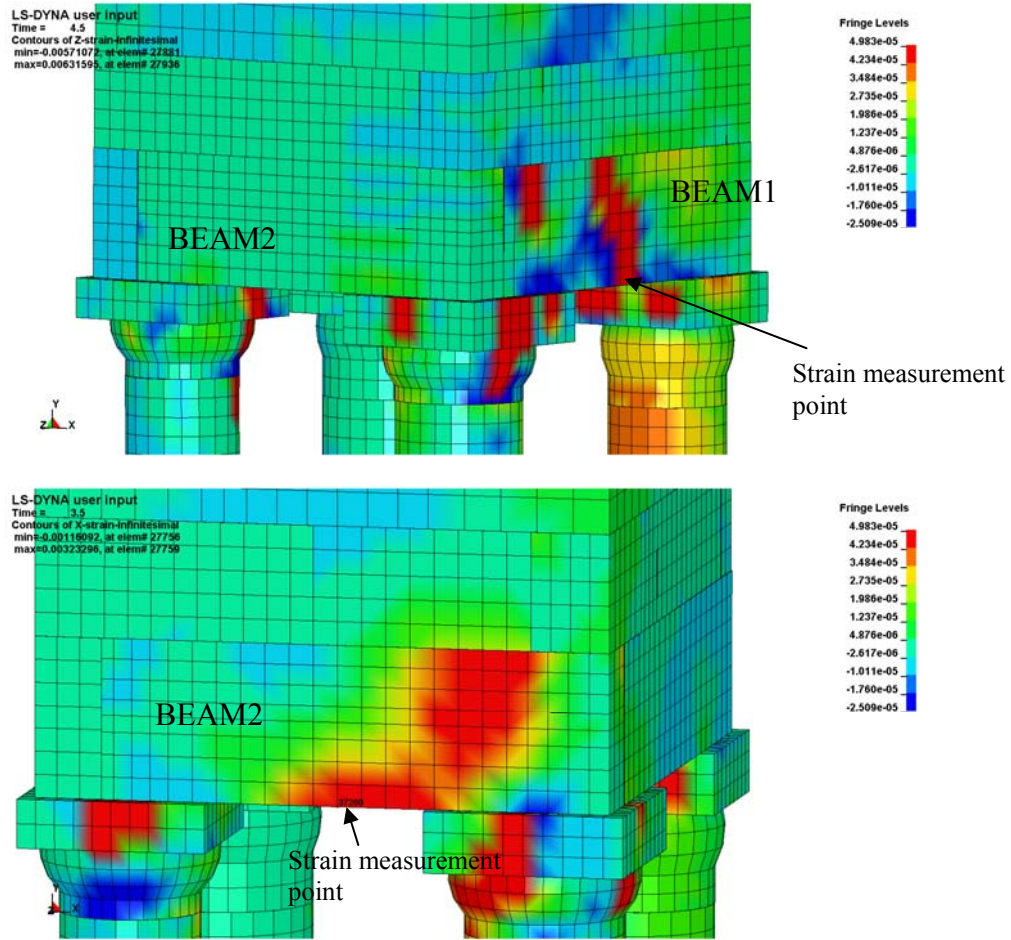
Figure 9. Axial strain plots for BEAM1 and BEAM2
