The Analysis of Non-Linear Seismic Response between a Collapsed and a serious damage Infilled Frame Structure in Yingxiu Town—the Heavy Disaster Areas of Wenchuan 8.0 Earthquake

15 WCEE

YAN Peilei

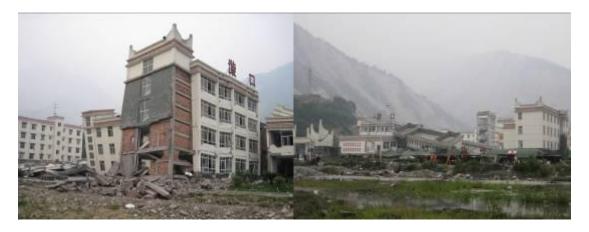
Figure2.The complex building of the Xuankou secondary school(Global)

In Fig.1, the complex building is composed by 1-18 axis and K-G axis; there is a seismic joint between 6 axes and 7 axes. In Fig.3 and Fig.4, the part of 1-6 axis inclined eastwardly, the first story disappeared. In Fig.2, the part of 7-18 axis collapsed completely. [1]

Figure3.The complex building of the Xuankou secondary school(Local1)

(1)In Figure.10, the first story drift angle of the 1-6 axis part of the complex building is 0.020587 at 32.310s, exceed the limit value of the elastic-plastic inter-story displacement angle of RC frame structure (1/50) [5], the maximum value is 0.0210024. So the first story collapsed at 32.310s in the earthquake(as Figure.3 and Figure.4);

(2)In Figure.11, the first story drift angle of the 7-18 axis part of the complex building is 0.0201153 at 32.310s, the maximum value is 0.04398; In Figure.12, the second story drift angle of the 7-18 axis part of the complex building is 0.203989 at 33.010s, the maximum value is 0.04004; In Figure.13, the third story drift angle of the 7-18 axis part of the complex building is 0.0200684 at 33.240s, the maximum value is 0.03033; In Figure.14, the fourth story drift angle of the 7-18 axis part of the complex building is 0.0202572 at 33.280s, the maximum value is 0.02355;so the first to the fourth story collapsed in the earthquake(as Figure.1);

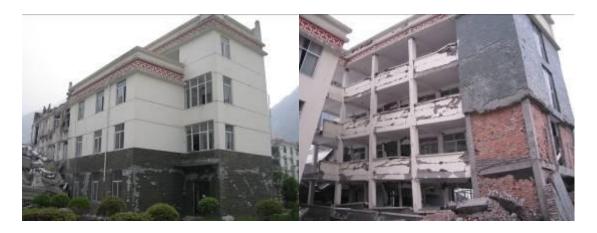
Fig4.The complex building of the Xuankou secondary school(Local 2)

The office building is composed by 19-23 axis and A-J axis. In Fig.5, the main structure of the framework is basically undamaged; the local part of the office building is serious damage by the collision with the complex building that collapsed^[1].

Fig5. the office building of the Xuankou secondary school

(3)In Figure.15, the first story drift angle of the office building is 0.0211061 at 33.27s, and the other time is less than 0.02.Compare with Fig.5, the office building didn't collapse. So the limit value of the elastic-plastic inter-story displacement angle of RC frame structure which is defined by the Code for Seismic Design of Buildings of China (GB50011-2001) maybe relatively small. From Figure.16 to Figure.18, the story drift angles of the second and the third and the fourth story did not exceed the limit value of the elastic-plastic inter-story displacement angle of RC frame structure. So the office building did not collapse in the earthquake (as Figure.5).
