# Experimental Study on the Behaviour of Plastered Confined Masonry Wall under Lateral Cyclic Load

The behaviour of two full-scale ( $3\text{m} \times 3\text{m}$ ) plastered confined masonry wall specimens under cyclic lateral load was experimentally studied and analyzed in this research. Both specimens had framed window in the middle of the wall and were constructed following the general construction practice in Indonesia. Aside from different detailing, two continuous horizontal anchors were added on one specimen. The parameters evaluated were failure mechanism on the wall panel, load resistance, energy dissipation, and ductility. The results showed that the plaster improved the load carrying capacity of the wall. Additional ductility and development of more appropriate diagonal strut-tie mechanism were also observed rather than sliding mode failure on the unplastered wall specimen. The load carrying capacity increases from 8.7 tons to about 10 tons in the model with horizontal anchorage. In conclusion, the study shows that installing plaster as well as proper wall-frame connection strategies is crucial in improving the structural performance of confined masonry wall.

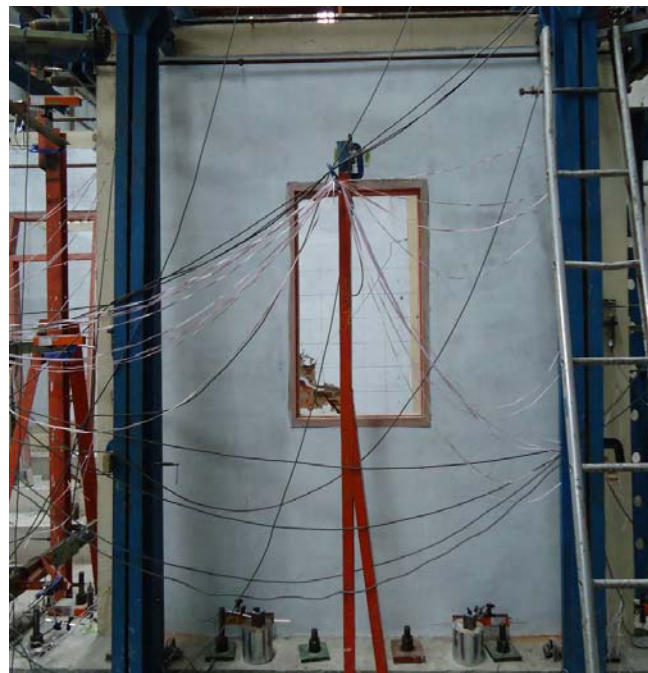
**Figure 4.** Picture of one of the wall specimens.

The lateral cyclic load was applied at the top beam-column joint. The load came from a hydraulic jack attached to the reaction wall. Figure 3 shows the test setup for the lateral cyclic load of confined masonry wall and Figure 4 presents the picture of one of the wall specimens prior to the test. The response of the wall specimen was measured using strain gauges and LVDT (Linear Variable Displacement Transducers).

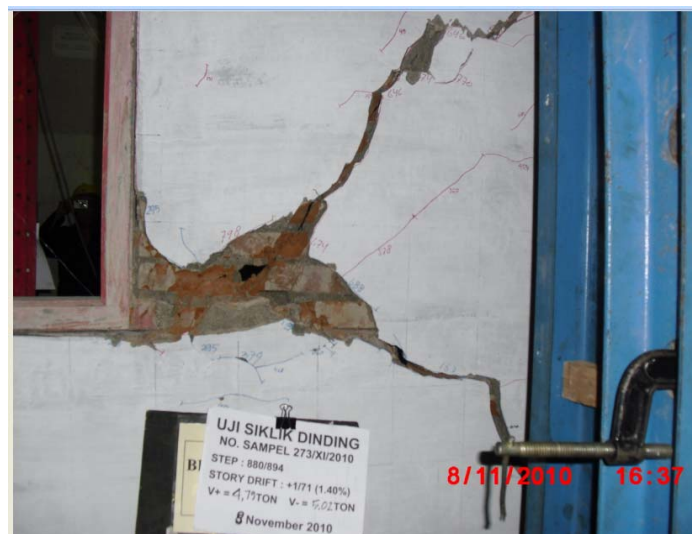
**Figure 6.** Damage observed at the corner of the window frame during the test of specimen 1.

During the experiments, observation was focused on development of cracks, damage pattern and failure mechanism at the end of each test. Figures 6 and 7 show selected pictures of each specimen during the tests.

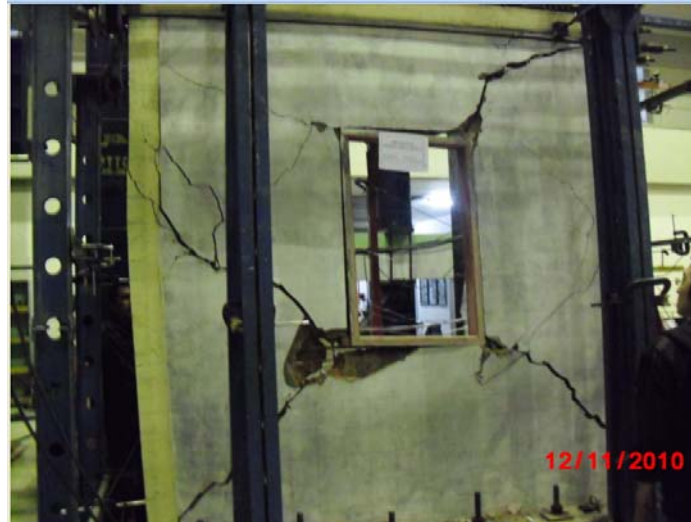
**Figure 7.** Specimen 2 near the end cycle of test.

Similarly, the diagonal crack pattern was also observed for specimen 2. The strut and tie mechanism was also developed in this model. However, less bulging of columns were observed on the columns. The installed continuous anchorage seemed to limit the bulging effect on columns, and the model was able to maintain its shape for larger displacement. With the additional strength from the anchorage, the model was able to resist more lateral load, compared to specimen 1. Although less column deformation was observed, specimen 2 developed large crack at the bottom of the right column frame and further observation reveals that two of the longitudinal reinforcement failed near the end of the test. The damage was much severe on this column compared to the other specimens.

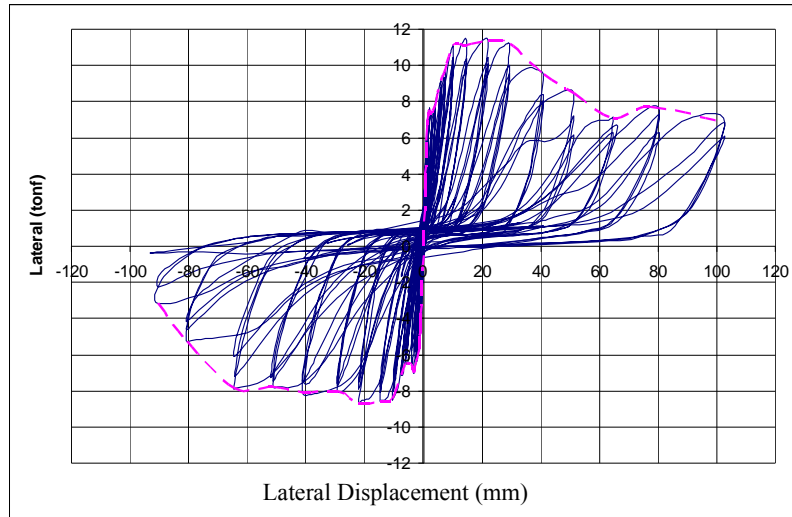
**Figure 12.** Hysteretic load-displacement of specimen 2.

Figures 11 and 12 present the hysteretic diagram of load-displacement for specimens 1 and 2 during the tests. Both models appear to have similar hysteretic behaviour, with difference only in the maximum load where specimen 1 can sustain about 8.7 tons while specimen 2 with additional anchorage has a maximum load about 10 tons. The difference in maximum load can probably be caused by the additional anchorage on specimen 2. There is not much difference observed in stiffness degradation and ductility of both models.

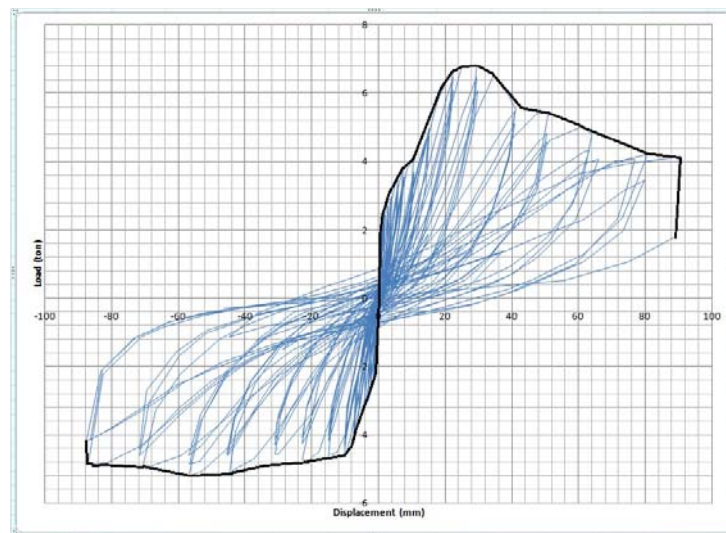
**Figure 13.** Hysteretic load-displacement of wall specimen without plaster.

In Figure 13, the hysteretic diagram from previous research is shown to analyze the effect of plaster. The specimen was similar to specimen 1, but did not have plaster on the wall. The model without plaster shows a maximum capacity of 6.4 tons, in the tensile direction, and 5.2 in the compressive direction, or average of 5.8 tons.

Comparing the results of specimens 1 and 2 to the one without plaster, it is clear that both specimen 1 and 2 can resist more lateral load than the specimen without plaster. With approximately 35 percent increase, the additional strength of plaster should be considered in evaluating the performance of confined masonry wall.
