# Subsidence Map of Tokyo Bay Area Liquefied in the March 11th Great East Japan Earthquake

## SUMMARY:

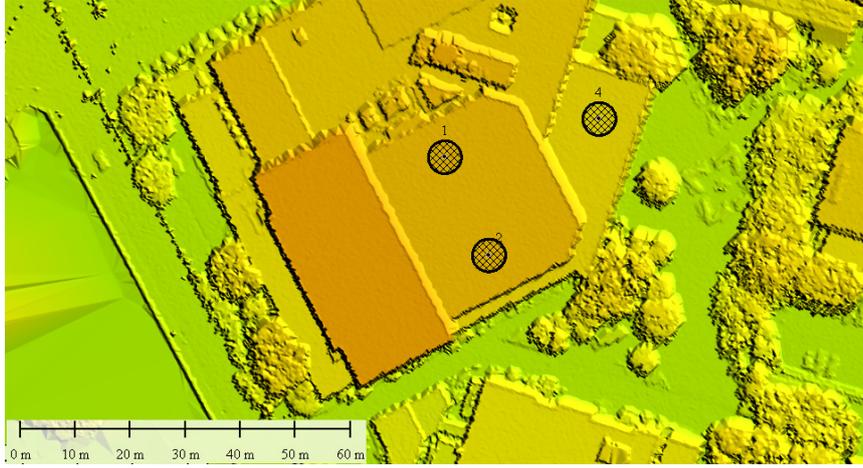
Figure 1. Template points on a pile-supported RC building

17 points on flat roofs of 6 buildings and 121 points on piers for the Bay-shore Route of the Tokyo Metropolitan Expressway were taken as templates for Urayasu and Ichikawa-to-Chiba areas respectively to find the best matching depths for both areas. At each template point, a circle with radius of 3m is drawn around it, and elevations of pixels within this circle are averaged for the representative value of the point's elevation (**Figure 1**). As for Urayasu area, the elevations of the chosen points after the earthquake are 20.78cm lower than those before the earthquake in average with the standard deviation of 1.93cm. The Ichikawa-to-Chiba area was divided in two sub-areas, west and east of Edogawa Diversion Channel. For the west and east subareas, 3D-planes that best-fit into the spatial elevation changes of the chosen template piers along the expressway viaducts were obtained with the standard deviations 2.47cm and 4.75cm, respectively. Though the errors for the two sub-areas are a little larger than that for Urayasu because of the higher flight altitude, they are considered to be small enough to discuss large soil subsidence that appeared as clear several tens centimeters differences in level between ground floors of pile-supported RC buildings and the surrounding sidewalks.

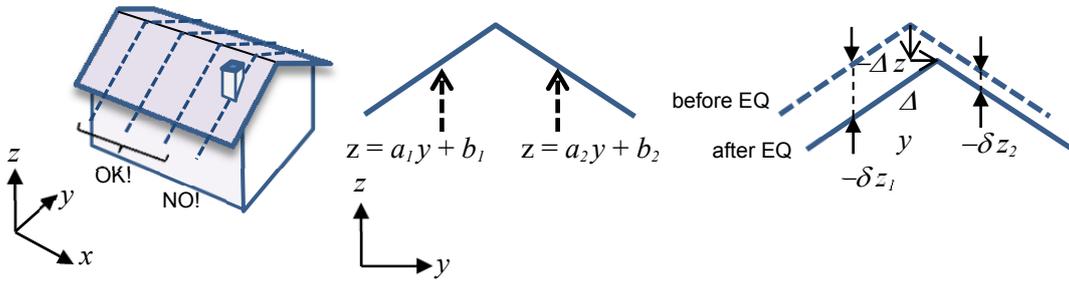
Figure 2. Template building with sloping roofs for adjusting

Given the higher density of pixels for Urayasu, an attempt was made to extract lateral components of Lagrangian displacements for template matching. Comparing DSMs at different times only allow us to detect displacements in the Eulerian description, in which the description of motion is made in terms of the spatial coordinates which does not follow the motion of a particular target. One practical method to deal with this problem is to detect edges of buildings where elevation changes sharply, and keep tracking the motions of the detected edges. However, as described previously, the DSMs have a spatial resolution of 4 pixels/m<sup>2</sup> at most, which is a little to sparse for sharp edge detection. After the 2004 Mid-Niigata Prefecture Earthquake, Konagai et al. (2009, 2011c) estimated Lagrangian components of tectonic displacement induced within a mountainous terrain of Yamakoshi Village by assuming that tectonic displacement varies gently in space, and therefore three adjacent pixels of DEM would have the same Lagrangian displacements. The same method is applied here for detecting lateral Lagrangian displacements of roofs with sloping surfaces towards walls. As illustrated in **Figure 2**, several cross-sections of a roof are taken first, and after those with outshooting objects are excluded, they are averaged for the representative roof shape with two sloping surfaces towards walls on both sides. If two points on the two sloping surfaces of a roof undergo a rigid-body-translation movement  $\{\Delta y \ \Delta z\}^T$ , their Lagrangian components  $\{\Delta x \ \Delta z\}^T$  can be obtained by solving the following simultaneous equations.

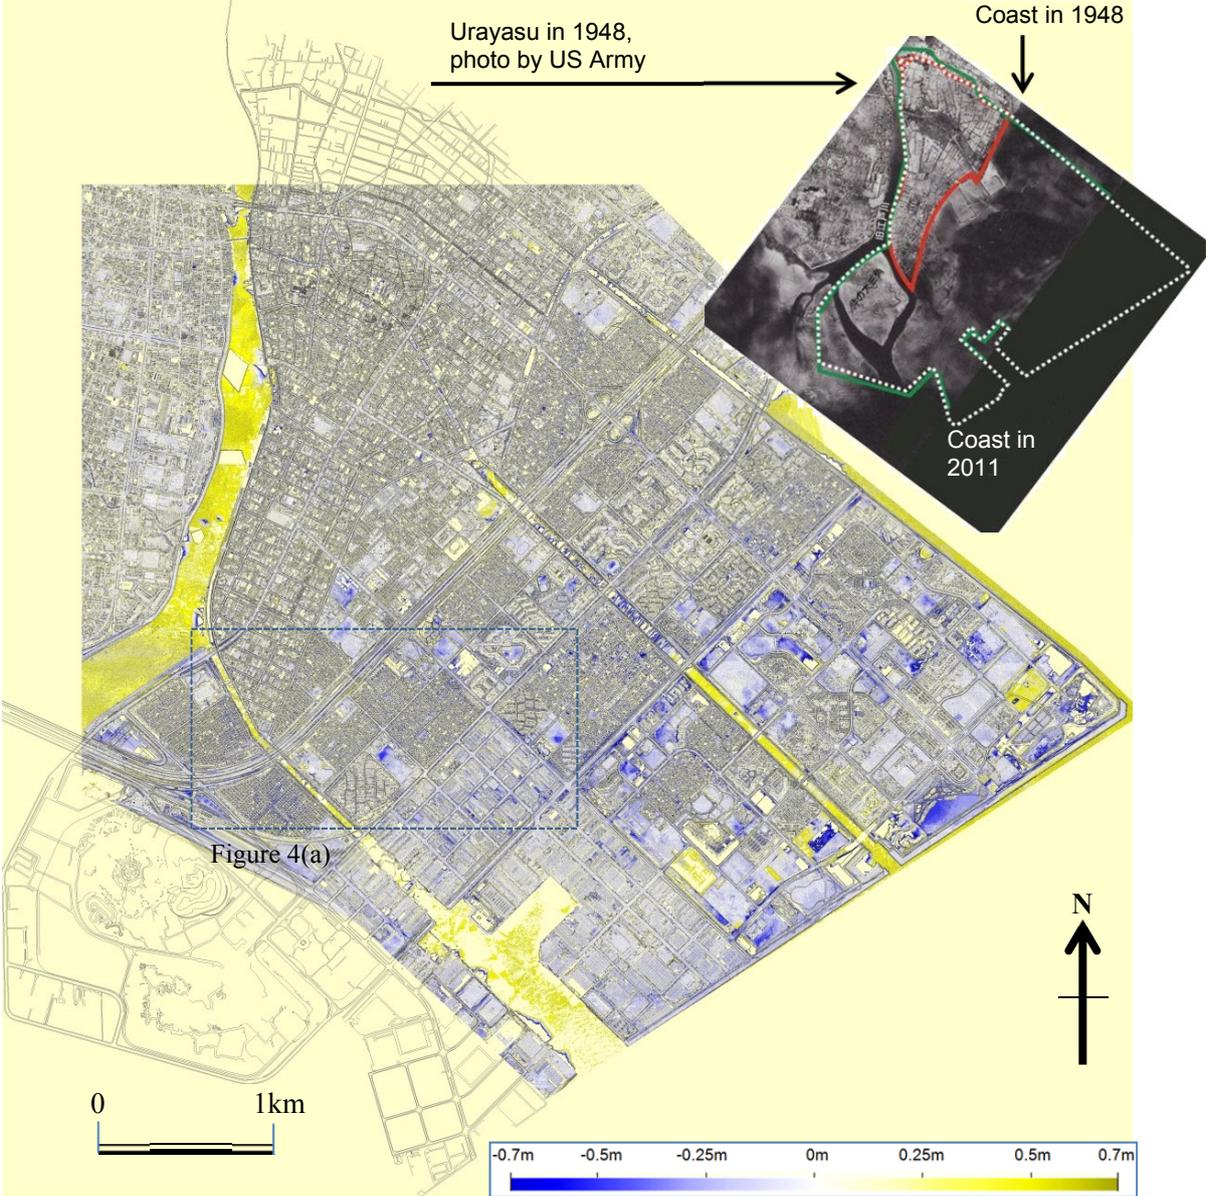
Figure 3. Soil subsidence map of Urayasu

Figure 3 shows the obtained soil-subsidence map of Urayasu. The aerial photograph of the same area on the upper right of the figure was taken in 1948 by the US Army (Geospatial Information Authority of Japan, 2011b), clearly showing that it was post-World War II when the majority of land reclamation in Urayasu was undertaken, and the greater part of the city today spreads over the reclaimed land of sand dredged from the Tokyo Bay. On this map, subsidence can be seen over the entire stretch of the reclaimed land. In particular, remarkable subsidence is seen where the aerial photo of 1948 shows darker black indicating the presence of deeper water. On the other hand, on the long-existing natural land of Urayasu before the time of land-fills, no or slight subsidence less than 0.1m is seen.

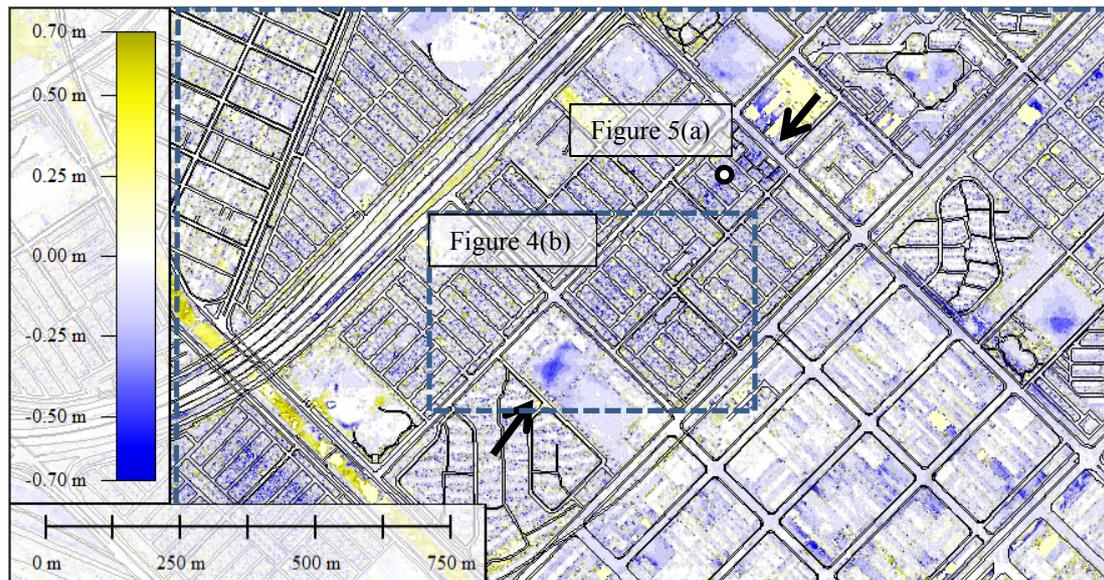
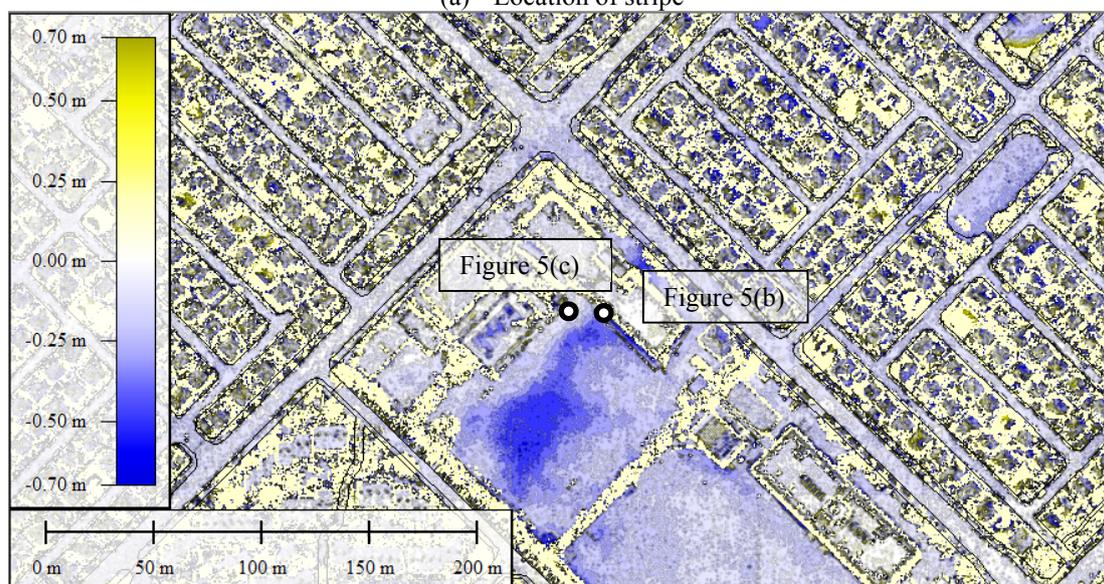
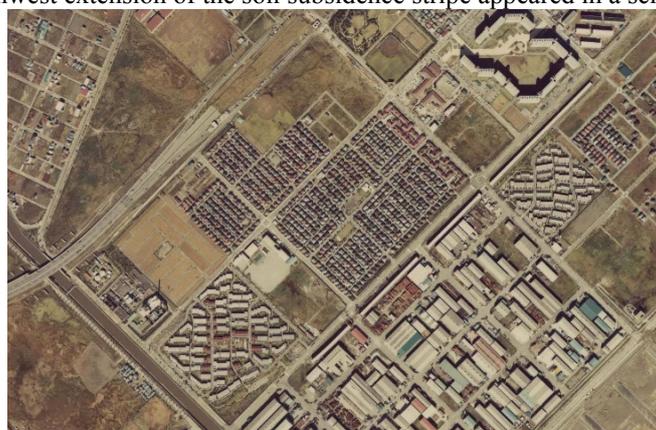
(a) Location of stripe

(b) Southwest extension of the soil subsidence stripe appeared in a school-ground

(c) Benten area in 1979: The area was developed in late 1970s. Geospatial Information Authority of Japan (2011b)

**Figure 4.** Stripe of soil subsidence of across Benten residential area

Zooming in on one of residential areas, Benten, a clear blue brush of large soil subsidence is found running across several town blocks as indicated with arrows in **Figure 4**. In these residential town blocks, where strip footings and mat foundations are the most common, houses have sunken in the soil by about 0.5m in average (**Figure 5(a)**). The southwestern extension of the brush appeared as sand blows lined up in the school ground of Miakegawa Primary School (**Figure 5(b)**). Later, on April 24, there appeared a puddle as shown in **Figure 5(c)** due to a heavy rain of April 23<sup>rd</sup> 2011.

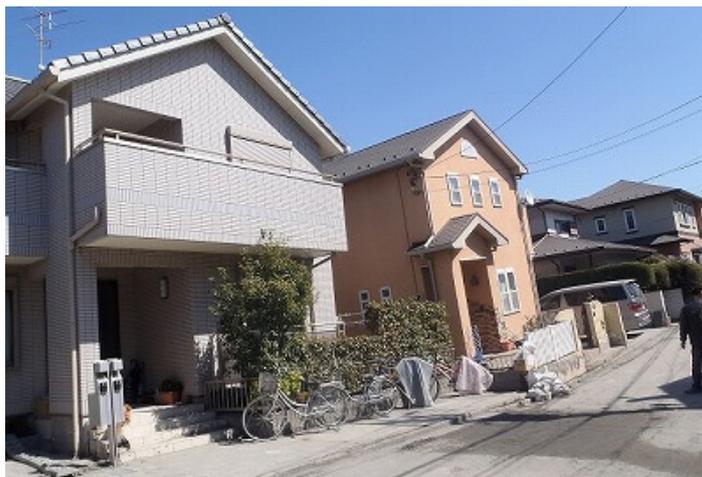
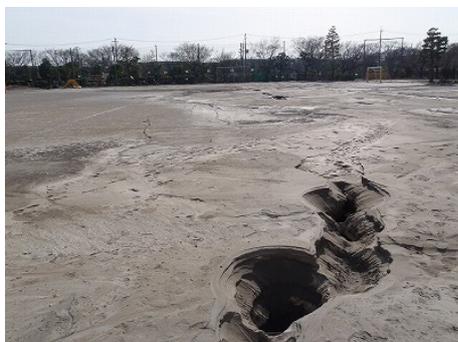
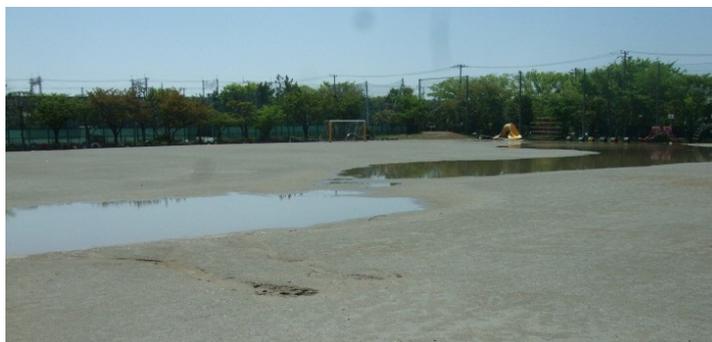
(a) Inclined and sunken houses  
 Photo by Kiyota T., at 35.641895, 139.89886

(b) Sand blows lined up in school ground  
 Photo by Kiyota T., on March 19<sup>th</sup>  
 at 35.638933, 139.895619

(c) Puddle appeared in school ground  
 Photo by Konagai K., on April 24<sup>th</sup>  
 at 35.639117, 139.895471

**Figure 5.** Extension of the subsidence stripe appeared in a school-ground of Miake Primary School

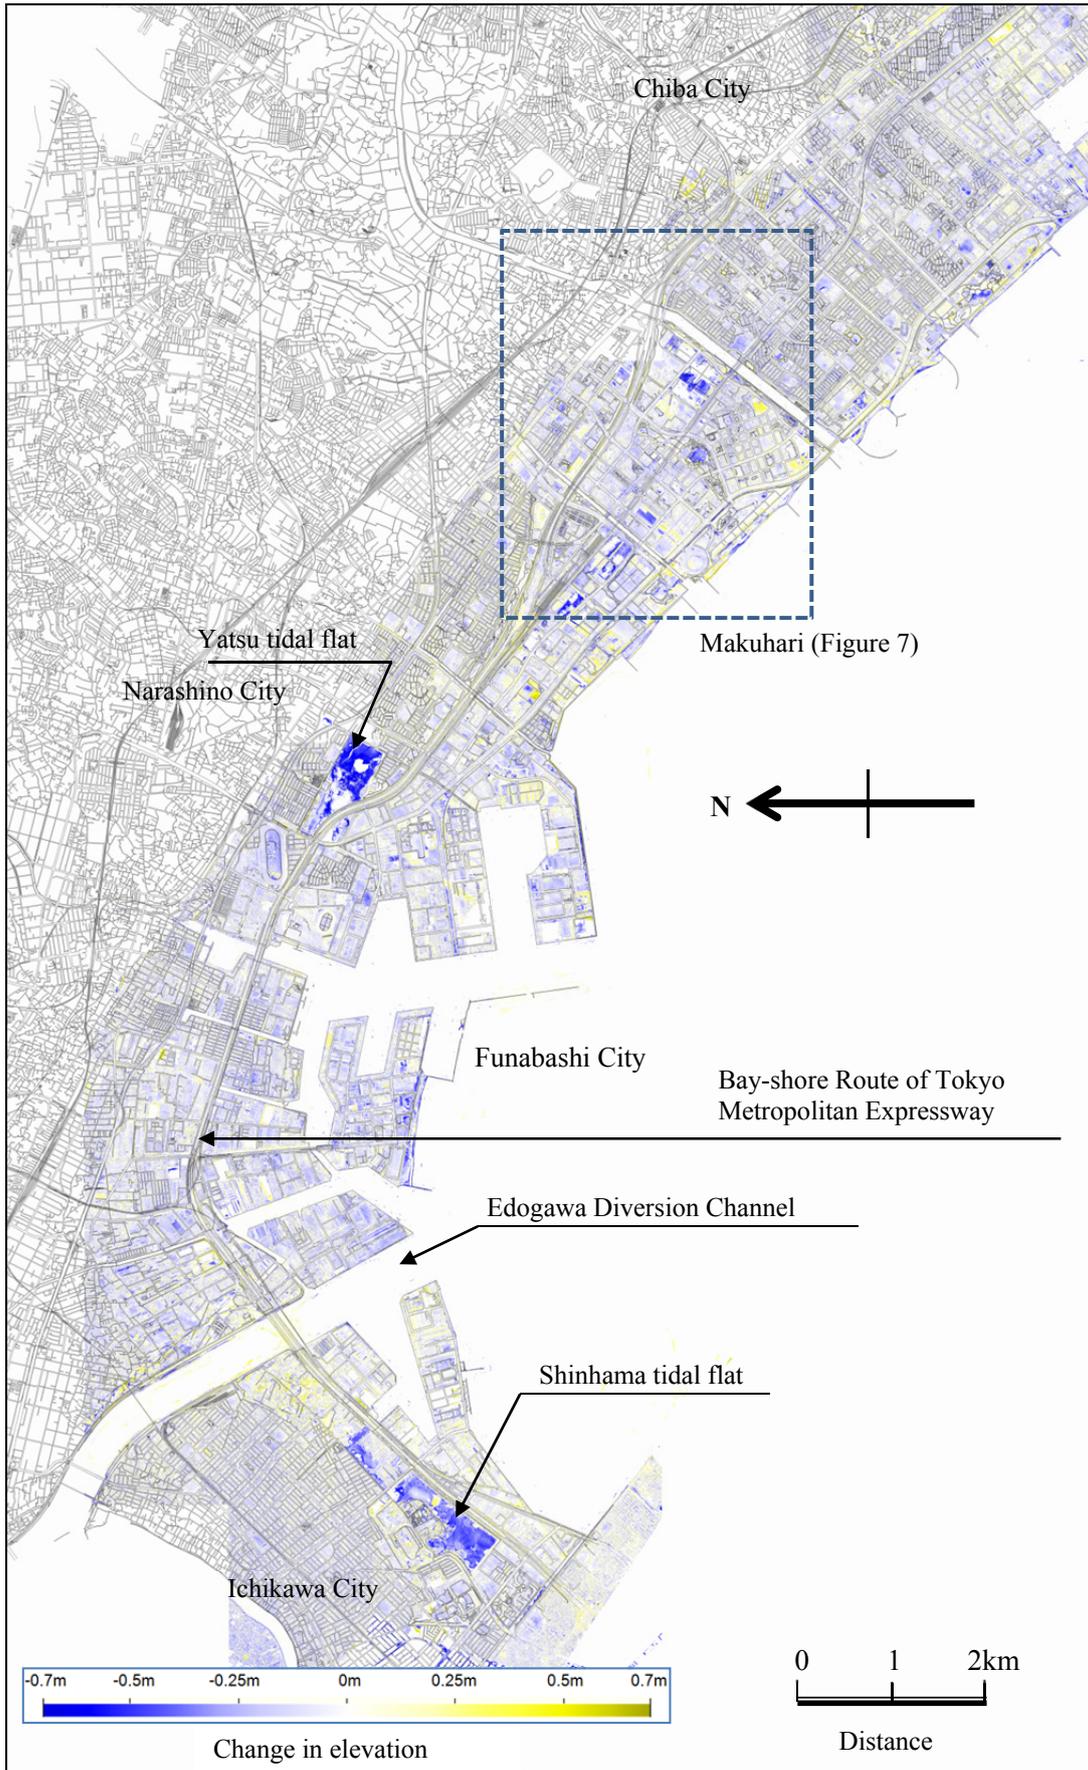
**Figure 6.** Soil subsidence map of Ichikawa-to-Chiba area

**Figure 6** shows the obtained soil-subsidence map of Ichikawa-to-Chiba area. An about 1 to 2 km wide stripe of subsided area extends all along the Tokyo Bay. Excluding two conserved tidal flats in Ichikawa and Narashino, seriously subsided spots are found clustered in Makuhari area of Chiba City (**Figure 7**). This area had been a tidal flat until 1960<sup>th</sup>. The first landfilling project was completed in 1964 as shown in **Figure 7(a)**, and followed by the 2<sup>nd</sup> three-years landfilling project for a Makuhari new city complex in 1973. **Figure 7(b)** shows the aerial photo of the new-city complex in 2006 with the original coast line a few kilo meters inland. These subsidence spots included Makuhari-Kaihin Park and the areas in front of JR Kaihin-Makuhari Station, where manholes were found sticking out (**Figure 8(a)**) and buildings next to the pile supported JR Kaihin-Makuhari Station fell forward (**Figure 8(b)**).

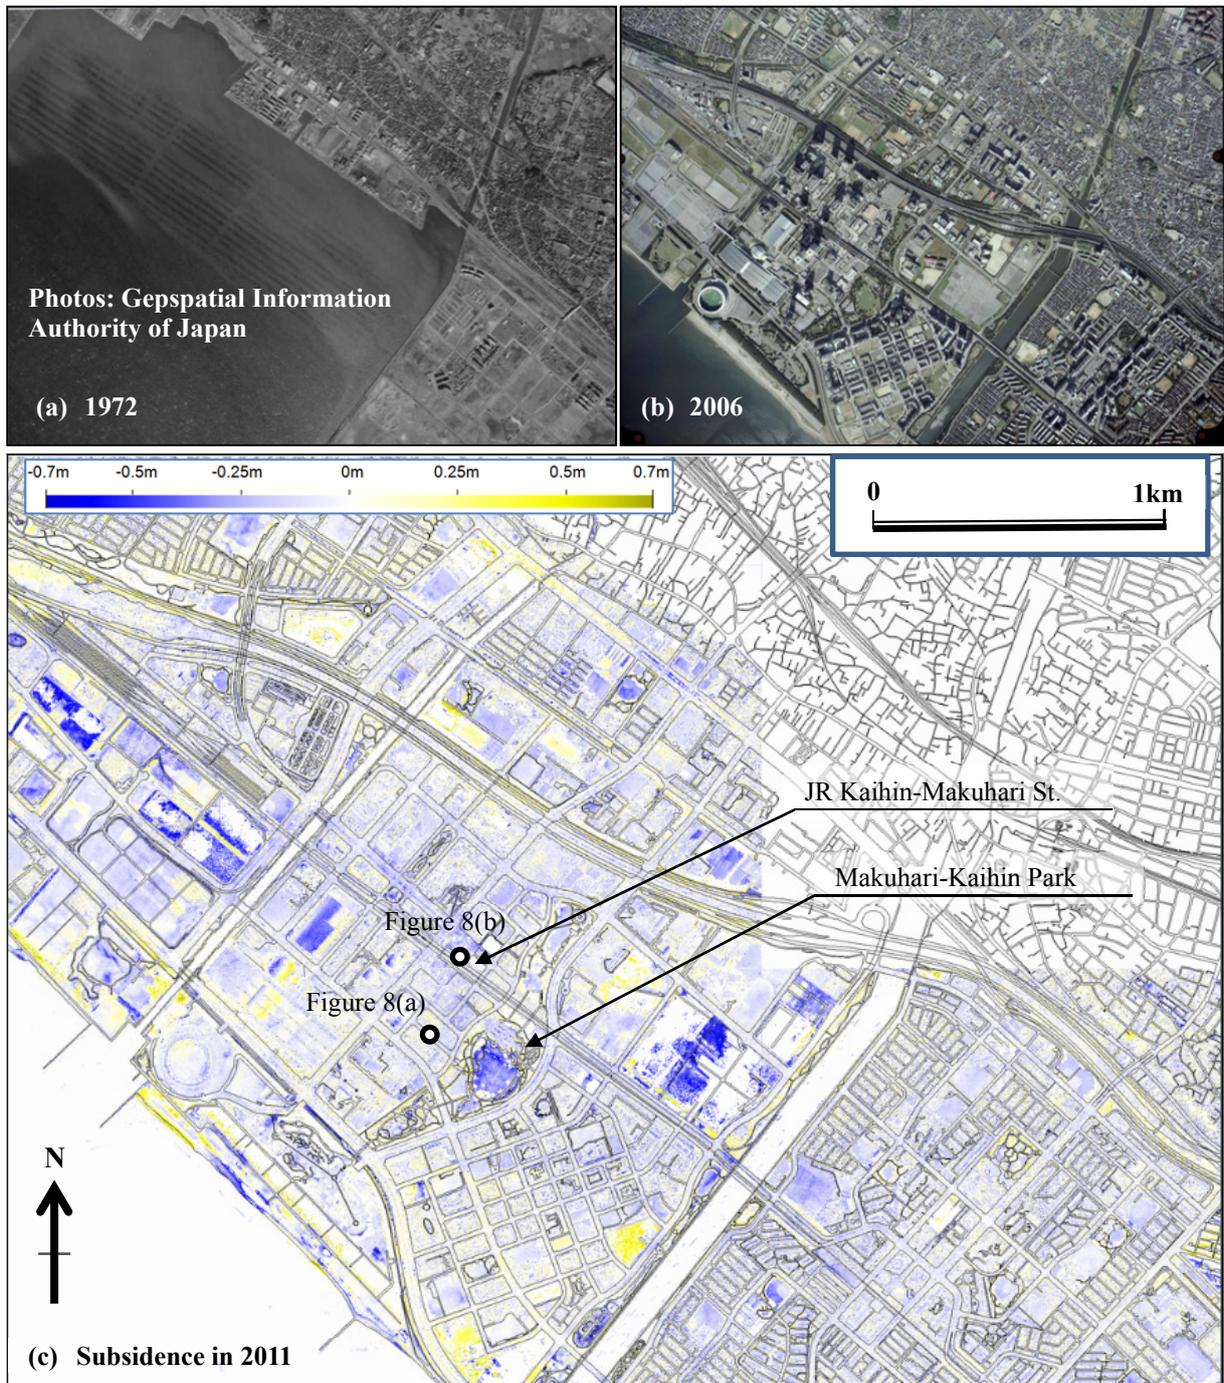
Figure 7. Soil subsidence map of Makuhari

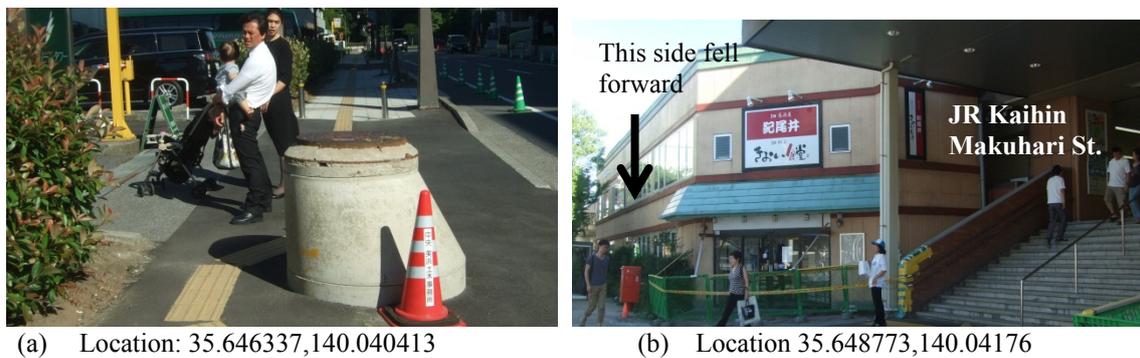
Figure 8. (a) Manhole sticking out of sidewalk and (b) a two story building falling forward (Photos by Kazuo Konagai on July 10<sup>th</sup> 2011)
