# The Performance of High Dams in Wenchuan 5-12 Earthquake and Follow-up Analysis of the Shapai Arch Dam during the Event

We briefly introduce the seismic performance and damage of four high dams (>100 m high) during the Wenchuan 5-12 earthquake, and further analyze earthquake response of the Shapai Roller Compacted Concrete (RCC) Arch Dam using 3D finite element modelling, and explain the mechanisms of its excellent performance during the event. Finally, concluding remarks on aseismic design of high dams in China are discussed.

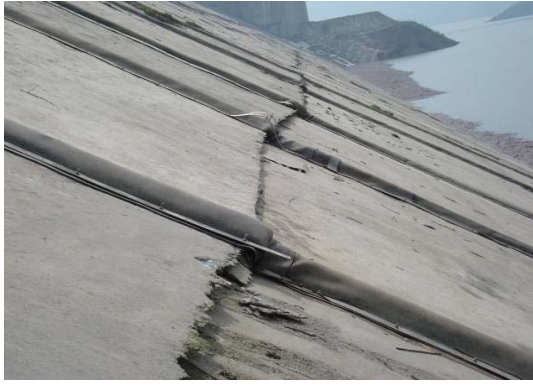
(a) Concrete face joint breakage and slip

**Figure 1.2.** The performance and damage of the Zipingpu CFR Dam

The 156 m-high Zipingpu Dam is located 17 km away from the epicenter of the earthquake. The peak ground acceleration (PGA) was estimated around 0.65 g-0.8 g, far beyond the design PGA of 0.26 g. The dam was subjected to very strong shaking in the earthquake, with the affected intensity of IX-X degree. The reservoir level was only 100.74 m in depth during the event. The damage of the dam can be summarized as following (Figure 1.2): (1) the maximum settlement at crest reached 810 mm and horizontal deflection reached 180 mm toward downstream; (2) seepage quantity increased from 10 L/s to 20 L/s; (3) vertical and horizontal slippage of the joint were 350 mm and 170 mm respectively; (4) serious collapse of the sidewalk guardrail and other auxiliary facilities at the crest; and (5) significant uplift and loosening of the downstream protection stone. Detailed discussion of the damage may be referred to Zhang C.H. (2011).

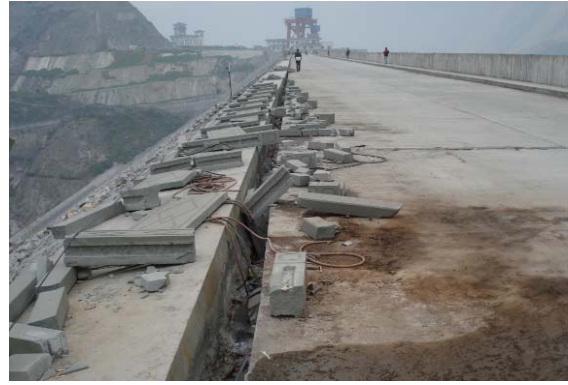
(b) Collapse of fence columns at crest

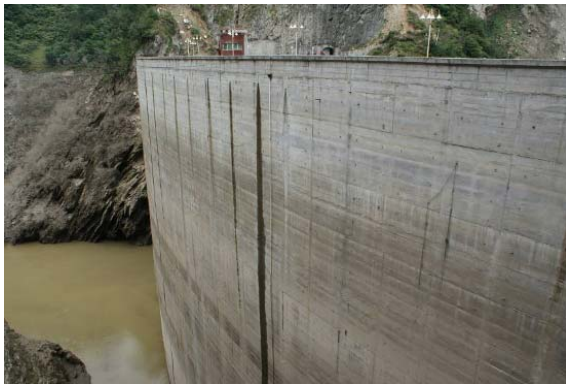
(a) No cracks observed in the dam after reservoir emptying

**Figure 1.3.** The performance and damage of the Shapai RCC Dam

The 132 m-high Shapai Dam is 36 km away from the epicenter. When the earthquake occurred, the reservoir was full, with a normal water level of 128 m in depth. The design PGA of Shapai Dam is 0.138 g, but the affected intensity reached VIII-IX degree. However, the dam was intact with no crack observed after the reservoir was emptied (Figure 1.3(a)). The abutments also remained stable. The dam foundation did not show significant difference of the seepage. The only severe damage was that the penstock was destroyed by falling stones, resulting in serious flooding of the power plant (Figure 1.3(b)).

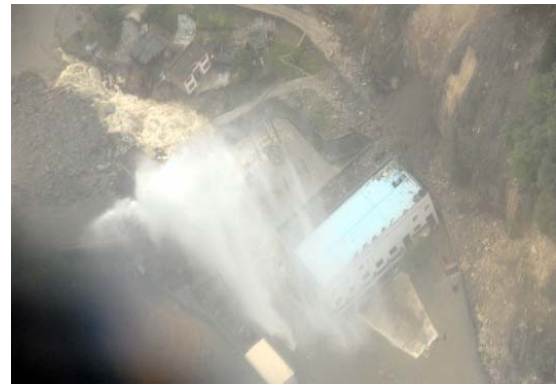
(b) Penstock breakage and power plant flooded

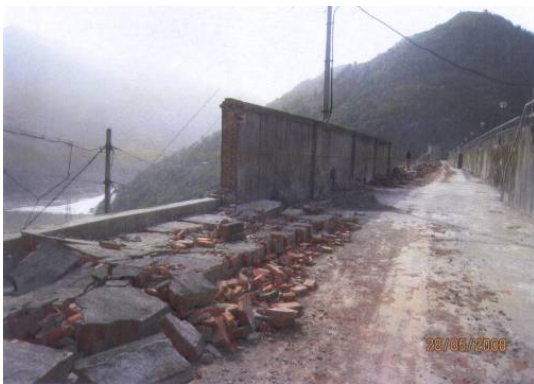
(a) Downstream wall collapse at crest

**Figure 1.4.** The performance and damage of the Bikou Earth-Rockfill Dam

The damage of the 101.8 m-high Bikou Dam includes: (1) collapse of downstream wall at the crest (Figure 1.4(a)); (2) the extrusion and opening of the contraction joints of the upstream protection wall (Figure 1.4(b)); and (3) the maximum crest settlement reached 242 mm and maximum horizontal deflection reached 154 mm toward upstream.

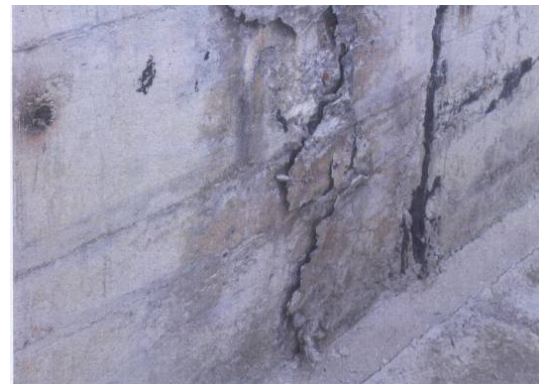
(b) Wave protection wall contraction joint opening and crush

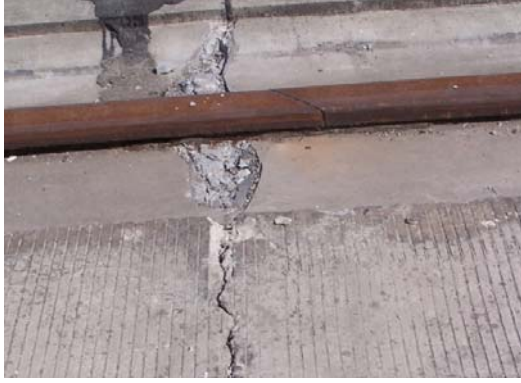
(a) Joint opening and cracking at crest

**Figure 1.5.** The performance and damage of the Baozhusi Gravity Dam

The 132 m-high Baozhusi Dam is 260 km away from the epicenter. The dam was at a low water level of 71.5 m in depth when the earthquake occurred. The damage details include: (1) an increase in seepage quantity from 35.6 to 59.1 m<sup>3</sup>/h, (2) opening, cracking and extrusion of the contraction joints (Figure 1.5(a)); (3) cracking of the guardrail; and (4) the 33t hoisting device at the crest had a permanent residual movement of 430 mm toward the left abutment and 50 mm toward downstream (Figure 1.5(b)).

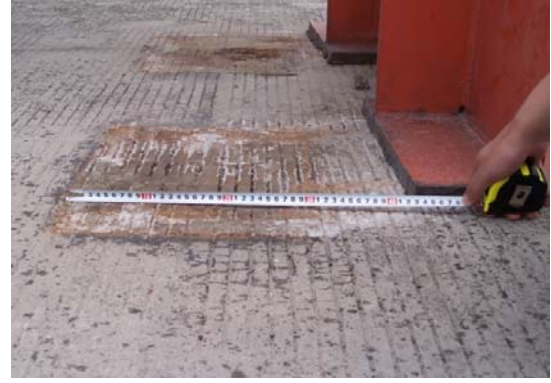
(b) Movement of the hoisting equipment along dam axis

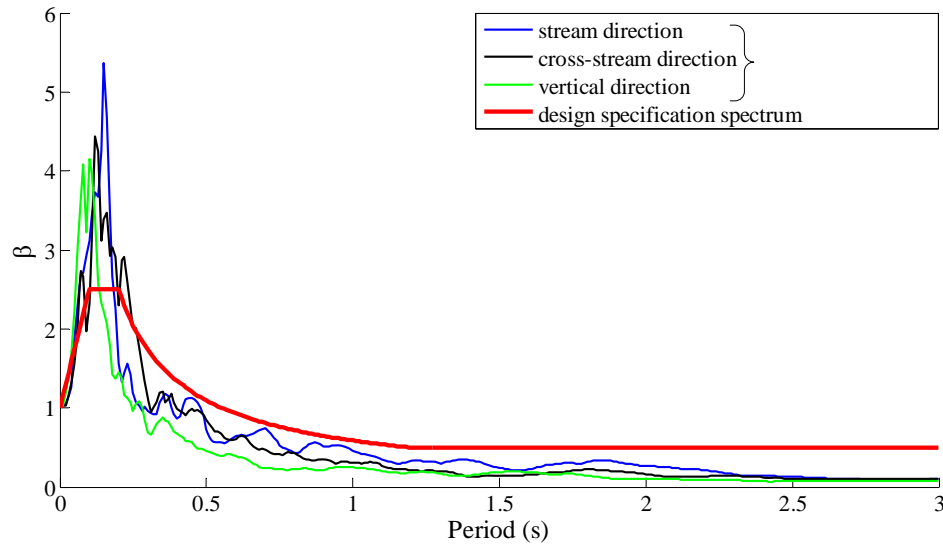
**Figure 2.2.** Response spectra of the input motions

The finite element discretization for the dam and foundation is shown in Figure 2.1. Both linear and nonlinear analyses with the latter considering contraction joint opening are accomplished. The input motions are either produced from the spectrum of the State Design Specification (DL 5073-2000) or the field measurements recorded during the Wenchuan main shock at the LixianTaoping station that is 28 km away from the dam site. The response spectra of the input are shown in Fig 2.2. Evidently, the field records have narrower band of predominant frequencies but higher amplitude of peaks compared with the design specification spectrum. The ratios of stream/ cross-stream/ vertical components are 1/ 1/ 0.67. The maximum peak accelerations are assumed to be 0.2 g, 0.3 g and 0.4 g that are equivalent to the estimated affected intensity of VIII-IX. The hydrodynamic pressure of reservoir water is considered with Westergaard additional mass model. The following cases of analysis are performed.
