Seismic Sustainability Assessment of Structural Systems: Frame or Wall Structures?

T.Z. Yeow, G.A. MacRae, R.P. Dhakal & B.A. Bradley

University of Canterbury, Christchurch, New Zealand

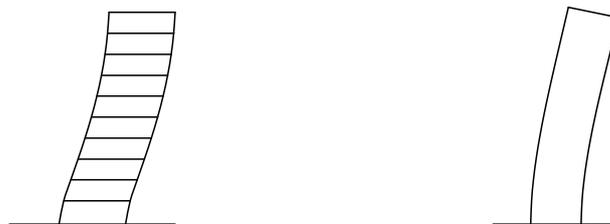
(a) Frame Structure

(b) Wall Structure

Figure 4.2 General deflection shapes for frame and wall structures

The trends can be explained by observing the expected deformation shape of the two structures. Figure 4.2 shows the general deflection shapes of the frame and wall structures. For the frame structure, it can be seen that the interstorey drifts are larger at the bottom half of the structure compared to the top half. For the wall structure however, the interstorey drift is largely governed by the rotation of the wall and therefore increases with height.
