# Human Casualty and Behavior due to the Great East Japan Earthquake in 2011

## SUMMARY:

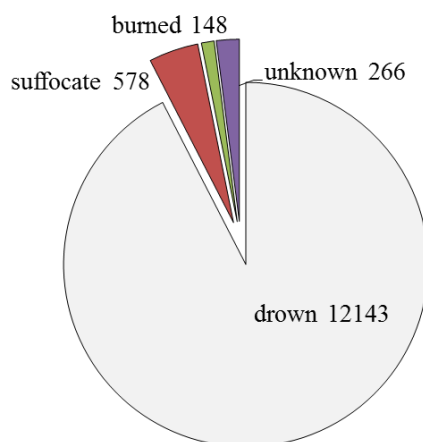
**Figure 2.** Cause of death

Over 90% of the dead was caused by drowning due to the tsunami as shown in Figure 2.(after National Police Agency, (2011))

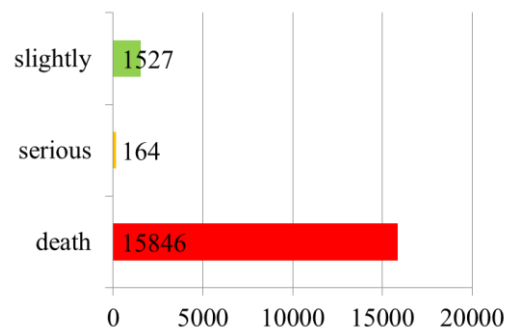
**Figure 3.** Number of casualties  
(at the point of Feb. 3, 2012)

Figure 3 shows a characteristic of the damage extent of casualty in the tsunami disaster. The difference between life and death was clear and accurate in this figure. This is a distinguishing trait from other disasters. (after National Police Agency, (2012))

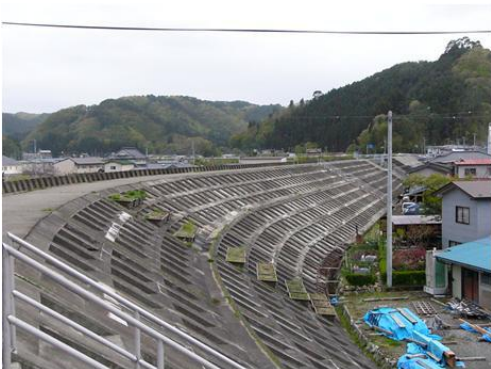
**Photo 1.** Seawall in Taro district

Over about 50% evacuees took refuge by on foot in both cities. On the other hand, many people evacuated by cars as shown in Table 3. It is very important problem to think about right and wrong to use a car at the evacuation from tsunami. Table 4 shows the destination of evacuation. Almost all of evacuees took refuge to the places those were decided for evacuation places of outdoor or indoor. In Taro district, Miyako City, they constructed not only the seawall 10 meters in height but also evacuation passage to the perch to protect their lives as shown in Photo 1 and 3. However, the tsunami overflowed into residential area (Photo.2; Miyako City).

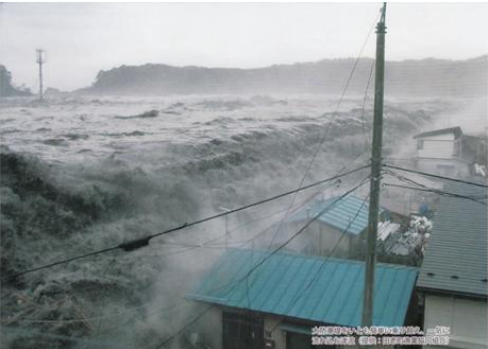
**Photo 2.** Overflowed after the tsunami

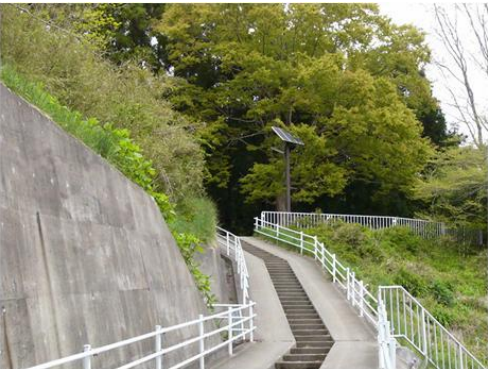
**Photo 3.** Evacuation place in Taro district

Figure 4 shows the courses of evacuation at the Taro district in Miyako City, together with the zone submerged by tsunami. According to this figure, it can be seen that many people headed toward the higher places around the district, specifically to the evacuation places such as shown in Photo 3. Taro suffered tsunami damage in 1896, 1933 and 1960. After the 1933 Tsunami, they constructed seawalls ten meters tall. Mostly, this seawall was efficient facility as in case of the 1960 Tsunami which caused by Chile Earthquake. However, too extreme case as this tsunami of 2011, it did not function adequately. 144 people died or missing in this tsunami, and death ratio of Taro was 5.5%.

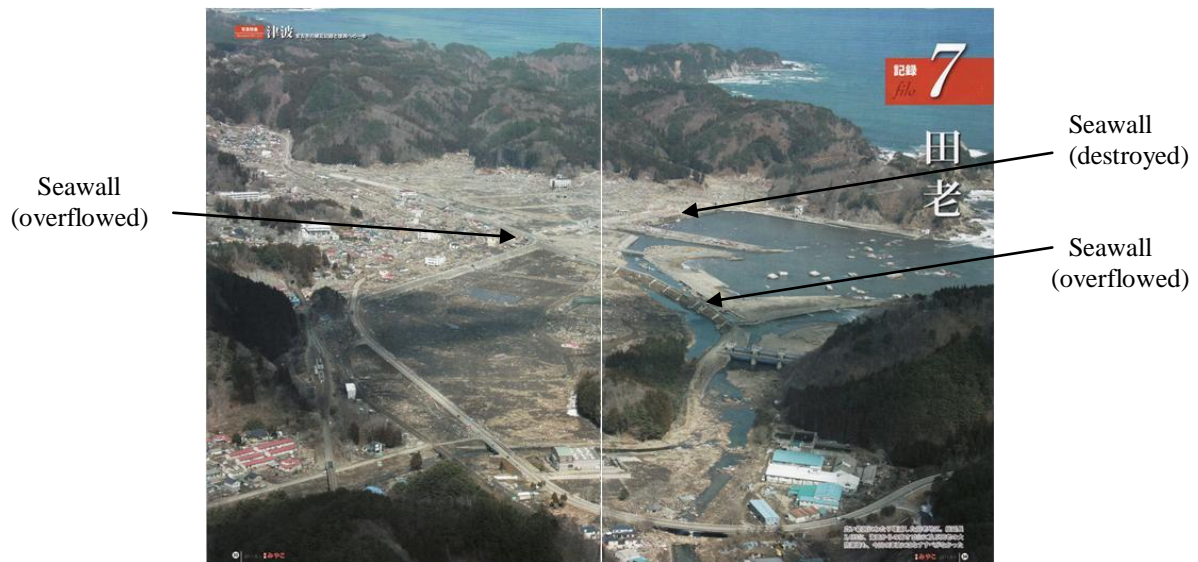
**Photo 4.** Devastated area in Taro (Official report by Miyako City)
