Overview of Seismic Strengthening Interventions in School Buildings in Portugal

Jorge Miguel Proença & António Sousa Gago

This paper contains an overview of the seismic strengthening interventions in school buildings, within the scope of the School Building Modernization Programme.

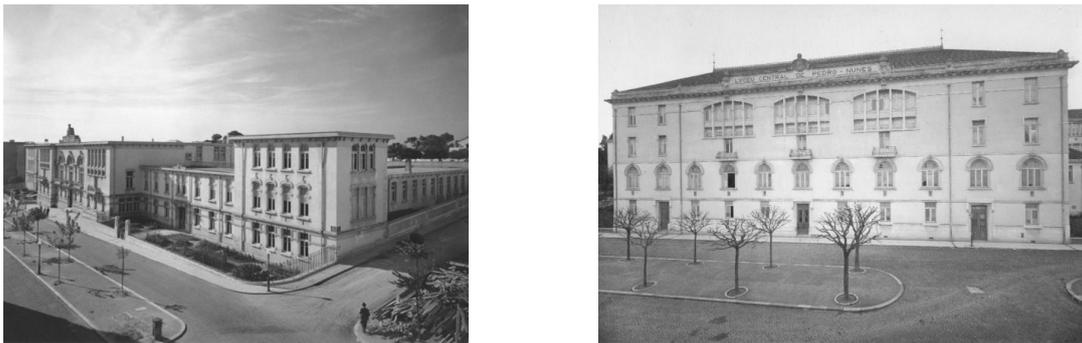
Figure 1. Maria Amália V. De Carvalho (left) and Pedro Nunes (right) Lyceums, Lisbon (AF SG/ME)

On the whole, the structures of these buildings consist of outer and interior walls made of stone masonry and solid brick, which support the floors. Stone masonry exterior walls are usually very robust and may be 1.10 thick at their foundations and varying between 0.80-0.90m and 0.60-0.70m higher up. Interior walls, mostly made of brick masonry, are less robust and are rarely any thicker than 0.30-0.40m. The construction of this group of buildings coincides with the first applications of reinforced concrete and structural steel in schools, comparatively new materials in the building industry.

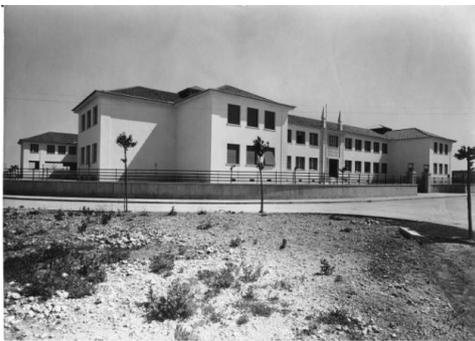
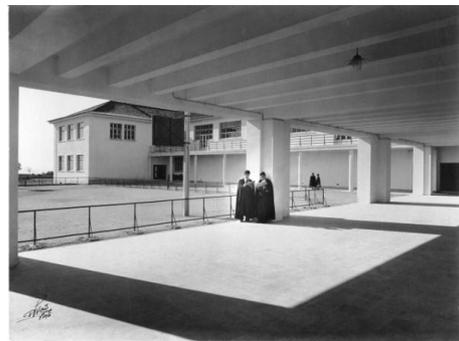
Figure 2. Sá da Bandeira Lyceum, Santarém (AF SG/ME)

The structure of these buildings can be considered robust and mostly consists of load bearing walls of stone masonry (the exterior ones being at least 0.60m thick), ceramic brick or concrete block masonry (the interior ones are only 0.25 to 0.30 m thick), which support reinforced concrete slabs (as a rule voided, ribbed and reinforced in one direction) and reinforced concrete beams. The stairs are also of reinforced concrete, but solid. In areas where an open space is required, generally the entrance lobby and covered play areas, there are usually reinforced concrete substructures consisting of grids of reinforced concrete beams (main and secondary), which, supported on columns, support the overlying floor. Load bearing masonry walls that support the slabs of the upper floors and the roof slab are often

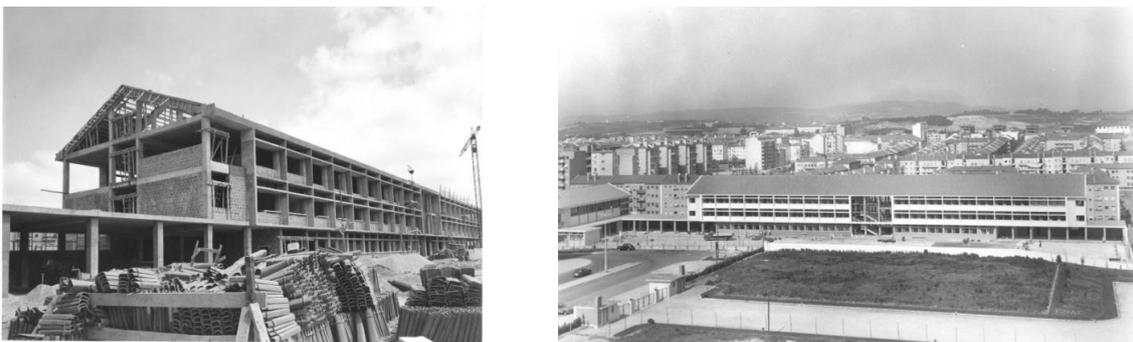
Figure 3. Rainha D. Leonor Lyceum (precursor 1st Standard Design), Lisbon (AF SG/ME)

This 1st Standard Design was developed based on a linear configuration of the main building with several aggregated bodies (separated by expansion joints) and a "central corridor" layout. The blocks that constitute the main building have a longitudinal development from three to seven bays, and are separated by 2cm thick expansion joints. In most cases the main building elevated two floors, roof slabs and sloping roofs. The main building presents a reinforced concrete frame structure, with longitudinal façade and corridor frames made of columns and beams which bear the loads associated with the slabs. The floor slabs are voided in the classrooms and solid in the corridors. Longitudinally the structural system considered for seismic action consists of the aforementioned frames, façade and corridor, which were designed for the horizontal forces in this direction (seismic coefficient of 0.10). Transversally the designers planned a more unusual structural system in which the solid corridor slab acts as a horizontal beam, making it possible to gather the transverse inertia forces and route them to the transverse substructures at the end (joint), thus serving as (transverse) supports of this beam. The structure is locked transversally by reinforced concrete diagonals in both lines of classrooms, hence enabling the resultants of the inertia forces to be routed from the floors to the foundation. Leaving aside the thickening of slabs in the classrooms under the respective end walls, the only existing transverse beams are in the joint alignments, in the same plane as the aforementioned diagonals. Considering the current seismic action (RSAEEP), there is a widespread deficiency of strength in structural elements, as well as the risk of pounding between bodies separated by joints.

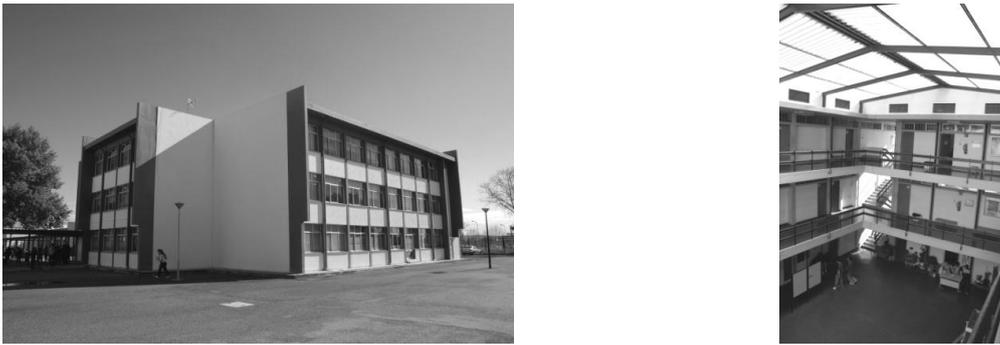
Figure 4. “Technical base” academic pavilion

The pavilion-type solution, which started with the 2nd Standard Design, was used from the end of the 1960s and became steadily more important. The “lyceum base”, “technical base” and “3x3” standard designs are all structured from a group of separate blocks linked by covered external galleries, allowing the building to adapt to different situations, being replicated nationwide in the succeeding decades. One of the more disseminated occurrences corresponds to the “technical base” model generally composed of one administrative pavilion and some academic pavilions. The more numerous academic pavilions, with variable height up to three storeys high, are developed based on a square plan around a central courtyard covered by skylights. Structurally speaking, all the pavilions have a framed structure using a reinforced concrete beam-column-slab system; the slabs are voided in the classroom areas and solid on the stairs and accesses (which are narrow cantilevered balconies).

The reinforced concrete frame structure of the classrooms consists of frames in the two directions, with expansion joints separating each of the blocks in four independent buildings. In all buildings inspected, with one or two elevated floors, high weaknesses were identified near these joints, resulting from differences in deformability of neighbouring structural elements (slabs and beams). These deficiencies have consequences particularly with respect to the use of the building and its durability. The expansion joints were only 2-3cm wide, which is not enough given the foreseeable amplitude for the vibration of the buildings and may lead to the pounding effect. As expected, the seismic vulnerability assessment studies also pointed out to a general lack of strength (particularly in the more generous corner columns, with little reinforcement) and outdated detailing rules in the critical cross-sections of these columns.

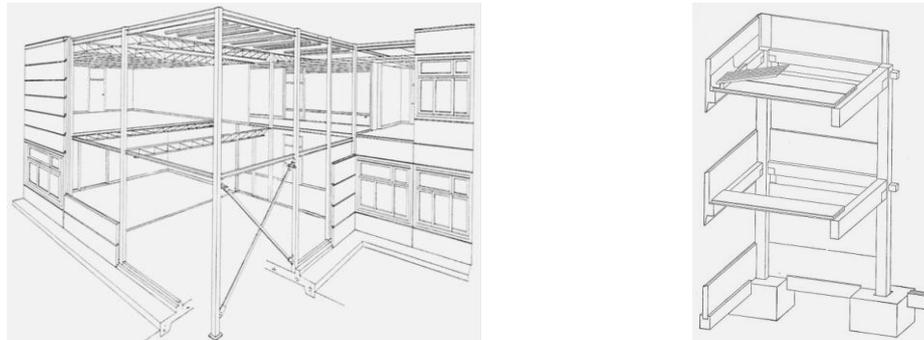
Figure 5. CLASP mixed system (left) and Indubel IP2 (precast frame RC, right)

In the Indubel IP2 solution the pavilion structure is framed (columns and beams) with hollow core floor slabs. Assuming that the column-beam connections are pinned, the structural system resistant to seismic action consists of columns with cantilever-type behaviour. The studies show that these columns have insufficient strength (especially at their base), also raising questions about whether the floors can be considered rigid in their planes.

CLASP is a mixed steel-concrete prefabricated solution that uses steel columns (considered hinged at the base) and steel beams (main and secondary) that support the floor slabs. These slabs are of precast reinforced concrete, with built-in triangular lattice girders, finished with a cast-in-place concrete topping). Another of the identifying features of this typology is the walls: in the exterior, made of prefabricated concrete panels; in the interior, consisting of lightweight partitions made of particleboard panels. The stability of the structure under horizontal actions is provided by steel bracings installed in some spans and in both horizontal directions. Studies point to a clear failure of the existing bracings, along with the short column effect caused by these bracings being connected to the columns at a different elevation from that on which the floor beams (and slabs) are supported.

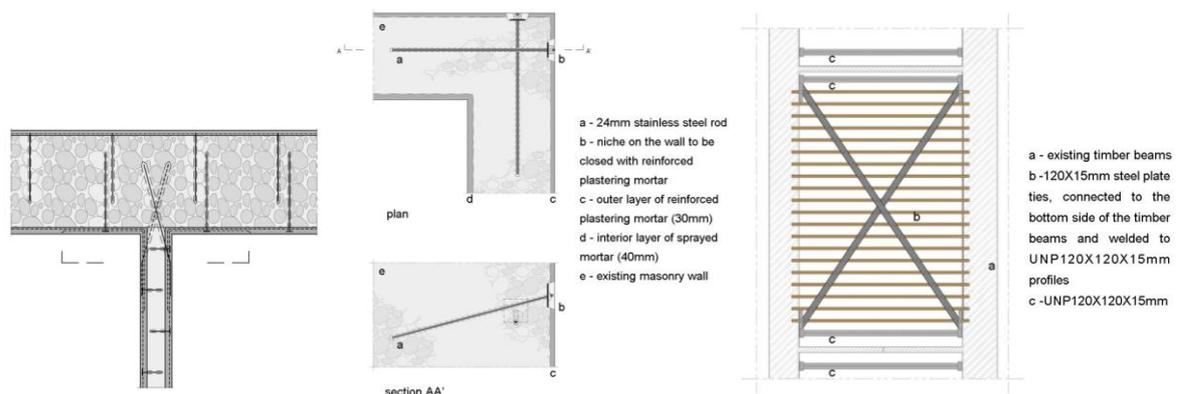
Figure 6. Examples of improvement of the connection between orthogonal walls and stiffening of floor structures through the addition of steel plates (A2P)

This limited but important group of school buildings presented deficiencies common to all load bearing masonry wall buildings (also considered in the second group), in this case aggravated by in-plane deformability of the (timber) floor structures. The improvement of the behaviour of the load bearing masonry walls was generally accomplished through a number of variants of what could be called “reinforced plastering mortar” solution (described in a companion paper, Proença et al, 2012). A particular attention was devoted to improving the connections between orthogonal walls and stiffening the floor structures in their plane (figure 6) and improving floor to wall connections.

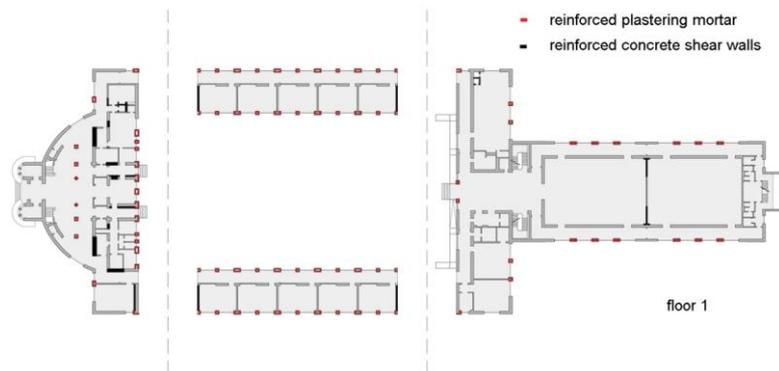
Figure 7. Location of seismic joints and reinforced plastering mortar interventions (TT)

In some cases, the extricated and long dimensions of the main building (single building with no expansion joints) led to the division into separate, more regular, building blocks with the inclusion of new seismic joints (figure 7).

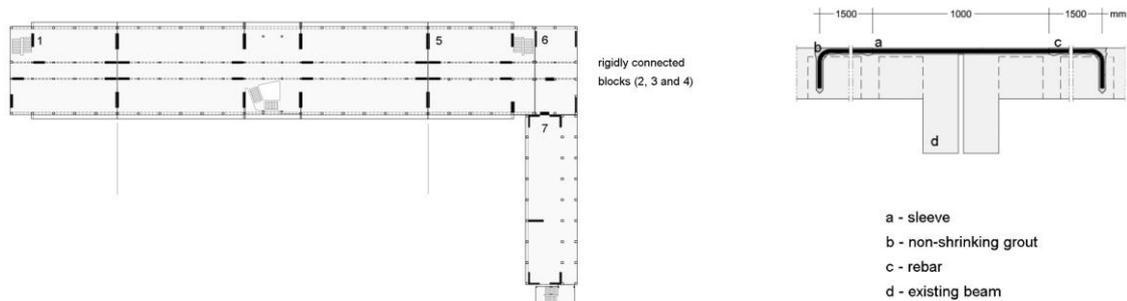
Figure 8. Examples of location and orientation of RC shear walls and elastic connection between blocks (ARA)

concept but, as a consequence of the low values for the seismic coefficient (and inappropriate distribution of inertia forces along height) and the insufficient thickness of the seismic joints, presented a series of deficiencies. These deficiencies were solved by different approaches in which the most common consisted in the construction of reinforced concrete shear walls (with individual foundations, generally with micro-piles) distributed in plan and in both directions (figure 8, left). Another common feature of these interventions consisted in rigidly joining groups of adjacent blocks and elastically joining groups of (rigidly joined) blocks, so that pounding between these could be dismissed (figure 8, right, shows a typical connection detail).

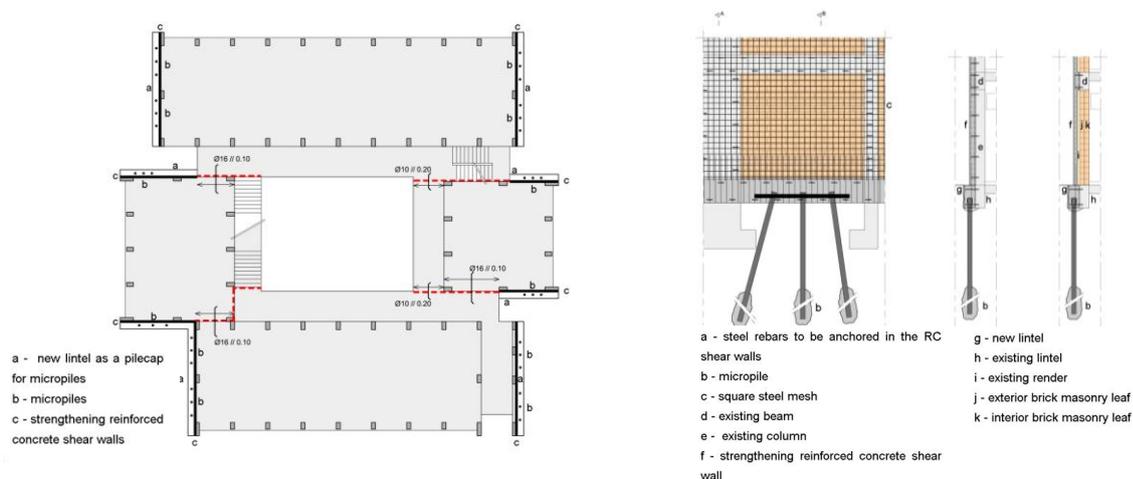
Figure 9. Examples of interventions in “technical base” academic pavilions (PC)

One of the most common strengthening solution comprised the following operations: (1) elimination of expansion joints, stitching these and building a peripheral beam at roof level tying all four blocks; (2) construction of external slender reinforced concrete shear walls in some of the facades, tied to the existing structure and with independent foundations (through micro-piles).

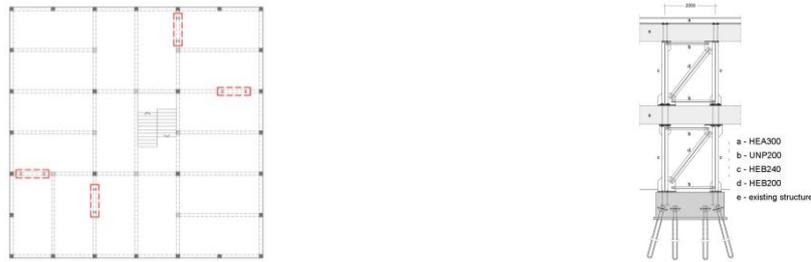
Figure 10. Location of steel bracing structures in plan and corresponding detail (FTD)

The variety of school buildings that fit into this group are mostly prefabricated – in some cases precast reinforced concrete – that correspond to interpretations of the pavilion model adopted for standardized design in the 1980s. One of the most common prefabrication systems corresponds to the Indubel IP2 (referred to previously). The lack of strength (and inadequate detailing) of the columns, particularly at their base, was solved through the inclusion of steel bracing structures, evenly distributed in plan and in both horizontal directions. These bracing structures presented micro-piles’ individual foundations.
