Long Term Recovery from the 3.11 East Japan Earthquake Disaster: Evaluating Resettlement Projects after Tsunami Disasters

Norio MAKI

Research Center for Disaster Reduction Systems, DPRI, Kyoto University, JAPAN

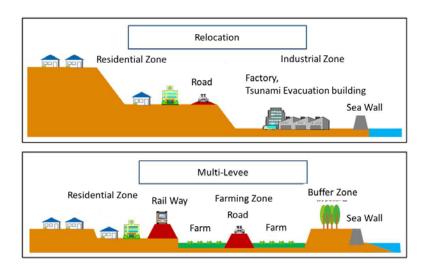
Figure 1. Concept of Land Use (Source: Miyagi Prefecture Recovery Plan)

The East Japan Earthquake Disaster on March 11, 2011 (EJED) resulted in 18,916 deaths and missing, and 129,472 severe damage, and 255,977 minor damage buildings, which occurred especially in Iwate, Miyagi, and Fukushima Prefecture (Level 1 Disaster Response Headquarter, 2012). Those damages were mainly caused by tsunami. After the event, national government set two category of tsunami hazard such as level 1 tsunami, and level 2 tsunami for tsunami disaster reduction. Level 1 tsunami is 100 year interval tsunami, and strategy for level 1 is "prevent damage", and constructs sea wall to prevent damage from this height of tsunami. Level 2 tsunami is 1,000 year interval tsunami, and strategy for this tsunami is "mitigate damage". Comprehensive disaster reduction including land use regulation, tsunami warning will be compiled to save human lives from level 2 tsunami. Recovery project from the East Japan Earthquake Disaster was planned considering those two levels of tsunami. Resettlement to higher ground or mound making in lower land is now planned in impacted area. Figure 1 shows the concept of land use plan for recovery projects.

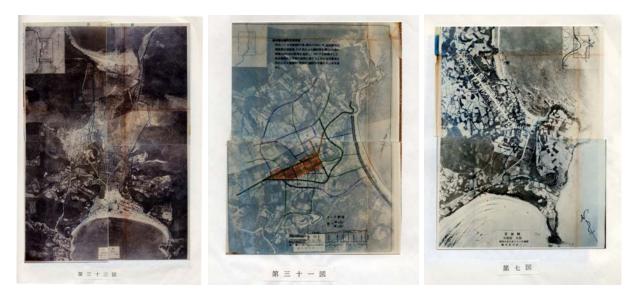
Figure 2. Site plan of resettlements: Left: Funakoshi, Yamada, Iwate, Middle: Kirikiri, Ootsuchi, Iwate, and Right: Ootani, Motoyoshi, Kesennuma, Miyagi (Source: Department of Urban Planning, 1934)

Contents of the plan are very similar to that of the EJED recovery plan. One difference is about sea wall. Though a big sea wall will be constructed to prevent level 1 tsunami for the EJED recovery, tools to disaster reduction was resettlement to higher ground in Syowa recovery. Figure 2 show the examples of drawing for resettlement site.

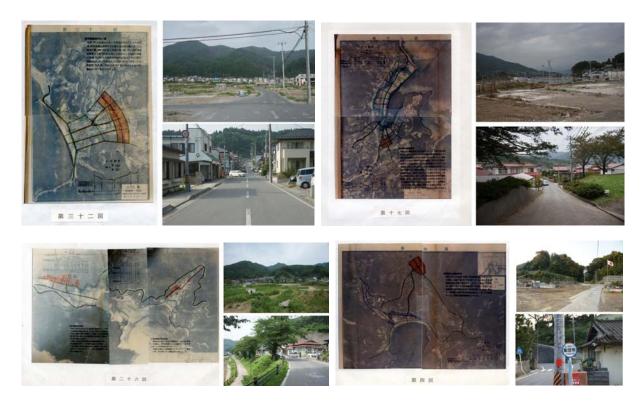
Figure 2. Syowa Resettlement, Upper Left: Tanohama, Yamada, Iwate Upper Right: Hosoura, Oofunato, Iwate, Lower Left: Hongo, Karani, Kamaishi, Iwate, Lower Right: Aikawa, Kitakami, Ishinomaki, Miyagi

Large scale Syowa resettlement site correspond this type of damage. Though there was no damage in the resettlement site at higher ground, expanding residential area in lowland suffered from devastating damage. Figure 2 shows the site plan of Syowa resettlement and impacts from the EJED.

Resettlement site of Syowa Tsunami Disaster have about eighty years history. Environmental condition of resettlement site looks nice. Tanohata community (Upper Right) got severe damage in lower part, but main part of resettlement site was safe. Basic layout of resettlement in Syowa has been kept, and several shops exist in resettlement site. Situation of Hosoura community (Upper Left) is same with Tanohata.

Hongo community have excellent layout. cherry trees were planted at the boundary of resettlement site, and lowland, though several houses located in lowland got damage. And Aikawa community have

interesting feature. Name of bus stop in resettlement site is still "resettlement site".

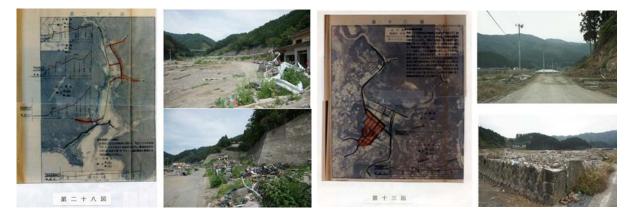
Figure 3. Syowa Resettlement suffered from devastating damage, Left: Ryoishi, Kamaishi, Iwate, Right: Osabe, Rikuzentakada, Iwate

Some resettlement site of Syowa suffered from devastating damage even at the resettlement site of higher ground. Recovery projects and damage from the EJED are shown in Figure 3. Ryoishi in Kamaishi (Left), Urahama in Okirai, Oofunato, Tanigawa in Ojika, Ishinomaki correspond to this damage type. And Osabe in Rikuzentakada (Right) made both mound and sea wall for tsunami protection after Syowa Tsunami Disaster, but those tsunami protections could not save community. Tsunami of the EJED was far beyond the height of Meiji and Syowa at those communities.
