Experimental cyclic behaviour of stone masonry spandrels

F. Graziotti

G. Magenes & A. Penna

Keywords: stone masonry, masonry spandrel, full scale test, timber lintel

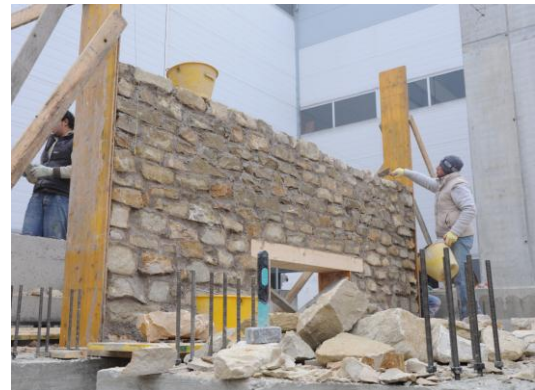
Two full-scale double-leaf stone spandrel specimens were tested. They were made up of two piers and a spandrel supported by a timber lintel. The difference between the two tests was the presence of a horizontal compression in the second specimen (S2), while the first one (S1) had zero compression. The presence of a horizontal compression in a real spandrel may be due for instance to the presence of horizontal steel ties, typically positioned at the floor levels. The dimensions of the two specimens were identical and they are reported in Fig. 3.1(left).

Figure 3.1. Dimensions of the two double-leaf stone masonry specimen [mm] (left) and picture taken during the construction on the first specimen (right)

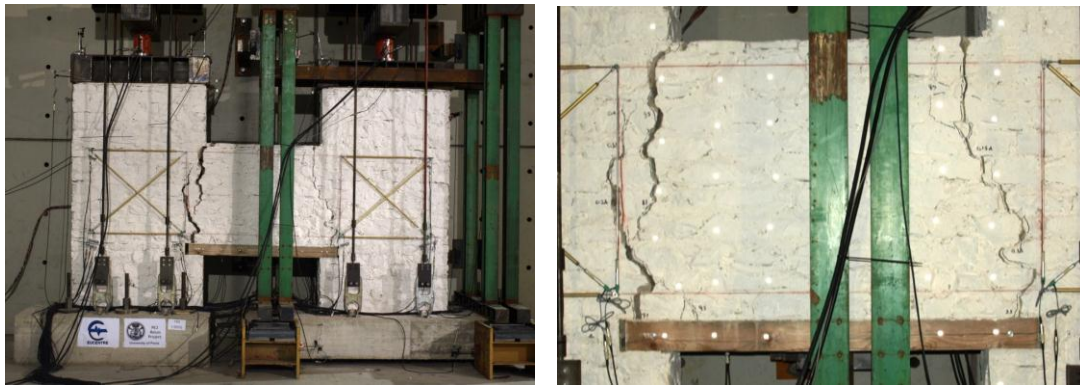
Figure 6.1. View of the entire specimen at C15 ($\theta_n = 1.5\%$) (left) and crack pattern of spandrel at C10 ($\theta_n = 0.6\%$) (right)

The first cracks of the cyclic test were induced by flexure due to the downward movement of the right pier and occurred at step C3 ($\theta_n = -0.1\%$). The first visible sliding of the lintel on the piers took place during step C7 ($\theta_n = 0.3\%$). The left part of the lintel was debonded from the pier due to the bending moment in the spandrel element; during the uplift of the right pier that part of the lintel works as a tensile strut. At this drift the friction between masonry and lintel reached its limit, providing the maximum resisting moment of the element. Continuing the test, the spandrel element showed a “rocking” behaviour. No new cracks appeared. During step C8 ($\theta_n = 0.4\%$) the cracks on the two interfaces opened and closed under cycle reversal allowing rigid rotations of the spandrel. During step C10 ($\theta_n = 0.6\%$) these cracks were opened more than 10 mm and, at the end of the cycles, a considerable residual crack width remained as shown in Fig. 6.1 (right). The distance between the piers increased at every cycle, due to the absence of a horizontal restoring force. In particular, the final relative displacements of the lintel (after the test C15, $\theta_n = 1.5\%$) were 3.8 cm on the left and 1.8 cm on the right (Fig. 6.1). It was not easy to detect a real qualitative “collapse” point. With this crack configuration, the spandrel element would have been able to “couple” the piers for higher drifts, thanks to the presence of the wooden lintel.

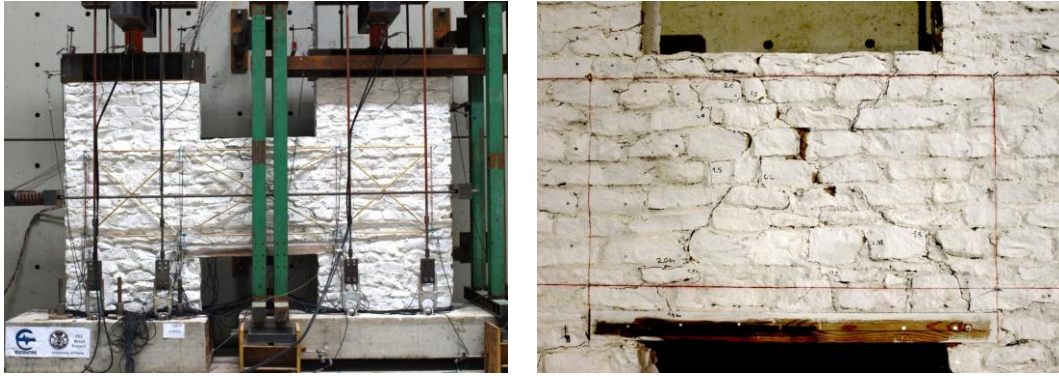
Figure 6.4. View of the second specimen at C19_38 ($\theta_n = 3\%$) on the left and close view of the crack pattern of the spandrel at the end of the test S2 on the right.

Two C19 ($\theta_n = 3\%$) cycles were conducted at two different horizontal force levels: 38 kN and 19 kN.
