# Revision of IAEE Guidelines for Earthquake Resistant Non-Engineered Construction

### GUIDELINES FOR EARTHQUAKE RESISTANT NON-ENGINEERED CONSTRUCTION

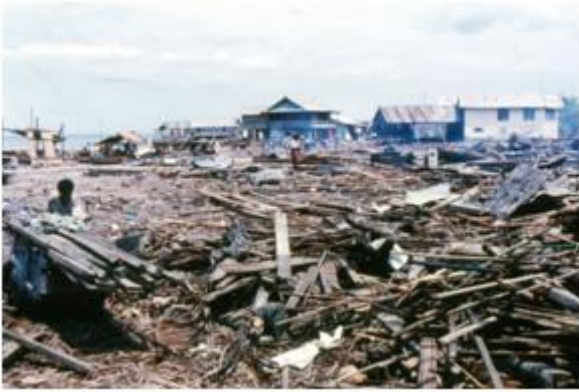
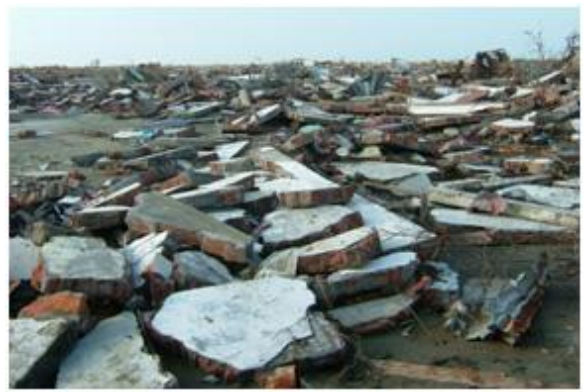
**Figure 2.** Damage caused by tsunami (Indonesia)

(a) 1992 Flores Earthquake

(b) 2004 Aceh Earthquake

Since the principles included in the Guidelines still apply until now, this revised edition essentially retains the Guidelines in the original form except for some minor editorial changes and modifications. Some building damage photographs from recent earthquakes have been included for illustration (see Figs.2, 3, 5, 6 and 7) so that the concept of the guidelines will be easily understood. A major addition is Confined Masonry in Chapter 4 (see Fig.4) and Appendices in Chapter 10 giving the MSK Intensity Scale as related to buildings, a table for assessment of seismic safety of a masonry building, and examples of posters on brick (see Fig. 8) and wooden buildings.

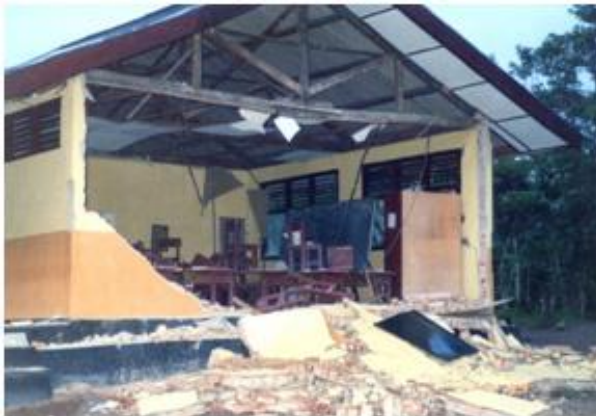
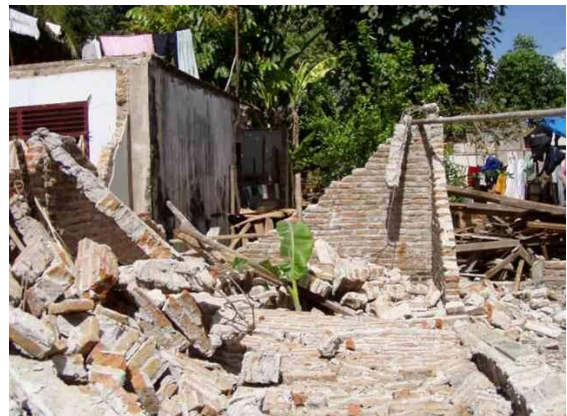
**Figure 3.** Out-of-plane failure of brick masonry wall (Indonesia)

(a) 1994 Liwa Earthquake

(b) 2006 Central Java Earthquake

Many buildings are spontaneously and informally constructed in various countries in the traditional manner without any or little intervention by qualified architects and/or engineers. Some types of the non-engineered construction are (1) un-reinforced masonry (stone, brick or concrete block masonry) (see Figs.3 and 5), (2) confined masonry (see Fig.4), (3) wooden construction (see Fig.6), (4) earthen construction (adobe or tapial, i.e. rammed earth) (see Fig.7), etc.

In un-reinforced construction, masonry walls consist of fired bricks, solid concrete blocks, hollow concrete or mortar blocks, etc. The main weaknesses in un-reinforced masonry construction are a) heavy and stiff buildings, attracting large seismic inertia forces, b) very low tensile and shear strength,

particularly with poor mortars, c) brittle behaviour in tension as well as compression, d) weak connections between walls, etc. Therefore, use of mud or very lean mortars is unsuitable.

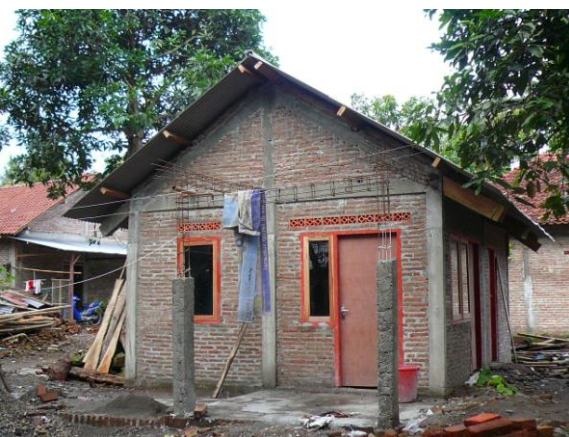
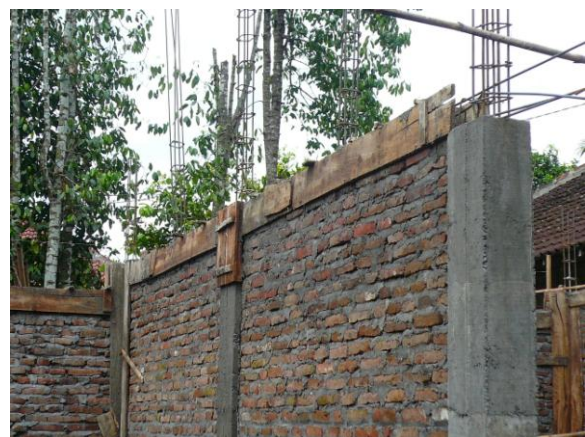
**Figure 4.** Construction of confined masonry (Indonesia)

(a) Single storey house (Aceh)

(b) Two storey house under construction (Jawa)

Confined masonry consists of masonry wall of clay brick or concrete block units and horizontal and vertical reinforced concrete members that confine the masonry wall panels at four sides. Vertical members are called “tie-columns”, and though they resemble columns in reinforced concrete (RC) frame construction they are of much smaller cross-section. Horizontal elements, called “tie-beams”, resemble beams in RC frame construction, but also of much smaller section. It must be understood that the confining elements are not beams and columns in the way these are used in RC frames. Rather they function as horizontal and vertical ties or bands for resisting tensile stresses.

As to the confined masonry, the finished appearance looks similar to the ordinary RC frame construction with masonry infills, but they are very different. The differences are related to the construction sequence, as well as to the manner in which these structures resist gravity and lateral loads. In RC frames, columns and beams are constructed, then the masonry wall units infill the frames. In confined masonry, usually masonry walls are constructed and then the tie-columns and tie-beams are constructed. In RC frames, the RC columns and beams carry the vertical gravity as well as the lateral loads from earthquakes or wind storms unaided by the masonry infills. In the case of confined masonry buildings, the wall panels are the main load carrying elements (both vertical and horizontal) aided by the confining elements (tie-columns and tie-beams) for resisting tensile forces.

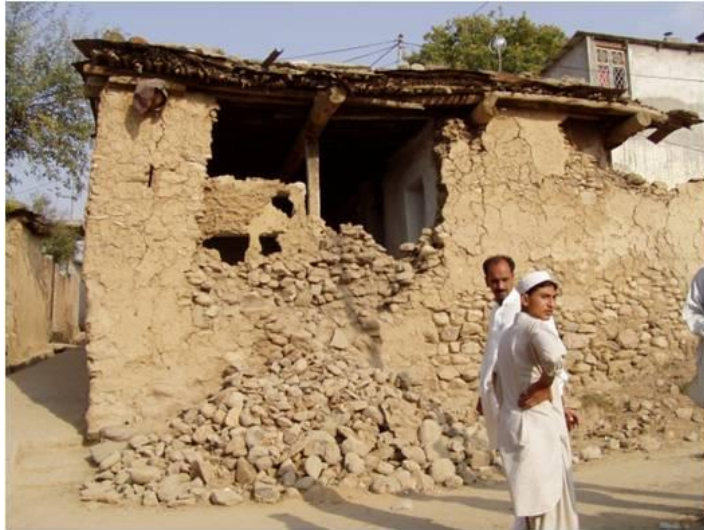
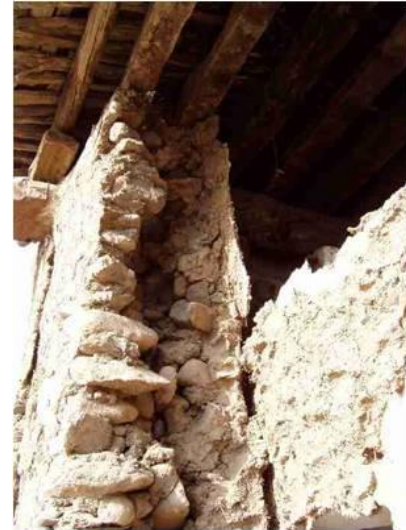
**Figure 5.** Damage to stone masonry (2005 Northern Pakistan Earthquake)

(a) Unreinforced stone masonry

(b) Damage to the stone masonry wall

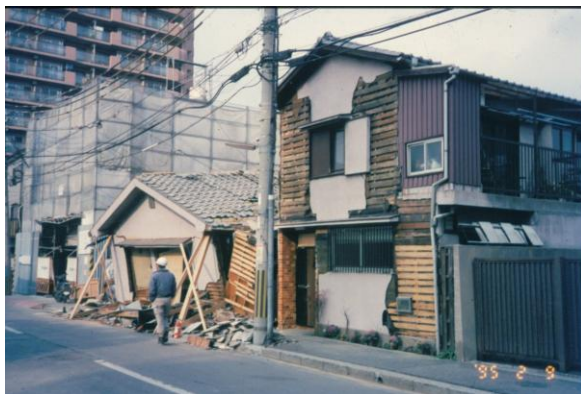
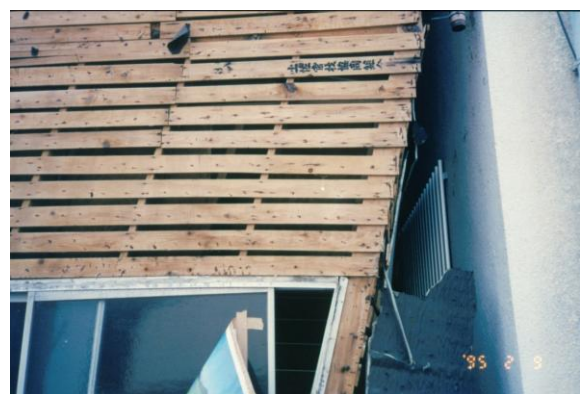
**Figure 6.** Damage to wooden houses (1995 Kobe Earthquake, Japan)

(a) Damage concentrated to the first storey

(b) Detail of the damaged wooden house

Wood has a high strength per unit weight and is very suitable for earthquake resistant structure. However, heavy cladding walls impose high lateral loads on a wooden frame beyond its structural capacity. Although seismically suitable, use of timber is declining in building construction even where it used to be the prevalent material on account of vanishing forests due to population pressure. The situation in many countries of the world has in fact become rather alarming on account of the ecological imbalance. Hence use of timber must be restricted in building construction for seismic strengthening weaker construction such as adobe and masonry. Wooden construction is suitable in those areas where wood is still abundantly available as a renewable resource.

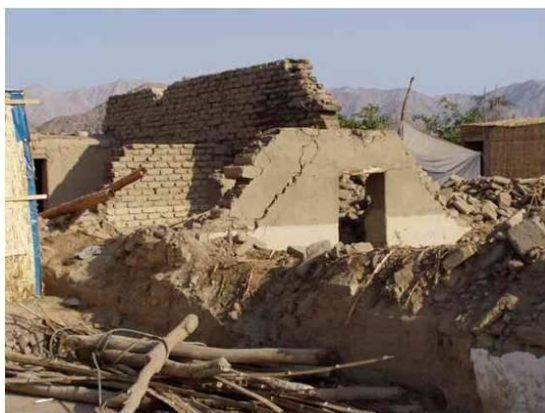
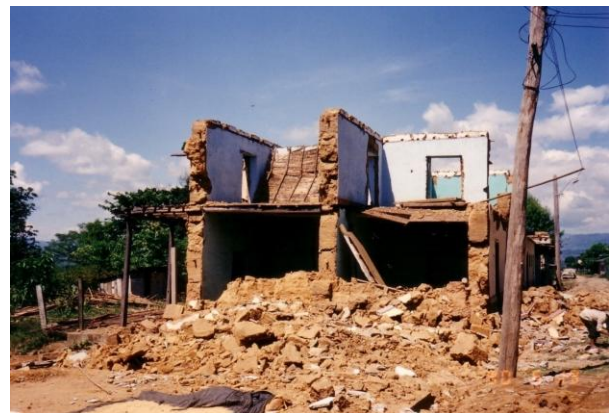
**Figure 7.** Damage to earthen buildings (Peru)

(a) Damaged adobe (2007 Pisco Earthquake)

(b) Damaged tapial (1990 Rioja Earthquake)

In earthen construction, walls are the basic structural elements and can be classified as a) hand-formed by layers, b) adobe or blocks, c) tapial or pise (rammed earth), and d) wood or cane mesh frameworks with mud. This material has clear advantage of costs, aesthetics, acoustics, heat insulation and low energy consumption, but it has some disadvantages such as being weak under earthquake forces and water action. However, technology developed to date has allowed some reduction of its disadvantages. Earthen construction is, in general, spontaneous and a great difficulty is experienced in the dissemination of knowledge about its adequate use. The recommendations are applicable to earthen construction in general, but they are especially oriented to popular housing, aiming to enhance the quality of spontaneous, informal construction which cause the greatest loss of life and damage during seismic events. Therefore, not included are solutions involving the use of stabilizers (cement, lime, asphalt, etc.) to improve the strength or durability. But to enhance the dynamic behaviour of the structure economically, minimum use of the expensive materials (concrete, steel, wood, etc.) is indicated.
