# Structural Rehabilitation Studies of Masonry Building Heritage Under Near Fault Earthquake: A Case Study

**N.G. Maldonado, P.E.Martín, I.A.Maldonado**

*CeReDeTeC, Universidad Tecnológica Nacional, Facultad Regional Mendoza, Argentina*

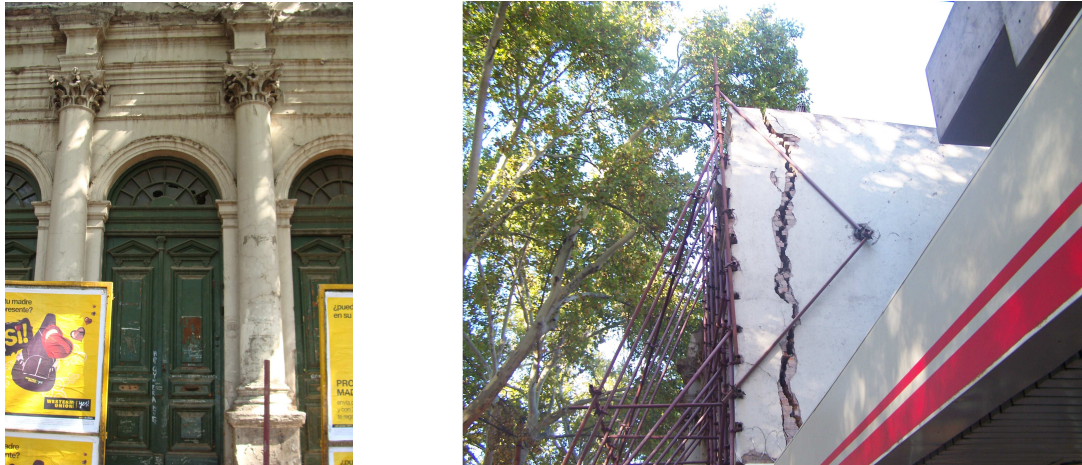
**Figure 1:** View of original front and the current temporary shoring.

The original building has had various enhancements, and some have created even more problems of pathology. The effect of earthquakes has been very important for the damage that occurred in the masonry. The first improvement, post-earthquake Laval, 1927, resulted in the placement of tension-level openings in one direction, not solution enough to achieve adequate structural behavior. The 1985 Mendoza's earthquake originated cracking of the masonry from the front to 45 degrees and the eviction of the building. A major earthquake August 2006 led to the separation of the front (Fig. 1).

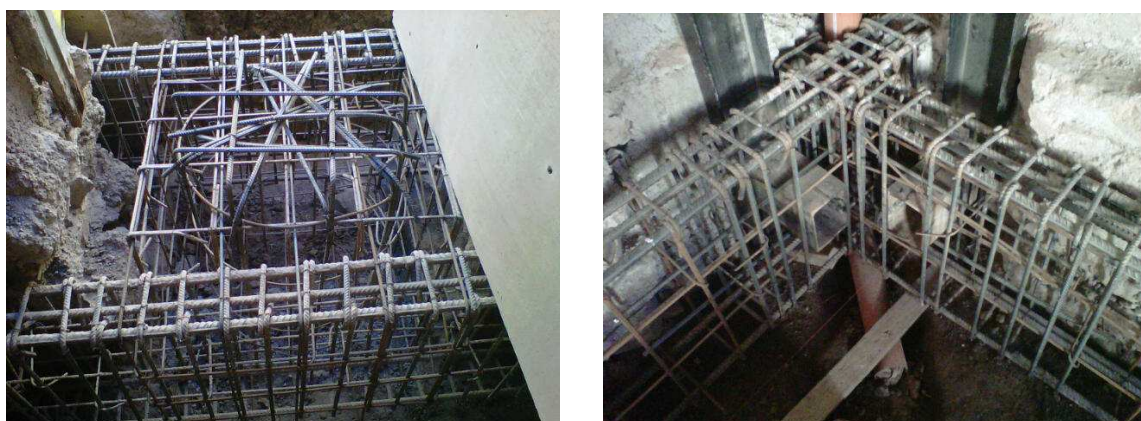
**Figure 6.** Details of reinforcement of pile cap (left) and foundation beams (right)

Rehabilitation is currently running. It has started sectioned to ensure the bearing capacity of foundations in the first place and advance the capacity of the superstructure. Fig. 6 and 7 present the execution states of foundations and locate assemblies for load bearing columns and the cleaning of masonry walls.

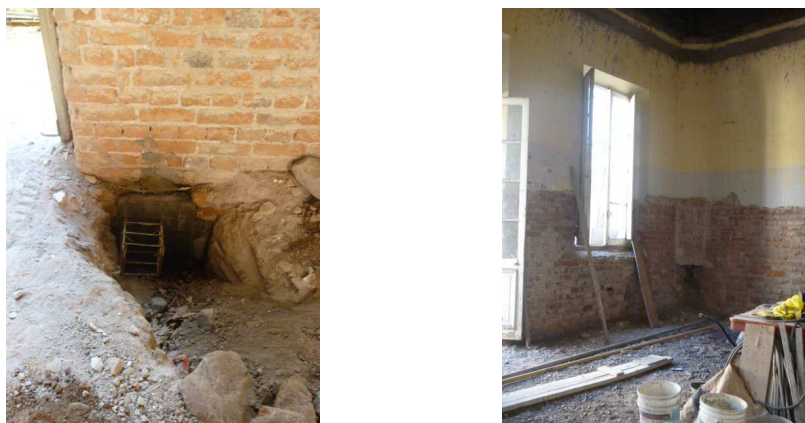
**Figure 7.** Reinforced foundation beam under wall (left) and cleaning of plaster of masonry (right)
