Calibration of Nonlinear Response History Analysis Results With Observed Structural Damage in an Apartment Building in Chile

15 WCEE
LISBOA 2012

S.G. Bolaños-Castro

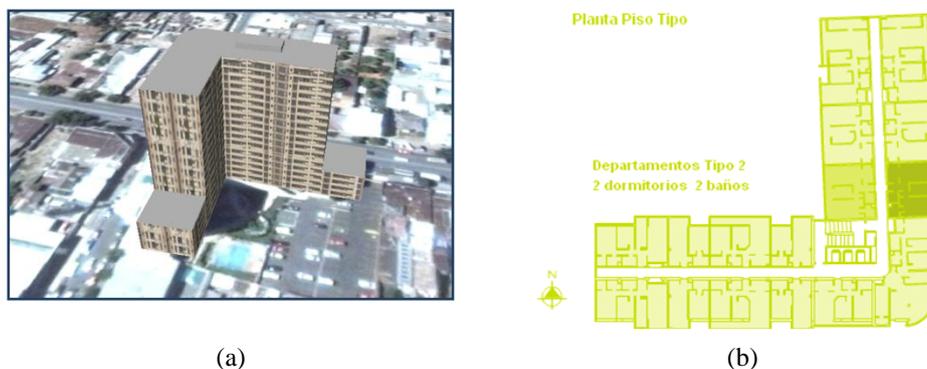
Figure 1. Study building. (a) Google Earth image; (b) plan and apartment layout of building.

During the EEFIT mission to Chile, one of the buildings surveyed was an apartment building in Talca, a few blocks from the city centre. The building is eighteen storeys high with two levels of basement. A Google Earth image is shown in Fig. 1(a). It includes six different apartment sizes as can be seen in Fig. 1(b). The building is L-shaped in plan, and there is movement joint between the two wings of the building. The structural system of the building is predominantly based on reinforced concrete (RC) structural walls (shear walls). Walls are coupled with beams above doorways, but these beams are relatively lightly reinforced, suggesting that they may not have been designed as energy dissipative elements. The walls are reinforced with a minimal ratio of reinforcement (0.25%), typical of buildings of this type with a large cross sectional area of walls. A detail of the wall and beams reinforcement can be seen in Fig. 2.

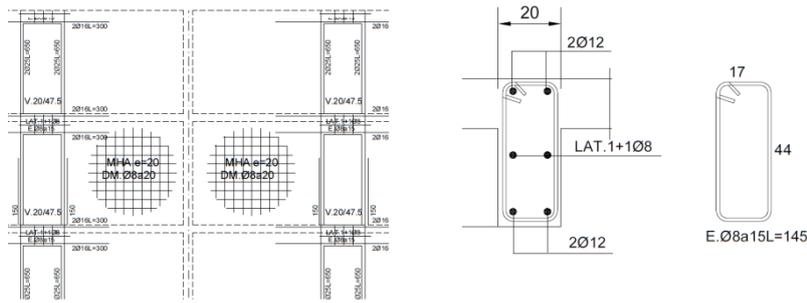
Figure 2. Distribution of reinforcement in walls and beams.

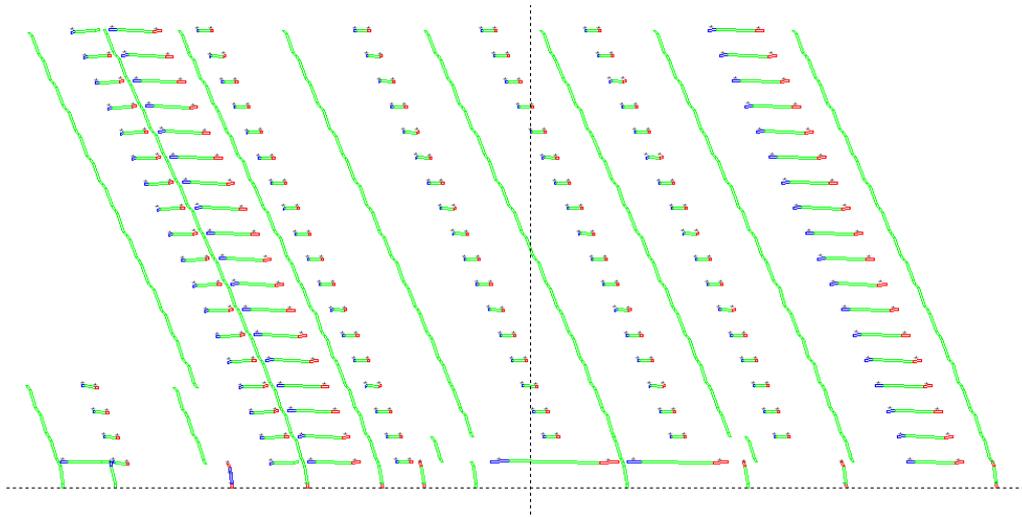
Figure 3. Screenshot from *Ruaumoko* showing arrangement of walls and coupling beams (both modelled with 1D beam elements). Red and blue colours represent yielding of plastic hinges at this point in analysis.

A 2D structural model was developed using *Ruaumoko*, a general purpose non-linear dynamic analysis program (Carr, 2007). An inelastic response history analysis was carried out, using the Newmark constant average acceleration algorithm, with a lumped mass matrix, tangent stiffness Rayleigh damping of 5% of critical and including P-Delta effects. The model was set up for the gridline corresponding to the horizontal inner wall considered to be the critical one according to its structural distribution as it encompasses the entrance opening on the ground floor. Three-dimensional torsion effects were ignored. Figure 3 shows the model layout and the process of the analysis with the yielding of the elements marked with blue and red at a point of the ground peak acceleration.

Walls were modelled with one-dimensional beam elements located at the centroid of each wall. Rigid offsets were used to model offsets from centrelines to the connection with coupling beams, as shown in Fig. 3. Member hysteresis and stiffness degradation was taken into account with the Modified Takeda hysteresis model, with γ and β parameters taken as 0.5 and 0, respectively, for the walls. The one-dimensional beams in the model were also defined with the Modified Takeda hysteresis rule, using γ as 0.3 and β as 0.6. Strength degradation for both beams and walls was taken as zero.

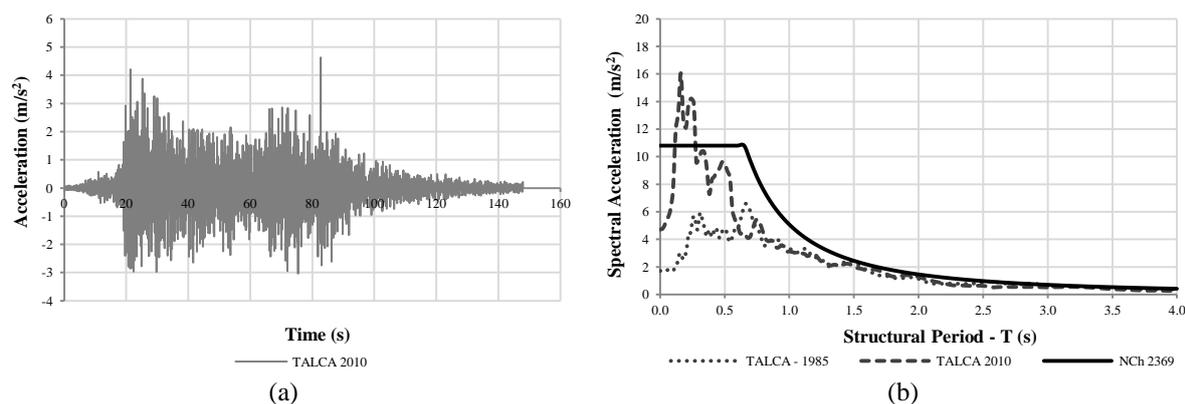
Figure 4. (a) Ground acceleration history recorded by the Talca Seismological Station. (b) Response spectra from Chilean code and at Talca station from Maule, 2010 and Valparaíso, 1985 earthquakes.

The nearest ground motion recording station to the study building was the Talca station, located around 90 km (Cosmos, 2007) from the building. Clearly, the differing effects of site conditions and wave passage effects mean the record may not represent the exact amount of shaking that the structure experienced, but this is the most representative accelerogram available for the study. Fig. 4(a) shows the time series for the acceleration values of the Talca record and Fig. 4(b) shows the spectra of the event compared with the design spectra from Chilean code and with the Talca recording of the Valparaíso, 1985 earthquake for comparison. The spectra of the 2010 recording is comparable with both the 1985 recording and the Chilean code spectrum for periods greater than 1.5 seconds (as noted in Section 5, this is relevant to the study building with a period of 1.7 seconds).

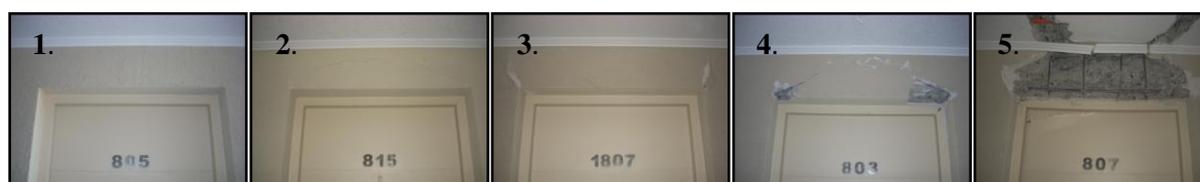
Figure 5. Damage states defined. 1. No observable damage. 2. At least one concrete crack. 3. Some cover concrete spalling. 4. Major cover concrete spalling. 5. Complete cover concrete spalling.

The damage suffered by the coupling beams was classified into five categories distributed from “No observable damage” to “Complete cover concrete spalling”. A bespoke damage scale was used for this purpose based on damage observable in the photographs. The damage scale was based on a classification of damage observed in this particular building, and is not calibrated against other scales in the literature. The defined damage states and a typical photo representing each one are described and shown in Fig. 5. As with other damage scales used in the literature, the assignment of numerical indices to different levels of damage does not mean that the scale is linear. These are simply a ranking of the minimum differences in degrees of damage that could be classified based on the photos alone.

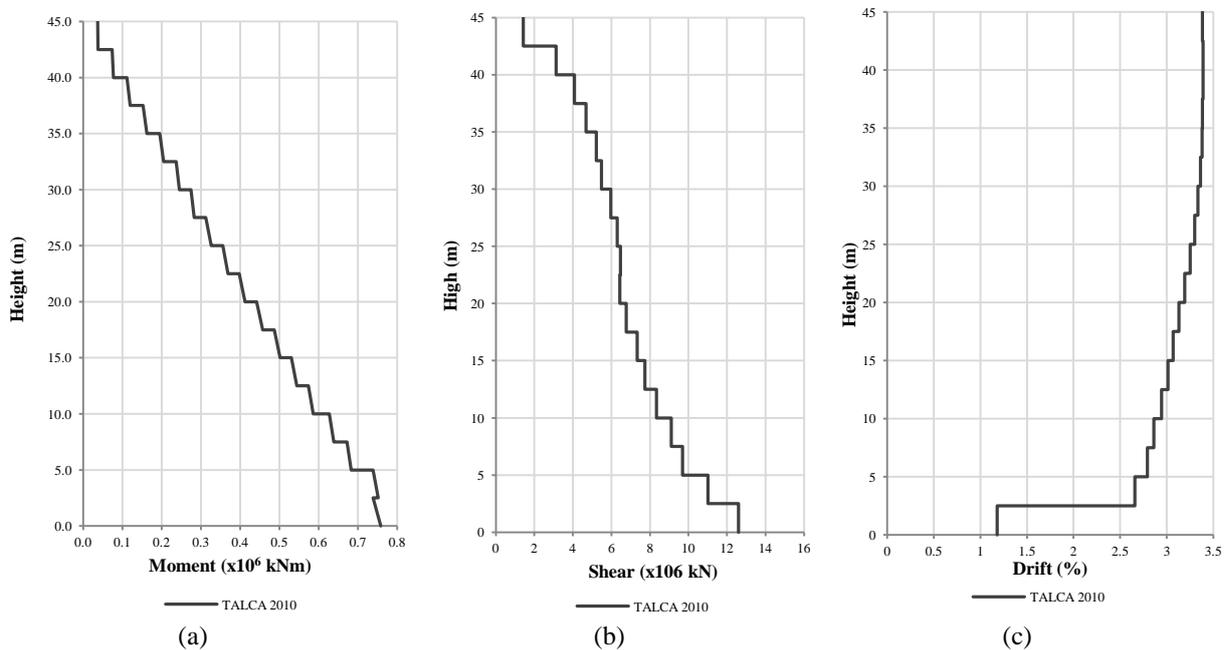
Figure 6. (a) Moment force felt by the structure. (b) Shear force felt by the structure. (c) Drift ratio suffered by the structure.

The structural analysis model gave a fundamental period of the structure of 1.72 seconds – a reasonable value for a building of this height and structural system. From the *Ruaumoko* output, the main storey forces were processed. The distributions of moment, shear and interstorey drift are shown in Fig. 6. Figs. 6(a) and (b) show a reasonably uniform distribution of moment and shear up the height of the structure, while Fig. 6(c) shows a relatively low interstorey drift in the bottom storey, but much higher drift for the second level in above, in excess of the 1.5% limit of the Chilean code NCh2369 (2003), were present. Unfortunately 1st level coupling beams were not documented, so we cannot tell if the damage experienced by these beams reflects the lower drift at this level. We also did not have photos of walls – either at base level (where drift is smaller) or at the base of the 2nd level, where we may expect damage to be concentrated according to the sharp change in drift at this level.

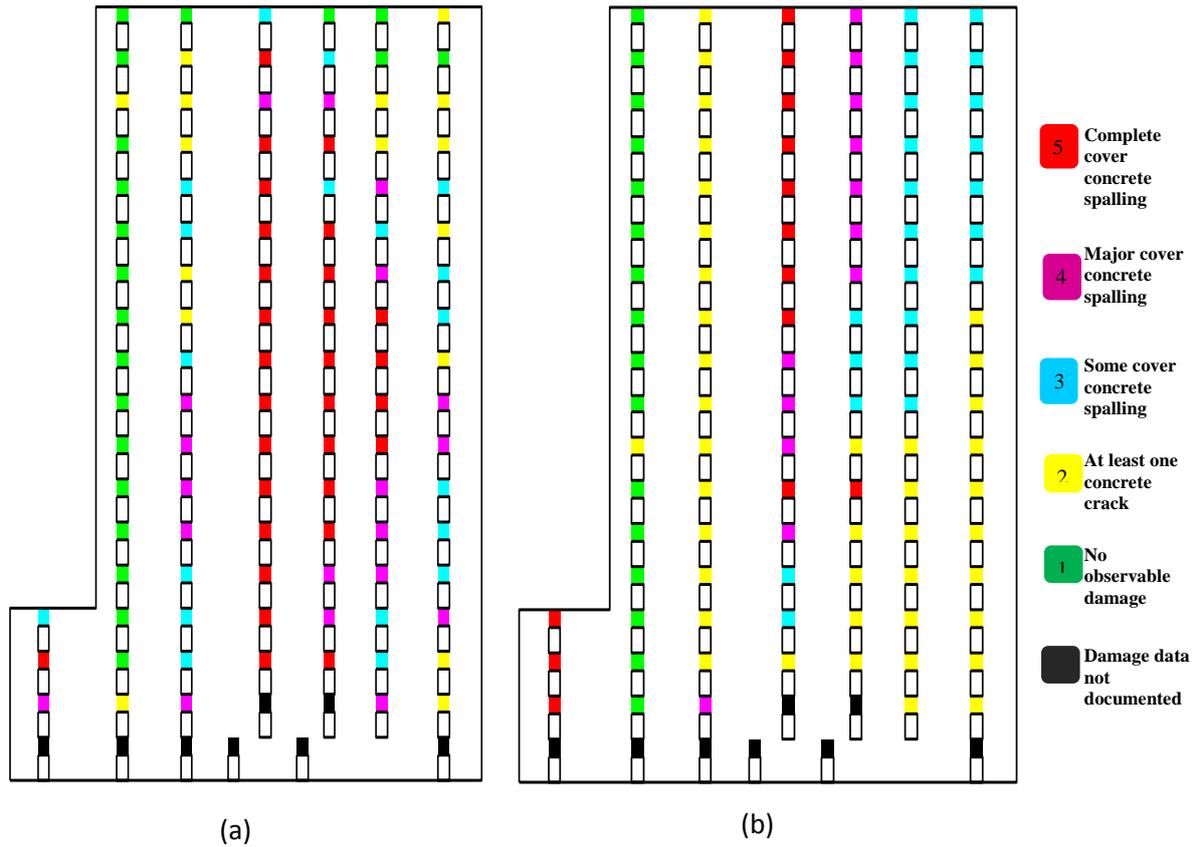
Figure 7. (a) Observed damage classification from photographs. (b) KZ empirical damage distribution.

As mentioned, the beams were first classified in five categories according to the observable damage from the photographs taken of each apartment doorway. The observed damage distribution after the event is shown in Fig. 7(a) and the central area of the building can be identified as the most damaged one, since all the beams are classified as Level 5. The damage distribution does not change significantly up the height of the building, which is consistent with the drift distribution in Fig. 6(c). The calculated damage distribution for the Krawinkler and Zohrei damage index is shown in Fig. 7(b), and shows that the overall distribution of damage has been calculated reasonably well by the analysis model and damage index calculation, although there are some discrepancies.

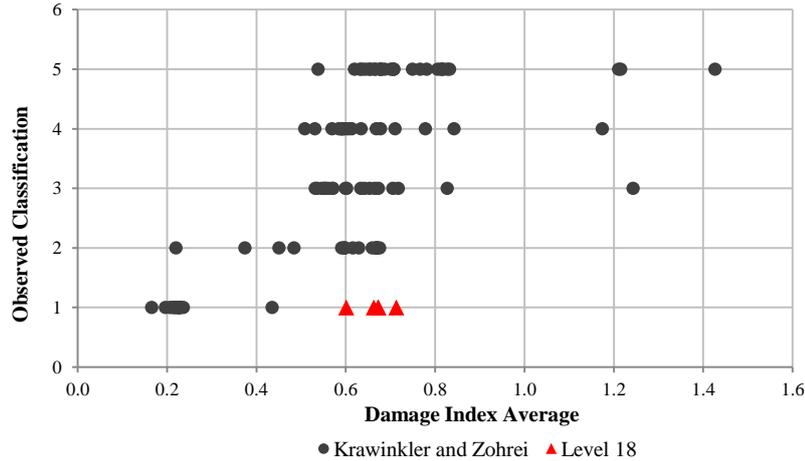
Figure 8. Correlation diagram between the observed damage and the Krawinkler and Zohrei damage index.

The observed damage versus calculated damage index is shown in Fig. 8. Values from Level 18 (highlighted in red) are outliers on this plot, where the observed damage was significantly lower than calculated in the analysis model. A possible explanation for this is that there is additional structure at the top floor supporting boilers and equipment, and this was not modelled in the structural analysis model, which just focused on the lateral load resisting system on a single gridline. The Spearman correlation coefficients with Level 18 data removed are also shown in Table 5.1, and it is seen that this improves the correlation.
