Force transfer between existing concrete columns with reinforced concrete jackets subjected to axial loading.

D. V. Achillopoulou, T. C. Rousakis & A. I. Karabinis

Reinforced Concrete Lab, Civil Engineering Department, Democritus University of Thrace, Xanthi, Greece

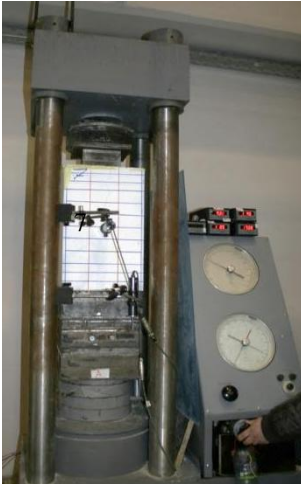
Figure 2.4: Experimental Setup

The axial loading is applied in a compression machine with a capacity of maximum load 3000 KN, and the ability to fit specimens with maximum height 950 mm and maximum side 310 mm (figure 2.4). Four different load cases are investigated as shown in figure 2.5.

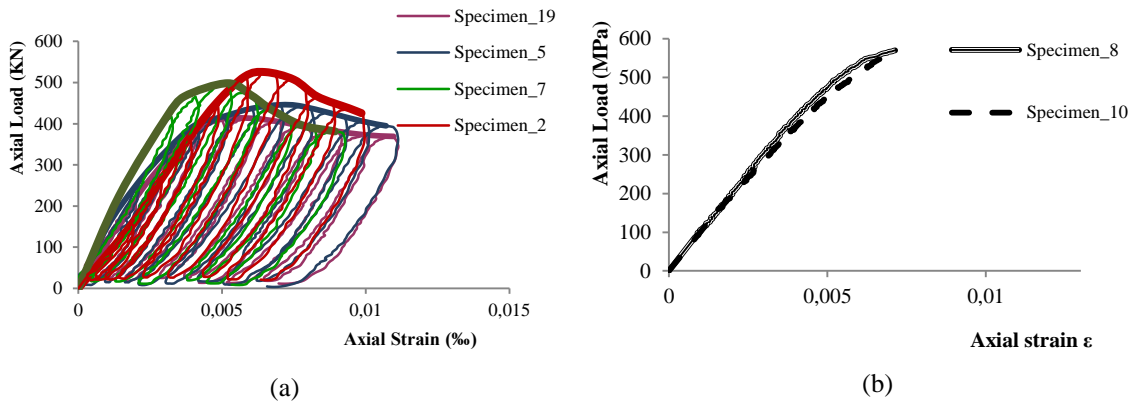
Figure 3.1.1. (a) Axial load- axial strain diagram of specimens subjected to repeated pre-loading.
(b) Axial load- axial strain diagram of specimens subjected to monotonic pre-loading.

Seven columns were subjected to initial loading (pre-loading), two of them without construction damages, so as to create loading damages. Specimens no 8 and no 10 were subjected to axial loading monotonically to maximum axial load ($\epsilon_{pr-l}^{max}=6\%$) before jacketing (figure 6b), while specimens 2, 5, 7 and 19 were subjected to pre-loading repeatedly at maximum strain $\epsilon_{pr-l}=10\%$ (cycles of 0,5% axial strain) (figure 3.1.1a and 3.1.1b).

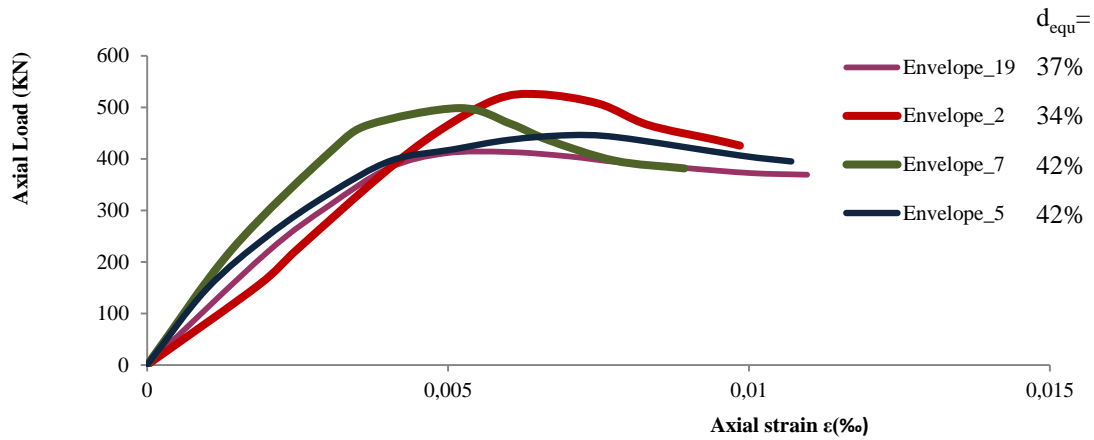
Figure 3.2.1. Envelopes of axial load- axial strain diagram of specimens subjected to repeated pre-loading with different percentage of initial (construction) damages.

Indicatively, figure 3.2.2 (c), (d) show the columns with structural damages and table 3.2.1 resumes all the calculated damage indicators. The effect of initial damages is shown in figure 3.2.1.

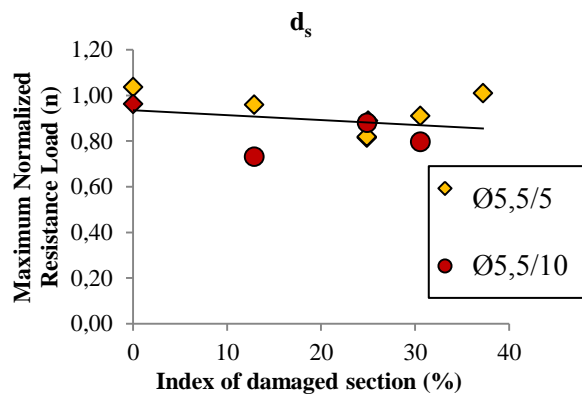
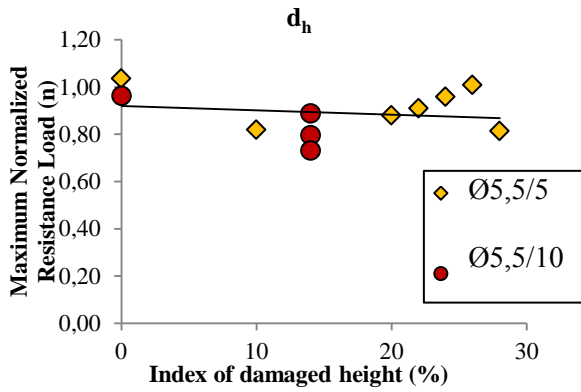
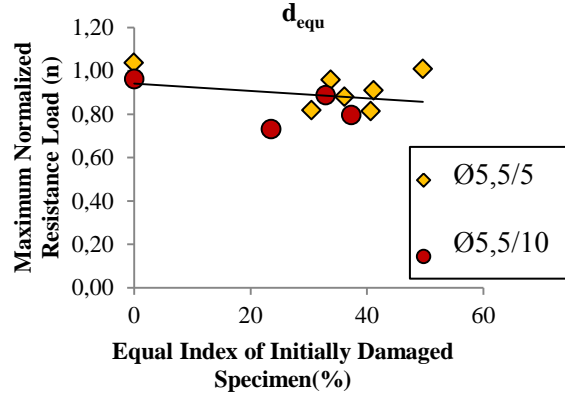
Figure 3.2.3. Maximum normalized resistance load versus section damage index (n- d_s)

Figure 3.2.4. Maximum normalized resistance load versus height damage index ($n-d_h$)

Figure 3.2.5. Maximum normalized resistance load versus equal damage index ($n-d_{equ}$)

Figure 3.2.3, 3.2.4 and 3.2.5 show the maximum normalized resistance load of core versus the percentage of the damage of the section d_s , the percentage of the damage of the height d_h and the equal damage d_{equ} respectively. The maximum resistance load in all occasions is normalized to the total section ($A_c=150 \times 150 \text{ mm}$) and to the nominal concrete strength f_c according to expression 3.2.1 c.

Figures 3.2.3 and 3.2.4 show high dispersion and testify the need of the combination of the two indexes to the equal index in order to predict the resistance load accurately, which is also confirmed from figure 3.2.5. Figure 3.2.5 shows that the damaged cores present lower resistance load than the ones without damages which means that the damage was not fully repaired. Also, minor damages do are not necessarily effectively repaired.

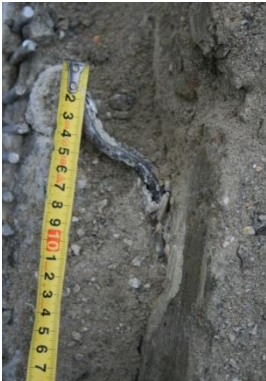
confinement mechanisms were activated and contributed to the load capacity and the resistance of the interface in slip. It is noted that the maximum values of bearing load happened in values of slip from 1,32 mm to 1,86 mm, values of slip in which cohesion is considered to be lost (marked in figure 4.1 for specimens 14 and 19). After that, specimens 14 and 26 remain to a rather stable friction resistance. On the other hand specimen 19 presents a descending branch after maximum load. Figure 4.2 shows a cut of the specimen 14 after loading and in figure 4.3 is shown the opening of the stirrups at the end of loading.

Figure 4.2 : Cut of jacketed specimen 14 after loading- dowel deformation
