# Experiment Research of Seismic Failure Model on Soft-Hard Alternant Strata Rock Slope

**B. Huang, J.W. Liu & D. S. Ling**

*Zhejiang University, China*

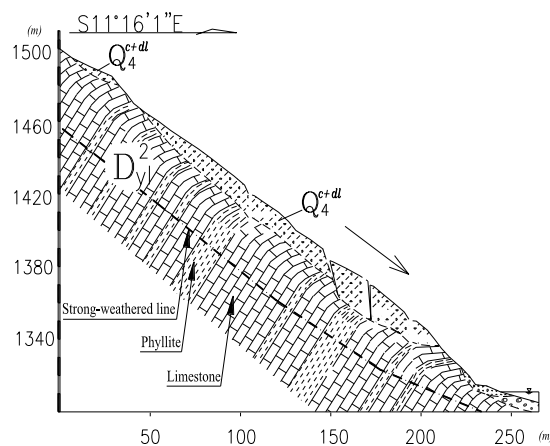
**Figure 2.1.** Engineering geological profile of Shawozi high and steep slope

Soft-hard alternant strata rock slopes mainly composed of phyllite and limestone are widely distributed along No.213 highway, from Dujiangyan to Wenchuan, China, where “5.12” Wenchuan Earthquake took place. Sha Wozi slope is along this highway where landslide happened frequently. Slope surface is covered by Quaternary colluviums, especially the open-cast mining areas, which is 70 meters below. Slope toe suffers erosions from Minjiang River directly. The counter-tilt slope, with its height over 250m, whose strike/dip are  $N60^{\circ}\text{-}70^{\circ}\text{E}/\text{SE}60^{\circ}\text{-}70^{\circ}$  on the upslope and  $N60^{\circ}\text{-}70^{\circ}\text{E}/\text{SE}30^{\circ}\text{-}40^{\circ}$  on the down-slope, is relatively gentle on the upper part while steep on the underpart along with fragment rock mass. While the bedding plane, consisting of phyllite and limestone which belongs to Yuelizhai Group of Devonian (Dyl2), strike at  $N45^{\circ}\text{-}70^{\circ}\text{E}/\text{NW}$ . Limestone is firm and crisp, while phyllite is soft. The zone of phyllite development mainly forms low landforms, like gentle slope and grooves. In general, the slope is soft-hard alternant strata rock like, consist of medium to thick-bedded limestone, limestone with thin layer phyllite, layer phyllite with medium to thick-bedded limestone. (Figure 2.1).

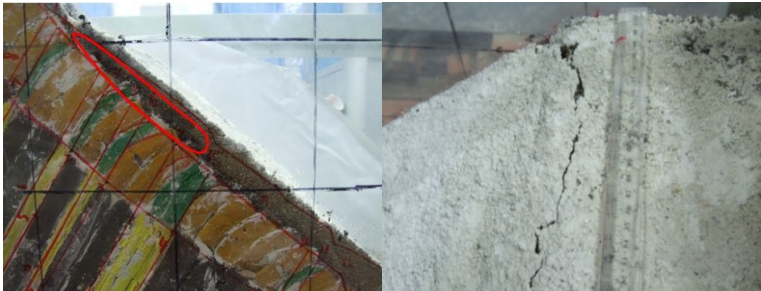
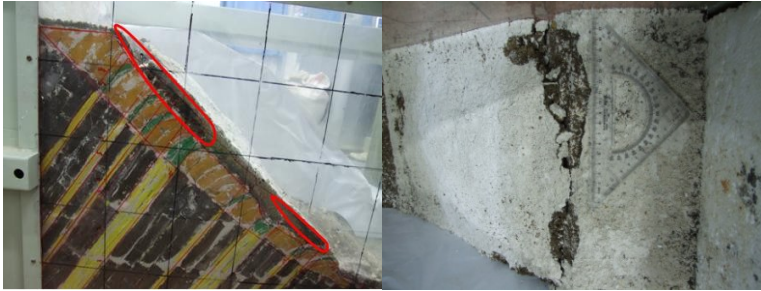
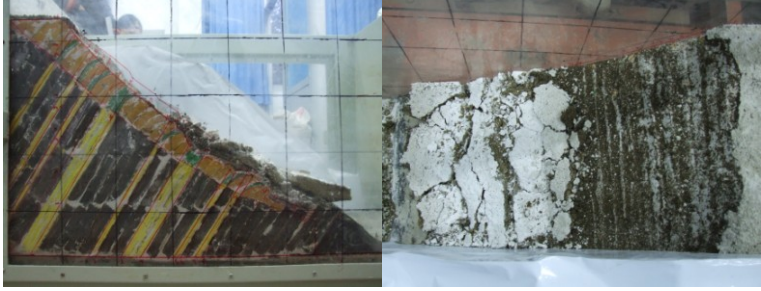
**Figure 3.1.** The deformation of model slope in the shaking from side view and top view

After 15 times shaking, the model slope was totally collapsed and the whole overlying debris fell down along the slip surface. Fig. 3.1 gives the photos of model slope after 11<sup>th</sup>, 14<sup>th</sup>, 15<sup>th</sup> shaking from side and top views, which showed us its deformation and failure process. Along the slope, the observed traces of failure were recorded after each shaking; some typical results are shown in Fig. 3.2.

Within the first 4 shaking, there were no obvious crack on the model surface and both side. In the 5<sup>th</sup> to 9<sup>th</sup> shaking, no obvious change happen, besides that a few fragments are thrown out from the top of the slope. After the 10th shaking, a 20cm long 15mm wide (to the maximum) crack occurred on the slope shoulder, close to the plexiglas window side, which was expanding gradually to the other side of the model box during the following 11<sup>th</sup> to 13<sup>th</sup> shaking; another 5mm wide crack appeared at the interface

between the Quaternary deposits and the base rock on slope shoulder also grew little by little during the 11th to 13th shaking, trending to expand from the shoulder to the slope-foot, as a result, a connected slide surface would come into being soon, as Fig. 3.1 shown. In the 14<sup>th</sup> shaking, protrusion and cracks can be observed easily in the slope toe, while the crack at the Quaternary deposits-base rock interface had been enlarged from the shoulder to the middle of the slope. Although the cracks haven't run through the slope, most part of the Quaternary deposits had been separated from the base rock, which can be seen clearly from the photo in Fig. 3.1. In the 15<sup>th</sup> shaking, the model slope broke up immediately, with the Quaternary deposits being thrown forward.

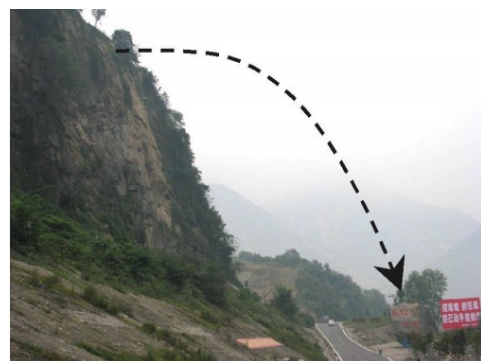
**Figure 3.4.** 300t rock travelled 60m by catapulting had been found on Duwen Road, Yingxu town<sup>[12]</sup>
