Collapse Mechanism of Multi-story Masonry Structure with First Soft Story

Xun GUO, Zhihua ZHENG & Fu HE

Institute of Engineering Mechanics, China Earthquake Administration, Harbin, 150080, PR China

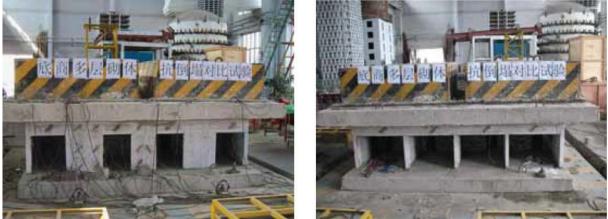
Figure 3. Scaled models (1/5) of with and without wings

(a) Model A with winged columns (Wall A)

(b) Model B with normal columns (Wall A)

In order to find out the function of winged columns in collapse resistant, models with 1/5 scale are constructed for earthquake simulating test. The models showed in Figure 3 focus on performance of first story of the object structures. The first one (Model A) just comes from drawings of the Apartment of Beichuan Communication Company which adopts winged columns in wall A; the second model (Mode B) used the same configuration except the shaded area in Figure 2 (b) is removed. Earthquake record showed in Figure 4 captured closed to the epicenter of Wenchuan earthquake is used for input of shaking table.

For Model A, the winged columns contribute much stiffness for Wall A, therefore the total horizontal earthquake inertial force in longitudinal direction will distribute uniformly among the three walls. This fact will greatly decrease the torsion effect at the first story. That means the balanced stiffness in longitudinal direction of Wall A, Wall B and Wall C survived this object structure with winged columns.

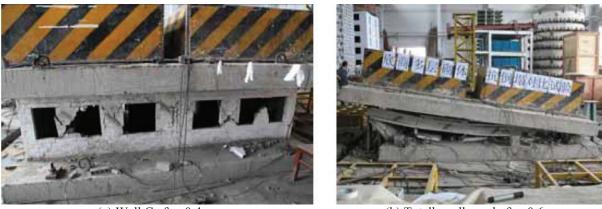
Figure 6. Status of model B after earthquake input at PGA of 0.4g and 0.6g

(a) Wall C after 0.4g

(b) Totally collapsed after 0.6g

Exciting results derived from the series shaking table test. The PGA of input record was increased from 0.1g to 0.7g, only minor cracks could be found in some walls of Model A; when the PGA reached 0.7g, the roof would slide back and forth, and the PGA could not increase any more. Figure 5 shows the status of Wall A and Wall C of Model A. But for Model B, when the PGA reached 0.4g, Wall C was crushed as showed in Figure 6 (a), and Wall B was similar; when the PGA reached 0.6g, it totally collapsed as showed in Figure 6 (b). Shaking table tests disclosed that the winged columns were key components for collapse resistant. Three longitudinal walls in Model B did not failed simultaneously. Wall C and Wall B failed first and Wall A failed at last. In fact, the longitudinal stiffness of Wall C and Wall B are much larger than Wall A in Model B, and earthquake inertial forces will be distributed in proportion to stiffness among three walls, therefore Wall C and Wall B bear most of the horizontal earthquake force in longitudinal direction. But the construction material and configuration resulted that the ductility of Wall C and Wall B is very poor, that means Wall C and Wall B are easy to collapse if the distributed earthquake inertial forces are higher that their capacities.
