Seismic Performance of Reinforced Concrete Columns With Spandrel Walls Retrofitted Using CES System

Juan Jose CASTRO, Ryo NOMURA & Hiroshi KURAMOTO
Osaka University, Japan

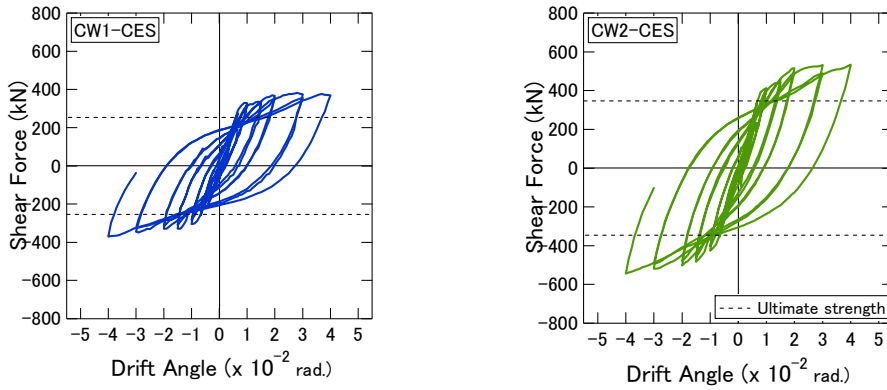
Figure 3.3 Retrofitting element hysteresis curves

The relationship of column shear force versus drift angle only for the CES retrofitting element is shown in Fig. 3.3. The values were obtained by subtracting from the shear force obtained for specimens CW1 and CW2 those obtained from PW without retrofit.

Specimens CW1 and CW2 presented spindle shape loops, with good energy dissipation characteristics, and showed no strength deterioration even at the large deformations. For both specimens, after the drift angle $R=0.0067$ rad. where the existing column showed a remarkable strength deterioration, the experimental values overtake the bending strength of the CES retrofitting element. The reason is that as the shear failure progress on the existing column, through the upper stub the axial force started to influence the CES retrofitting element therefore its bending strength also raised.

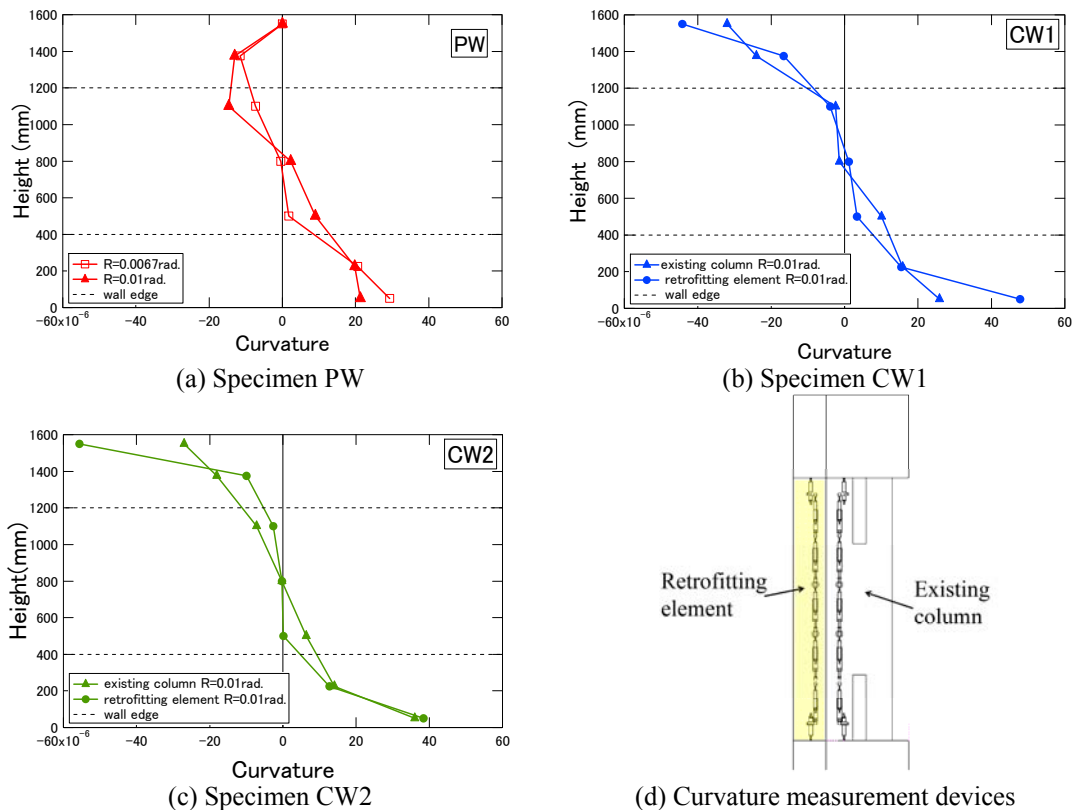
Figure 3.4 Curvature distribution

The curvature distribution of the existing column and the attached retrofitting element are shown in Fig.3.4 (a) to Fig.3.4 (c). The curvature was calculated using the data obtained from the LVDT attached to the lateral face of the column as shown in Fig. 3.4 (d).

Form the height of 400-1200mm the curvature of the existing column of Specimen PW showed larger values compared with CW1 and CW2 at the drift angle of $R=0.01$ rad., because of the influence of the CES retrofitting element that constrain the deformation.

For Specimens CW1 and CW2, at the height 0-400mm and 1200-1600mm, the curvature values obtained for the existing column were smaller than those obtained for the attached CES retrofitting element. This is because of the confinement given by the walls which constrain de deformation at both ends of the column. In other words the attached CES retrofitting element does not receive influence of the walls.

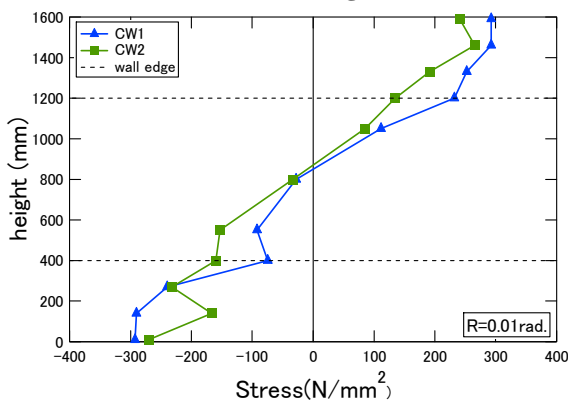
Figure 3.6 Stress distribution of steel flange

On the other hand for specimens CW1 and CW2, in the zone between 0-400 mm and 1200-1600 mm, the stresses of the steel flange showed a uniform distribution, therefore it is possible to infer that it not receive the any confinement influence by the walls. In this sense it is possible to say that the clear height of the CES retrofitting element can be estimated as 1600 mm.

Stress distributions on the longitudinal bars and on the steel flange of the CES retrofitting element are shown in Fig. 3.5 (a) and (b) and Fig. 3.6. The dotted lines represent the position of the edge height of the hanging wall and waist-height wall. Figure 3.7 shows the position where the strain gauges were located. The stress are plotted at the drift angle where the specimen reached the maximum shear force, that is $R=0.0067$ rad., for Specimen PW and $R=0.01$ rad. for Specimens CW1 and CW2.
