Experimental Seismic Investigation of Composite RC - Diagonal Steel Prop Joints

SUMMARY

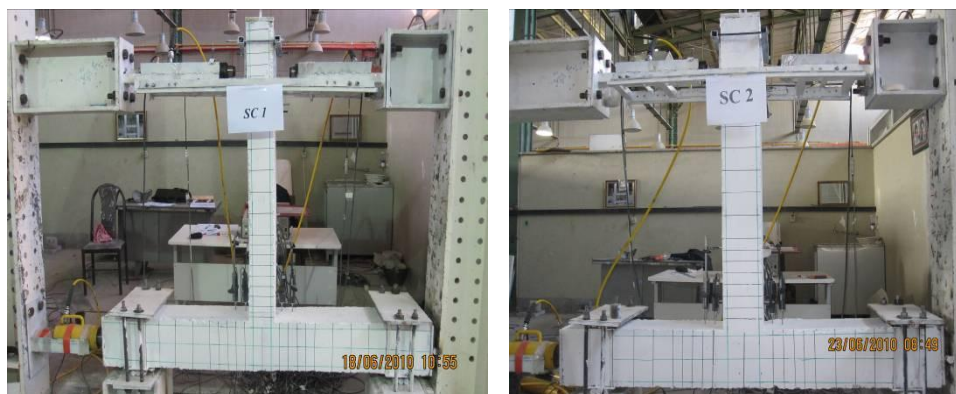
Figure 1. Joints specimens of SC1&SC2 before loading

Two half-scale specimens named as SC1 & SC2 used as control specimens as shown in Figure 1. The beam height in the specimen SC1 was reduced but the specimen SC2 had standard beam height. Two control specimens SC1 & SC2 shown in Fig.1 consisting of a column (1900mm in length, as horizontal part) and a beam (1400mm in length, as vertical part) that simulated a exterior joint in middle stories of a two dimensional frame, were designed, casted and tested. The columns cross section at the both control specimens were 250 × 250 mm and the beams cross section in specimen SC1 was 250 mm in width and 150mm in depth and in standard specimen SC2 was 250 mm in width and 200mm in depth. Columns in both specimens such as Fig.2 had 8 ϕ 14 as longitudinal bars and ϕ 8 @ 50 mm as transverse bars in beam-column critical zone. Also the beams in the critical zone in both specimens with same arrangement had 3 ϕ 12 as longitudinal bars at the top and bottom of section and ϕ 8 @ 50 mm as transverse bars, respectively as shown in Figure 2.

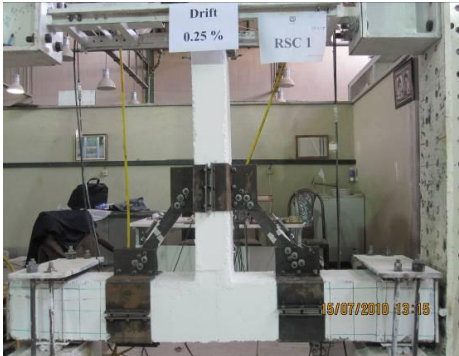
Figure 3. Retrofitted specimen RSC1 before testing

Specimen SC1 damaged under cyclic loading was repaired in critical zone with the same grade of concrete and then retrofitted with steel prop and curb. This prepared and tested specimen was called RSC1. Schematic retrofitting of damaged specimen and retrofitted specimen of RSC1 before cyclic loading test is shown in Figure 3.

Steel props and curbs were used in this retrofitting system. The cross section of steel props as Box was 60×30×2mm section and 500mm length that were erected in two sides of joints. The steel props were subjected to tension and compression force and probably bending moment under cyclic loading at tip of beam. Steel curbs had four edged L-shape plates connected and tied together at edged plates by high

strength 10mm diameter bolts. The steel curb played as role of concrete confinement and force transfer from prop to reinforced concrete beam and column. All plates with 5mm thickness and 200 mm width in steel curb were cut and bended in definite points with a gap about 20 mm between edges of curb plates proportional to beam and column cross section. Concrete beam-column critical zone during of cyclic loading are usually damaged and therefore need to be retrofitted such as steel brace system, but due to architectural reasons, the steel curbs were suggested in this paper to be erected at the in and also due to architectural reasons, so the steel curbs were suggested to be erected at end of critical beam-column zone. The erection place of steel curbs center at beam and column were 400mm and 300mm from the side of beam-column joint.

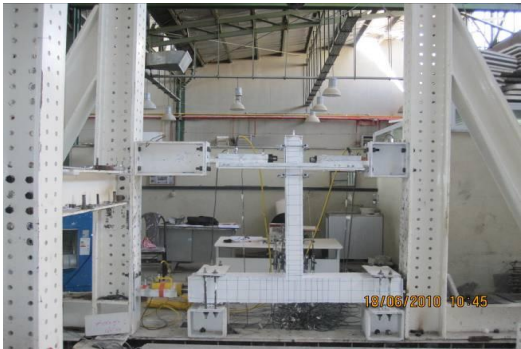
Figure 4. Test set-up view

Real view of test set-up is shown in Figure 4 with an axial horizontal load at column and a horizontal cyclic load at beam according to loading hystory. Axial load of column was equal to $0.15P_n = 170 \text{ kN}$ (P_n is nominal axial strength of RC columns) applied by 500 kN hydraulic jack to one end of column

and the cyclic lateral load was applied by two 200 kN compression hydraulic jacks at tip of joint beam at the distance of 120 cm from the side of column. The column acted as simple support specimen with roller and hinge ends. Cyclic loading history of tests was based on displacement control at 0.25,0.5,0.75,1,1.5,2,3,4,5,6 and 7% drifts at the tip of beam with double cycles at eleven steps and totally 22 cycles.

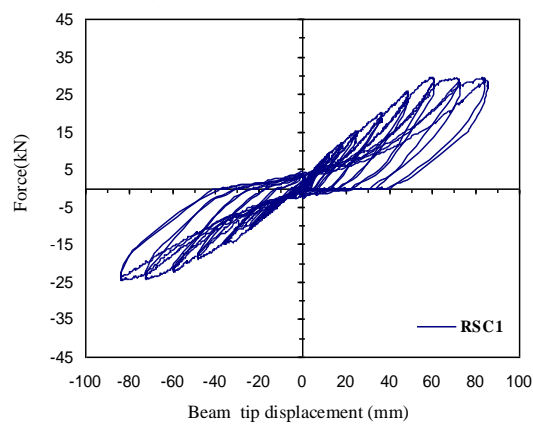
Figure 8. Load-displacement hysteresis curve at RSC1 (weak retrofitted specimen)

Maximum strength P_{max} and ultimate strength P_u (corresponding to the maximum displacement prior to failure) of each specimen and average increasing percentage retrofitted specimen related to control specimens were given at Table 1. Hysteresis load-beam tip displacement curves of specimens up to 7% drift were plotted in Figures 6, 7, 8. Hysteresis envelop curves of joints were plotted and compared together in Figure 9.
