Seismic vulnerability of the marble blocks colonnade of ancient forum in the archaeological site of Pompeii

SUMMARY:

1. MARBLE BLOCKS COLONNADE

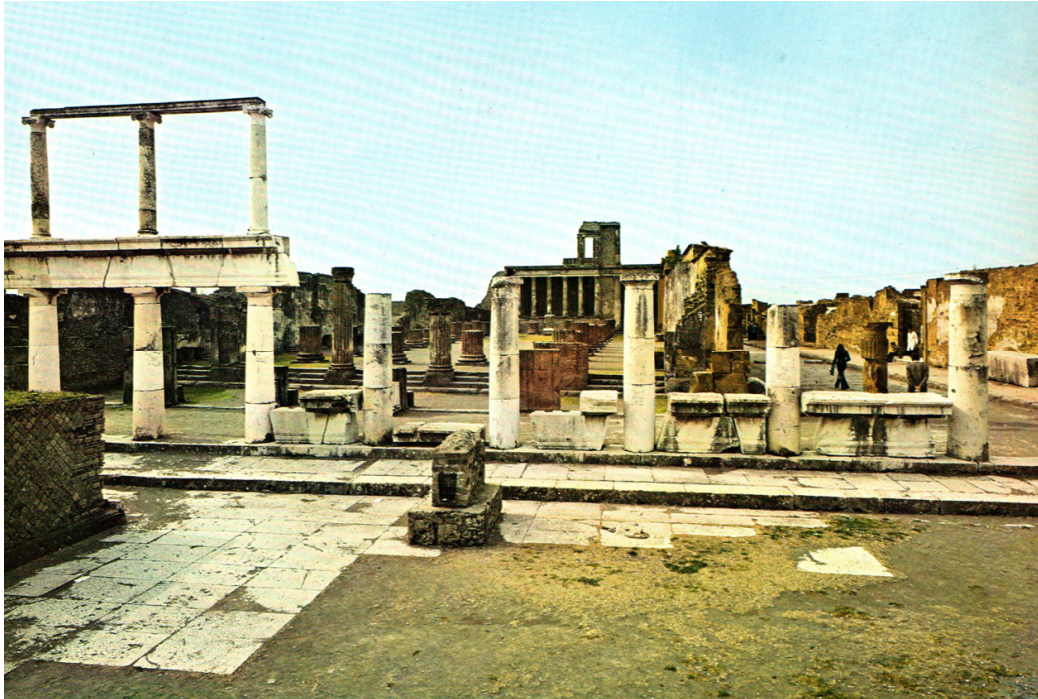
Figure 1.2. The southern part of the Forum (Guadagno *et al.*, 1973)

for educational and tourist purpose and resulted useful to show the real proportion of the gallery around the place. The earthquake in 1980 produced damages in the whole archaeological site and for the columns it made necessary to remove the entablature over the second storey (Fig. 1.2), even if it was assured in place with metallic elements. In the late '90th of the past century, the colonnade has been object of a new intervention of restoration.

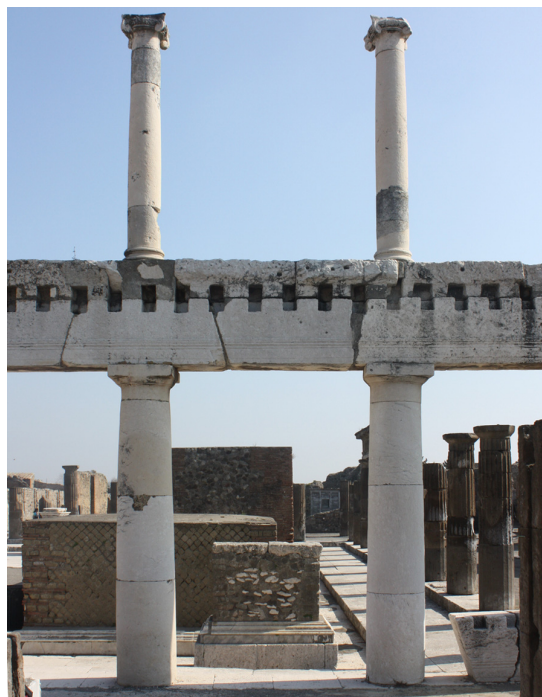
Figure 2.1. Particular of the analysed block colonnade today.

To understand the performance of this archaeological heritage colonnade and the influence of the behaviour of the joints on the global structural behaviour, a FEM model has been used as a theoretical tool (as previously done by some of the authors to evaluate seismic vulnerability of other masterpieces in Pompeii, de Martino *et al.* 2006). Micro-modelling was adopted and each block was modelled reproducing accurately the effective geometry of the blocks as they are today (Fig. 2.1).

It is clear that some blocks have different dimensions especially in the columns and partially in the trabeation. Numerical two-dimensional analyses have been performed under plane-stress assumption. This assumption is based on the fact that the width of the structure is much lower than the other two dimensions, and in plane loads are considered. The paper focuses on the in-plane behaviour of the colonnade, to emphasize the presence of inclined joints, however it is a partial seismic assessment because out-of-plane weak behaviour (not involving specifically the inclined joints, but a global overturning) could jeopardize the in-plane safety assessment.

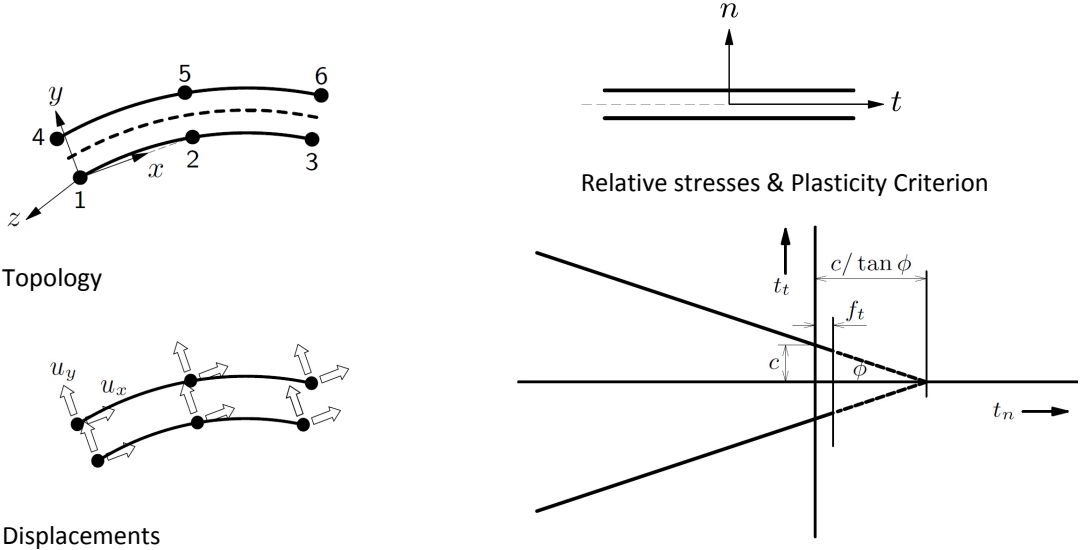
Figure 2.2. Interface nonlinear model

The analyses have been performed by means of the TNO DIANA v9.4.4 code. The colonnade is constituted by more than 1500 eight-node quadrilateral isoparametric plane stress elements. These elements are based on quadratic interpolation and Gauss integration. Crucial role has the special 3+3 nodes interface elements between blocks in a two-dimensional configuration. The 700 interface elements are based on quadratic interpolation and a 4-point Newton-Cotes integration scheme. Interfaces relate the forces acting on them to the relative displacement of the two sides as shown in Figure 2.2. The interface between two blocks is governed by a frictional behaviour. This behaviour is modelled with the Coulomb friction model, which has close resemblance with the Mohr-Coulomb plasticity model for continuum elements (Fig. 2.2). It is based on decomposition of total relative displacement rate into a reversible part and an irreversible part which is determined following the flow theory of plasticity (Manie and Kikstra 2012). In this case the tangent stiffness matrix is symmetric because the friction angle is equal to the dilatancy angle. In this way the nonlinear elastic bedding, e.g. 'no tension' bedding with a constant stiffness for compression and zero stiffness for tension is modelled also. Non-linear properties for blocks were inserted, namely plasticity in compression and brittle cracking in tension; however stress state was so reduced that blocks performed almost elastically.

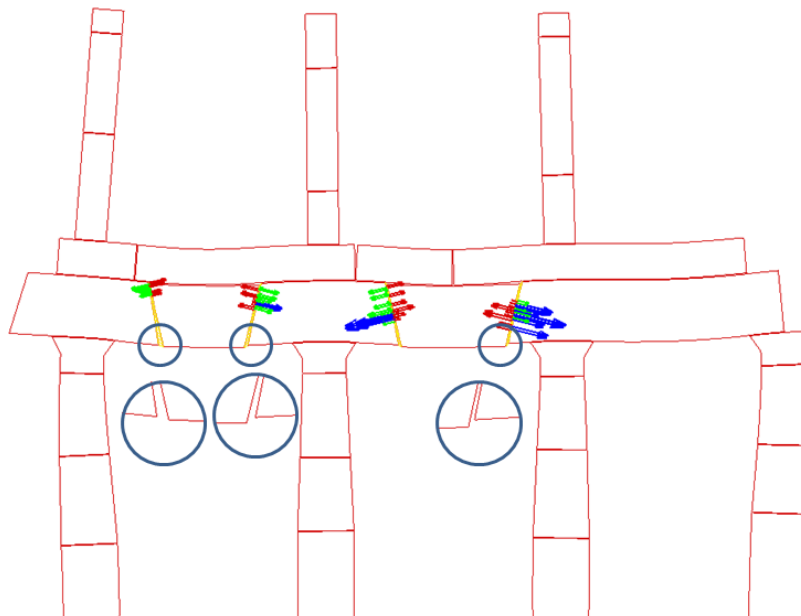
Figure 2.3. Deformed shape under gravity loads and enlargements of joint openings, with contact force arrows.

Static behaviour was analysed by means of deformed shape of the structure under gravity loads, evaluation of opening of the joints, contour maps of tensile and compression stresses. Under gravity loads, the structural scheme provided by inclined joints suffers due to the collapse of a wide part of the colonnade. The right portion, almost intact, representing the end of the colonnade, is almost stable and the horizontal thrust, induced by the inclined joints in the main blocks of the trabeation is well counteracted by the last two columns on the right. The main issues arise in the left part where columns and blocks collapsed and nowadays the horizontal thrust is not correctly counteracted by other symmetric portions of the structure and the overturning moment is carried by the first column on the left which tends to turn and widens the opening of the first blocks in the trabeation. Figure 2.3 shows the deformed shape of the colonnade under gravity loads; coloured arrows represent the only portions of the inclined joints still in contact, while a gap formed in other portions of inclined joints. It is remarked that the deformed shape has an amplification factor of 10,000x and contact forces are shown in inclined joints only. In particular, the enlargements inside the main deformed plot of the structure highlight the block displacements. Stability is surely still granted, however the opening of the joints allows water and other polluting agents to attack the hidden surfaces of the marble elements.

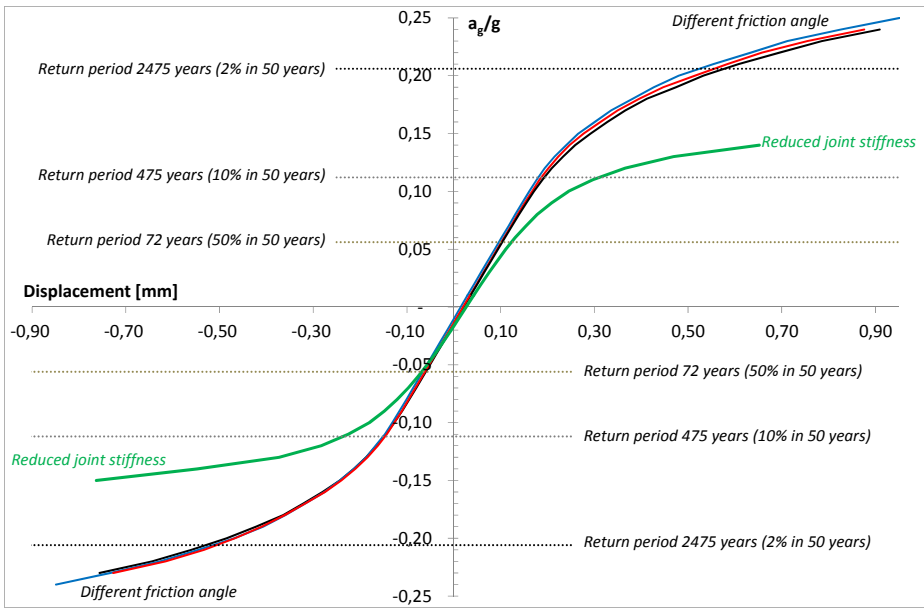
Figure 2.5. Pushover analysis in positive and negative directions and comparison with expected seismic actions

Under horizontal actions, the structural issues due to unbalanced horizontal thrust emphasize. However the stability issues arise at almost high (in-plane) acceleration, almost higher than 0.2g. Simply speaking, in any case, the tangent of friction angle represent a theoretical upper bound, representing the acceleration leading to shear plasticity in joints, however, the interaction of structural blocks, alter this basic idea.

Even considering a lower friction due to water lubrication the behaviour is almost similar, while the filling of joints by means of weaker material yields to lower seismic performance, but still acceptable being acceleration at failure almost equal to 0.15g. Figure 2.5 reports the pushover curves for different situations, three thin lines report response of the benchmark joint stiffness and changing the three values of friction angle. Thick line represents the case of reduced joint stiffness (accounting for a filling material). In any case the structure is able to resist an expected earthquake with a return period of about 1000 years, or 5% in 50 years, but only the benchmark joint stiffness with the highest friction capacity is able to satisfy a return period of more than 4000 years, or about 1% in 50 years.
