# Unbonded Prestressed Columns for Earthquake Resistance

A.S. Larkin, D.H. Sanders & M.S. Saïdi

University of Nevada Reno, Nevada

15 WCEE  
LISBOA 2012

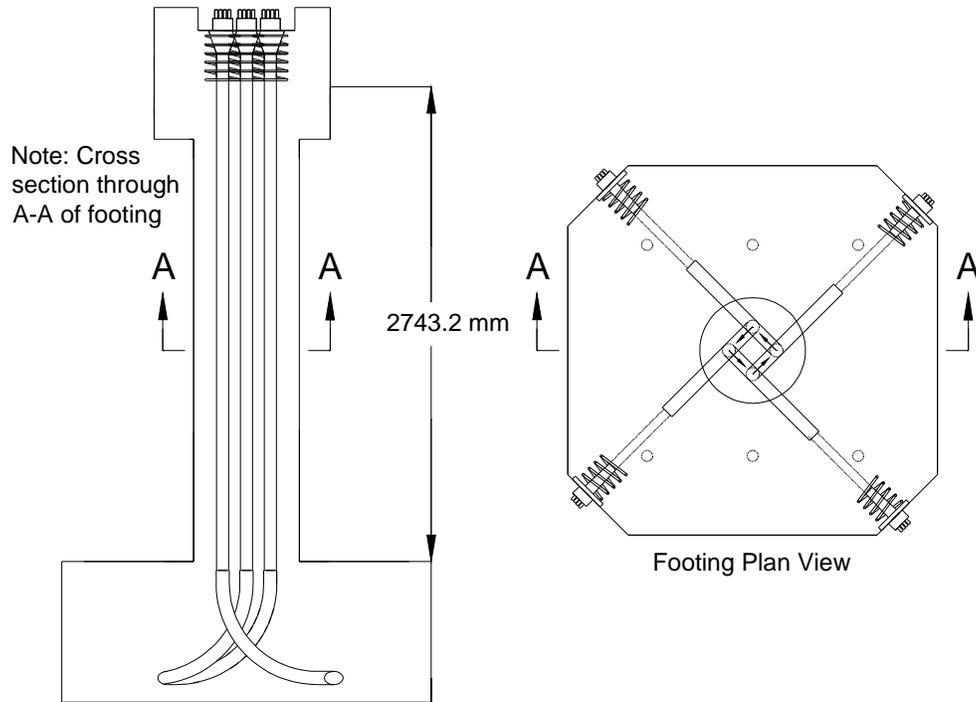
**Figure 1: Tendons Anchored in Corners of Footing**

Following a major earthquake, it is highly likely that bridge columns have undergone large lateral displacements. Post-tensioned columns are designed to not have any yielding or damage of the tendons. However, following a major seismic event it is essential to have the ability to inspect and replace the tendons if necessary. Previous tests have utilized straight tendon or bar that is anchored in the base of the footing. This makes it very difficult to replace the tendons. By anchoring the tendons in the side of the footing, it makes it possible to remove the tendons. For the specimens tested in this experiment, all four tendons were anchored in the side of the footing (see Figure 1).

Constructing each column with four separate tendons centrally located within the column cross section provided sufficient area and spacing for the tendons in the experimental specimens. The area and spacing of tendons would also work in a full-scale design. Exiting the tendons out of the corners of the footing provided the possibility of removing the tendons, and did not display any negative effects. Encapsulating the tendons in greased sleeves provided corrosion protection and held up well with minimal damage following many cycles at large drift ratios.

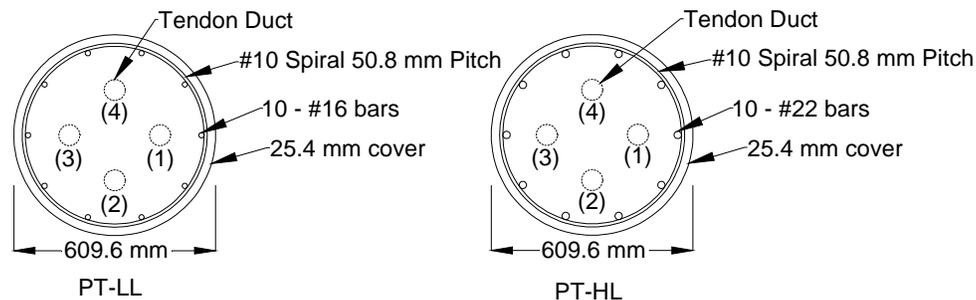
**Figure 2:** Column Cross Sections

The two columns selected for testing were initially targeted to have identical properties except for the amount of longitudinal reinforcement crossing the joint between the column base and footing. Achieving identical forces in the tendons between the two specimens was difficult and ended with a slight variation between the initial post-tensioning forces (% of  $f'_c A_g$ ). The column parameters and cross sections are shown in Table 1 and Figure 2, respectively. The tested material properties for each column are shown in Tables 2 and 3.

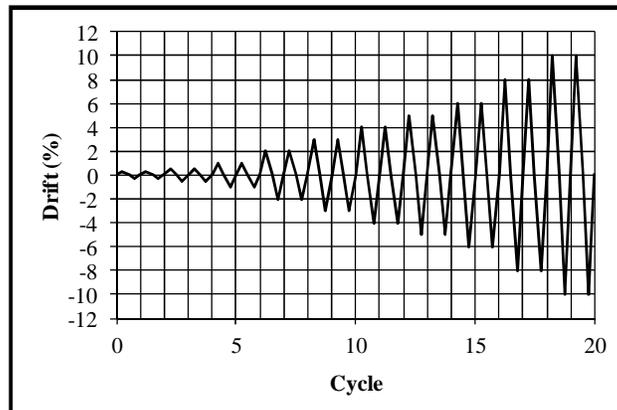
**Figure 3:** Loading Protocol

The test setup for each specimen consisted of a strong floor, reaction wall, and 979-kN actuator to produce the loading protocol shown in Figure 3. Before the column was placed in position on the strong floor, four 50.8 mm by 101.6 mm wood blocks were placed underneath the footing to allow for the placement of high strength grout. The grout allows for an even and level surface for the footing to rest on. The column footing was then secured to the 914.4 mm deep strong floor using six 31.75 mm post-tensioned bars. Each of the six post-tensioned bars had a 444.8 kN force applied to insure that the footing would not slide or rock during testing. The reaction wall was made by stacking two columns of three 1219 x 1219 x 2438 mm concrete blocks, with one additional block added to the top of the stack nearest the column to achieve the proper height for the actuator to meet the column head. The reaction wall was also secured to the strong floor with 31.75 mm post-tensioned bars, with each bar having a 444.8 kN force applied. The test setup is shown in Figure 4.

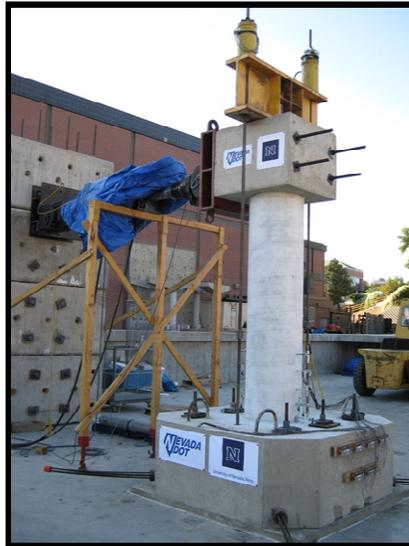
**Figure 4: Test Setup**

A steel spreader beam was bolted to the top of each column and was used to distribute the axial dead load to the column. The spreader beam was 1219 mm in length, leaving an overhang on each side of the column head. Two hydraulic rams were then placed on the spreader beam overhangs. Two high strength 31.75 mm threaded rods ran through the hydraulic rams, load cell, footing, and were anchored against the base of the strong floor to apply the axial dead load. The axial dead load was maintained throughout the testing sequence through an accumulator which held the axial load constant and equal in each of the hydraulic rams.

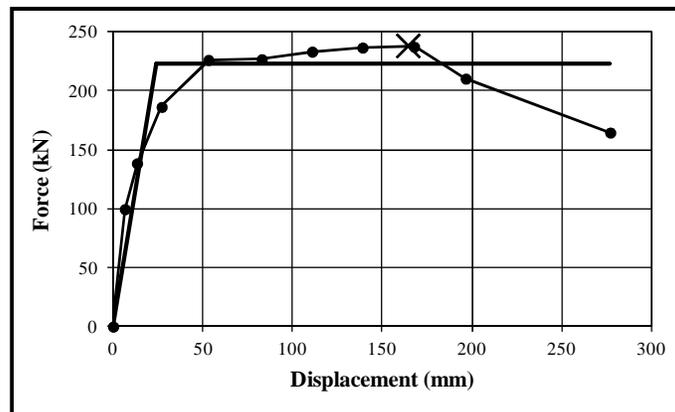
**Figure 5: PT-LL Average Pushover Curve**

From the cyclic loading applied to each column, a lateral force and displacement hysteresis curve was produced. Each hysteresis curve was broken up into the push cycle (positive), and the pull cycle (negative). The absolute values from the negative envelope were then taken and superimposed on the positive envelope and an average pushover envelope was taken between these two envelopes. This average curve was then considered the pushover curve for the column. The pushover curves for column PT-LL and PT-HL are shown in Figures 5 and 6, respectively. In each curve, the “X” indicates the location of the first longitudinal reinforcing bar fracture.

The first bar yield displacement was determined by the column displacement when the first longitudinal rebar yielded. This value was then used to plot a straight line on the pushover curve, beginning at zero force and zero displacement. A straight horizontal line was then plotted near the top of the pushover curve, where the area under the straight horizontal line bounded by the pushover curve was equal to the area under the pushover curve bounded by the straight horizontal line. The point where the two straight lines intersect is the effective yield displacement. Two different ductility displacements were then defined. The first is termed the “ductility displacement capacity” and is defined as the ultimate displacement (ultimate displacement was defined as displacement at 80% of the peak lateral force in the column) divided by the effective yield displacement. The second is termed “ductility at first fracture” and is defined as the column displacement when the first longitudinal rebar fractures divided by the effective yield displacement. Column PT-LL had a first bar yield displacement of 16.5 mm, leading to an effective yield displacement of 24.1 mm. The ultimate displacement was 231.1 mm at a drift of 8.4% leading to ductility displacement capacity of 9.6. The displacement at first fracture was 167.6 mm at a drift of 6.1% leading to ductility at first fracture of 6.9. Column PT-HL had a first bar yield displacement of 25.9 mm, leading to an effective yield displacement of 36.1 mm. The ultimate displacement was 250.7 mm at a drift of 9.1% leading to ductility displacement capacity of 7.0. The displacement at first fracture was 217.4 mm at a drift of 7.9% leading to ductility at first fracture of 6.0.

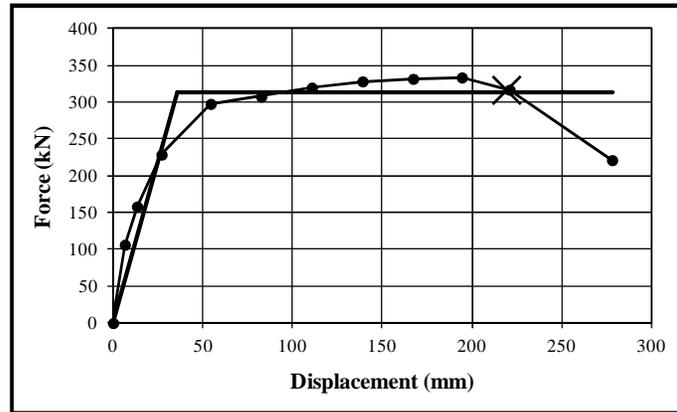
**Figure 6:** PT-HL Average Pushover Curve

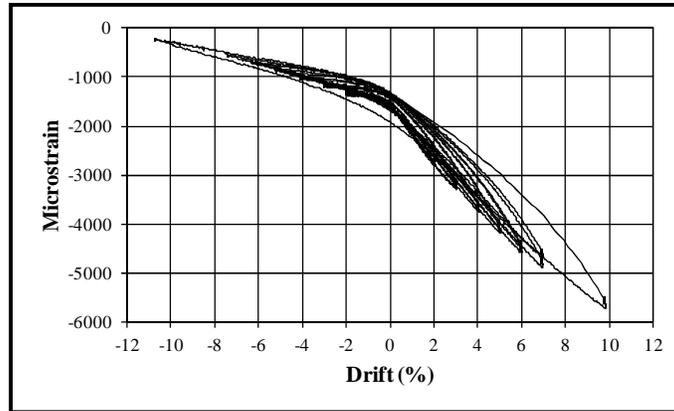
**Figure 7:** PT-LL Microstrain in Tendon 1

The four tendons in each column consisted of four 15 mm 1860 MPa 7-wire strands. The tendons were numbered one through four, with tendons two and four located on the axis of column rotation, and tendons one and three located on the extreme ends. Throughout testing, tendons one and three had the largest strains of the four tendons. The initial tendons force was carefully selected and kept within the lower elastic region so the tendons would not yield or fracture under large lateral displacements. Figures 7 and 8 show the microstrain in tendons one and four of PT-LL with respect to the lateral drift of the column. In each figure, negative microstrain represents tension. The two tendons (one and three) on the outside of the axis of rotation felt the largest strains, shown in Figure 7. The tendons (two and four) that were on the same axis of column rotation, felt significantly less strain as shown in Figure 8. The tendons do not begin to yield until a microstrain of at least 8600 is reached. It can be seen that even the tendons located on the extreme ends, such as tendon one, do not begin to reach their yield strains, even at large drift ratios. Column PT-HL behaved very similarly to column PT-LL and did not reach a strain of more than 6500 microstrain, even at drift levels as high as 10%. The columns were pushed to 10% drift, even though they had failed, to study the impact of large displacements on tendon stresses.

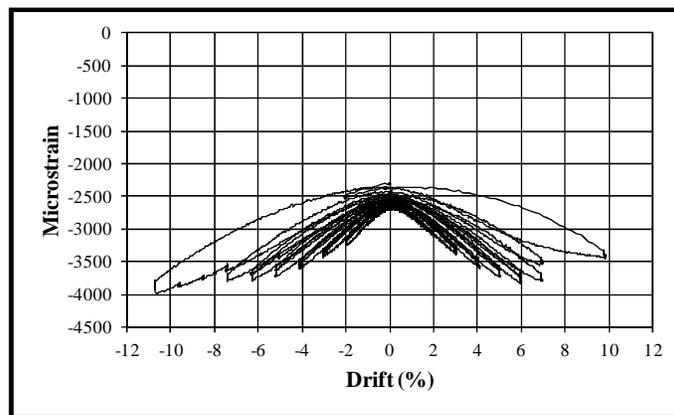
**Figure 8:** PT-LL Microstrain in Tendon 4

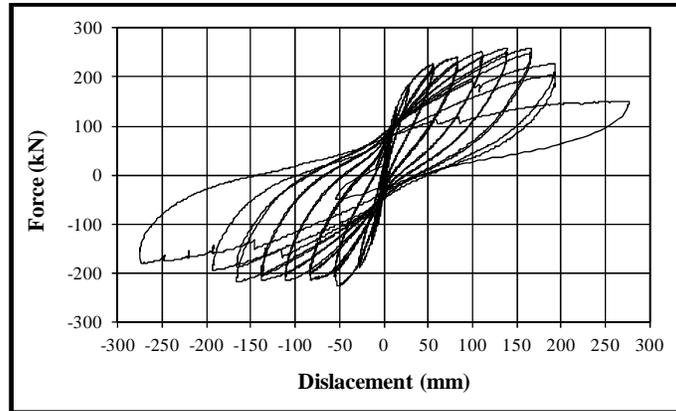
**Figure 9: PT-LL Hysteresis**

Figure 9 shows the full hysteresis curve for column PT-LL. Following construction, the cover concrete was found to be 25.4 mm on one side of the column, and 50.8 mm on the other side. Uneven concrete cover resulted in a shifted column core, so the core location was not at the true center of the column. This offset caused residual displacements and peak loads to differ from the push and pull cycles. Figure 9 shows the re-centering capabilities provided by the post-tensioning, leading to small residual displacements in the column. At a drift level of 6%, column PT-LL had a residual displacement on the positive side of the hysteresis curve of 39.9 mm and a residual displacement on the negative side of the hysteresis curve of 87.6 mm, resulting in an average residual displacement of 63.8 mm. The full hysteresis curve for column PT-HL is shown in Figure 10. The residual displacements are larger than PT-LL due to the increase in amount of longitudinal reinforcement. At a drift level of 6%, column PT-HL had a residual displacement on the positive side of the hysteresis curve of 79.2 mm and a residual displacement on the negative side of the hysteresis curve of 84.1 mm resulting in an average residual displacement of 81.7 mm.

Using unbonded tendons in each column helped minimize residual displacements. Column PT-LL showed an average residual displacement between the positive and negative sides of the hysteresis response of 8.0 mm at a drift ratio of 2% (54.9 mm). At larger drift ratios, the residual displacement remained low, with measured residual displacements of 47.0 mm at 5% drift (137 mm), 63.6 mm at 6% drift (165 mm), and 74.6 mm at 7% drift (192 mm). These residual displacements corresponded to 34.3% of the maximum lateral drift at 5% drift (137 mm), 38.6% of the maximum lateral drift at 6% drift (165 mm), and 38.9% of the maximum lateral drift at 7% drift (192 mm). Column PT-HL showed an average residual displacement between the positive and negative sides of the hysteresis response of 7.7 mm at a drift of 2% (54.9 mm). At larger drift ratios, the residual displacement increased beyond the values of column PT-LL, with measured residual displacements of 57.4 mm at 5% drift (137 mm), 77.9 mm at 6% drift (165 mm), and 100.0 mm at 7% drift (192 mm). These residual displacements corresponded to 41.9% of the maximum lateral drift at 5% drift (137 mm), 47.4% of the maximum lateral drift at 6% drift (165 mm), and 52.1% of the maximum lateral drift at 7% drift (192 mm). Note the lower residual displacements of column PT-LL compared to column PT-HL. The longitudinal reinforcement ratio had a large impact on the column re-centering capabilities, and the lower reinforcement ratio resulted in significantly smaller residual displacements.

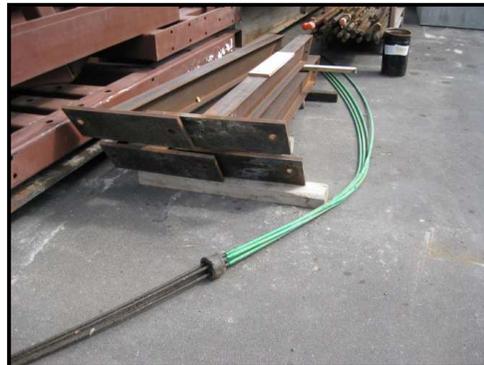
**Figure 11: Removed Tendon (After Testing)**

Once all testing was complete, it was important to remove one of the extreme tendons to determine how much damage was caused by the extreme curve in the footing that each tendon passed through. Since column PT-HL was initially stressed slightly higher than column PT-LL, it was decided to extract one of the extreme tendons from PT-HL for inspection. Figure 11 and 12 show the removed tendon. As the figures show, there is very minimal damage, even after eight cycles of 4% drift or greater. Since there was very minor damage in only one tendon, the encapsulated greased strands will be able to resist corrosion very well.

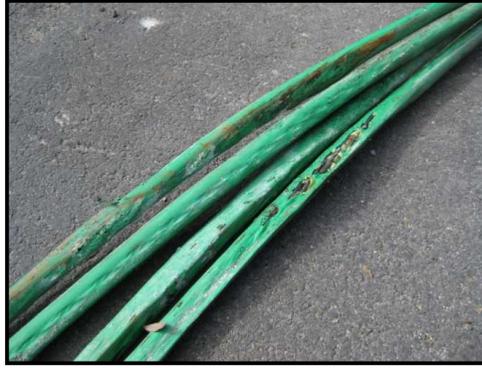
**Figure 12:** Removed Tendon at Bend in Location (After Testing)
