Recurrence of Liquefaction at the Same Site Induced by the 2011 Great East Japan Earthquake Compared with Previous Earthquakes

K. Wakamatsu

Kanto Gakuin University, Japan

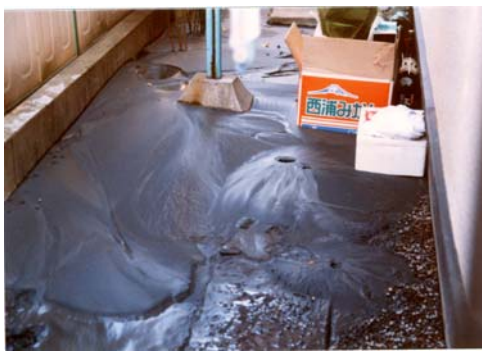
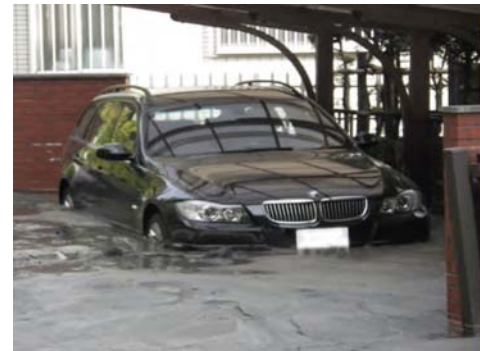
(a) 1987 earthquake

(b) 2011 earthquake (Urayasu City, 2011)

Figure 3.2. Sand boils in Mihama 3-chome, Urayasu City (35.6503N, 139.9062E)

Along the shoreline of Tokyo Bay, land reclamation has been performed since the Edo Era, especially since the 1950s. Extensive violent sand boils occurred in artificial fill along the Tokyo Bay, particularly in the areas from Urayasu to Chiba, during the 2011 earthquake in places where surface effects of liquefaction occurred during the 1987 Chibaken toho-oki earthquake. Repeated liquefaction was identified to occur at a total of 7 sites in Mihama 3-chome, Kairaku 1-chome, and Irifune 4-chome, as shown in Figure 3.1, that were filled in between 1965 and 1971. During the 1987 earthquake, a lot of sand boils erupted and water flowed out from the ground in the roads, parks, and residential lots; minor damage took the form of settlement and cracks to pavement, walls, and gateposts, but no effects of liquefaction occurred in houses and buildings (Figure 3.2 (a)). In contrast, liquefaction effects were severe during the 2011 earthquake: huge quantities of sand erupted and accumulated to depths of several dozen centimeters; single-family houses settled and tilted perceptibly and lifelines were damaged severely (Figure 3.2 (b)). Figure 3.3 shows the soil profile and SPT N-value in Mihama 3-chome, where severe sand boils were observed. The soil from the ground surface down to a depth of 8m is fills composed of loose fine to very fine sands and silty sands. The groundwater level is as high as around GL-3 m. The loose fill at a depth of 3 to 8 m seems to have liquefied in this area.

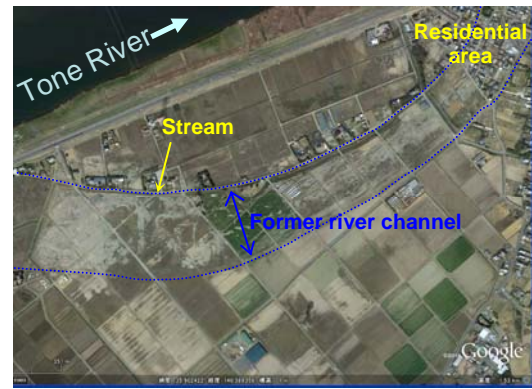
(a) 1987 earthquake (modified from Kotoda and Wakamatsu, 1989)

(b) 2011 earthquake (satellite image taken on March 29, 2011 by Google Earth)

Figure 3.8. Distribution of sand boils in former river channel in Mukouya, Kozaki Town, Chiba Prefecture due to liquefaction (35.9026N, 140.3910E)

Figure 3.8 (a) shows the distribution of sand boils observed in the former river course in Kozaki Town during the 1987 earthquake, as identified by field survey and aerial photographs taken after the earthquake. Numerous large sand boils were formed on the former channel; it seemed that the surficial ground had completely liquefied. A few small sand boils were also formed on the point bar in the convex bank of the former channel where the dredged sand had not been filled, whereas no surface effect of liquefaction were observed in the concave bank south of the former river channel.

Figure 3.8 (b) shows an aerial photograph taken eighteen days after the 2011 earthquake. There was widespread and very large thickness fine sand ejecta covering the former river channel: the small stream flowing at the northern end of the former river channel was completely filled with boiled sand. According to a resident, a road north of the channel was flooded by water ejected after the earthquake. A number of large sand boils, with a maximum hole-diameter of 4m, occurred on the point bar in the convex bank along the former channel, in places where a few small sand boils were formed during the 1987 earthquake, but no surface effects of liquefaction were observed in the concave bank as was the case during the 1987 earthquake. A residential area located at the lowest end of the former river channel was severely affected by liquefaction: most of the single-family houses, walls, and telephone poles were settled and tilted, and the roads were covered with boiled sand. Bridge piers of Kozaki Bridge across the Tone River and river dike were damaged due to liquefaction. No such effect of liquefaction had occurred in this residential area during the 1987 earthquake.
