Compression Failure of Thin Concrete Walls

P. Adebar & A. Lorzadeh

University of British Columbia, Vancouver, Canada

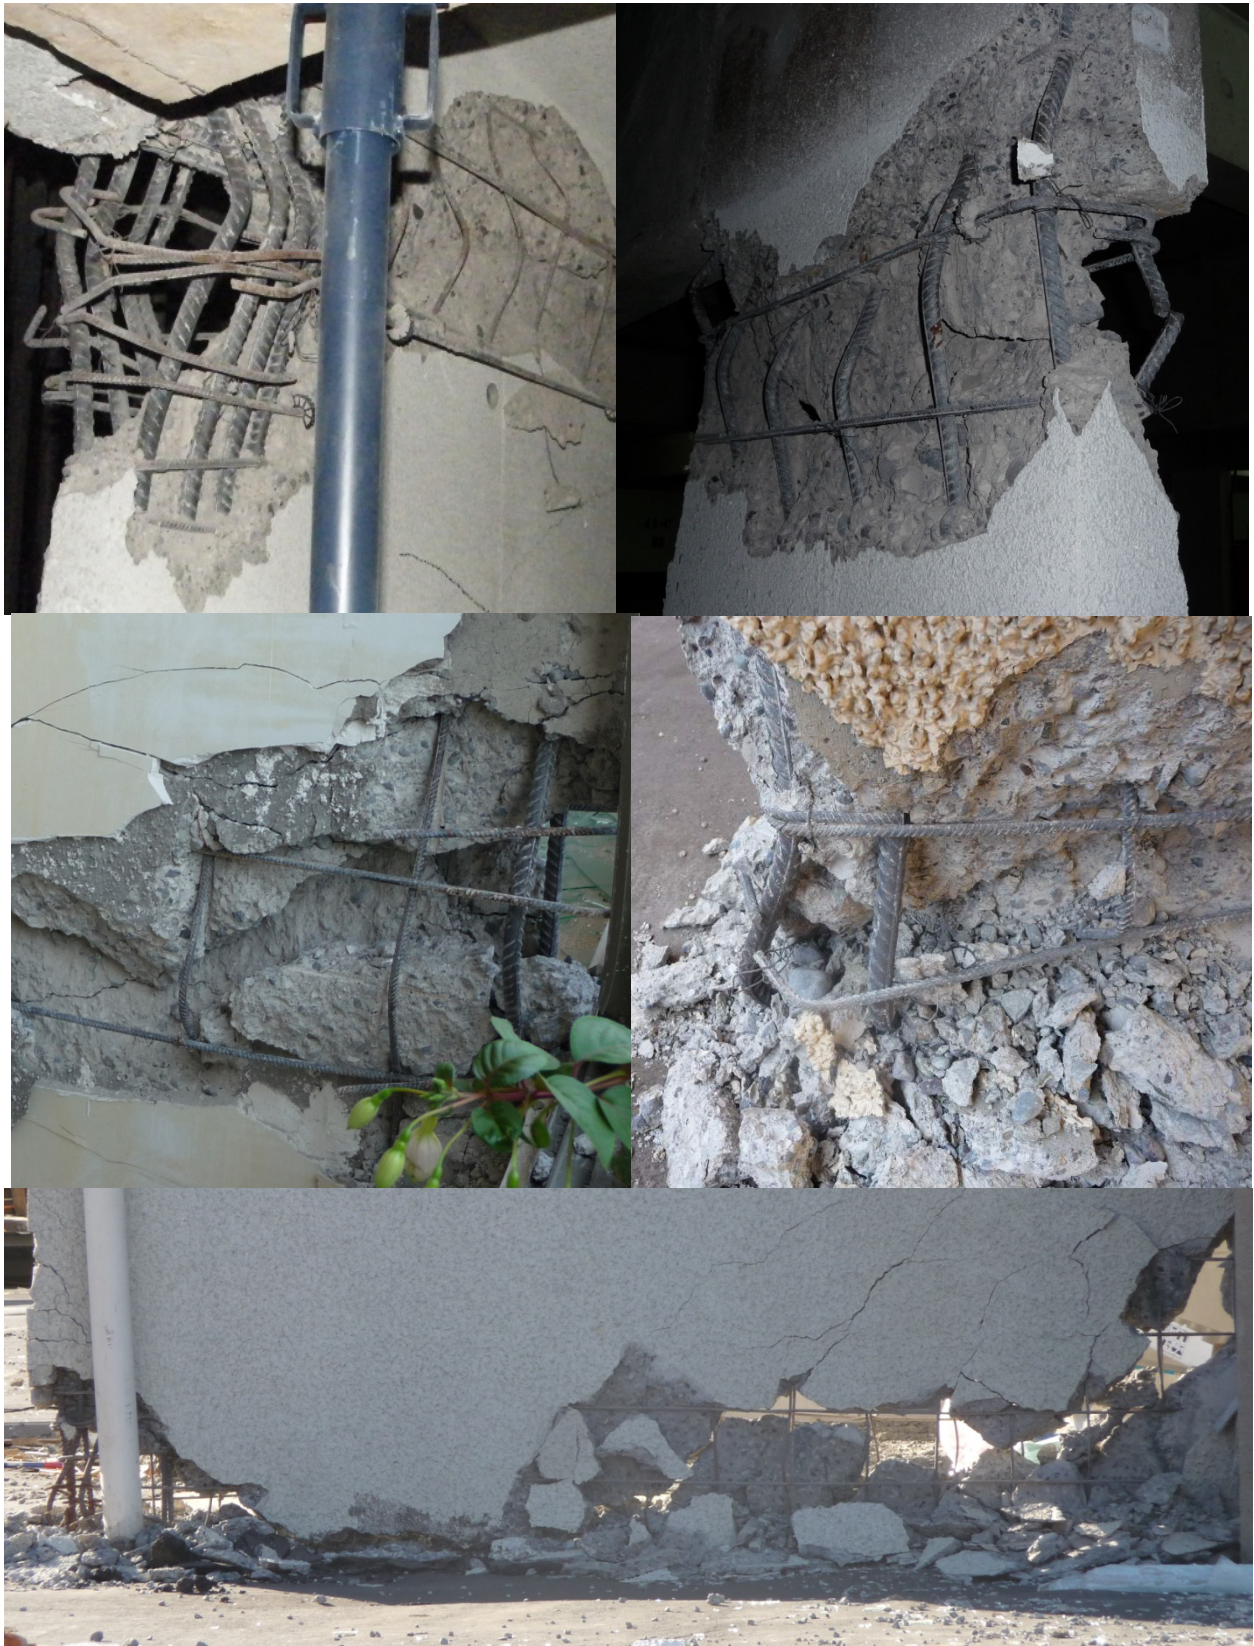
Figure 1. Compression failures of thin shear walls during the 2010 Chile Earthquake.

The impetus for the current study was the numerous compression failures of concrete walls that occurred in recent earthquakes. Many high-rise buildings were badly damaged due to compression failure of shear walls during the large earthquake that occurred in Chile in February 2010. The shear walls were typically between 120 and 200 mm thick and contained two layers of horizontal reinforcement. Figure 1 shows some of these failures. Sherstobitoff et al. (2012) provide details of the failure in one of these buildings.

Specimen 18, on the other hand, is a good example of a specimen with low compression strain capacity. The specimen was identical to Specimen 21 except the arrangement of horizontal reinforcement. The 20 cm thick wall specimen had two parallel layers of 15 mm horizontal bars that were not inter-connected in any way. This specimen represents an element of a wall away from the end where there are no cross ties. After cycling the load five times to a compression strain demand of 0.0015 with no visible damage, the specimen suddenly “exploded” when loaded to a compression strain of 0.0016 (see Fig. 3a). The photograph of the failed specimen in Fig. 3(c) suggests that the failure was influenced by the placement of the horizontal reinforcement. The failure is very reminiscent of many failures observed in thin concrete shear walls in Chile after the 2010 earthquake.

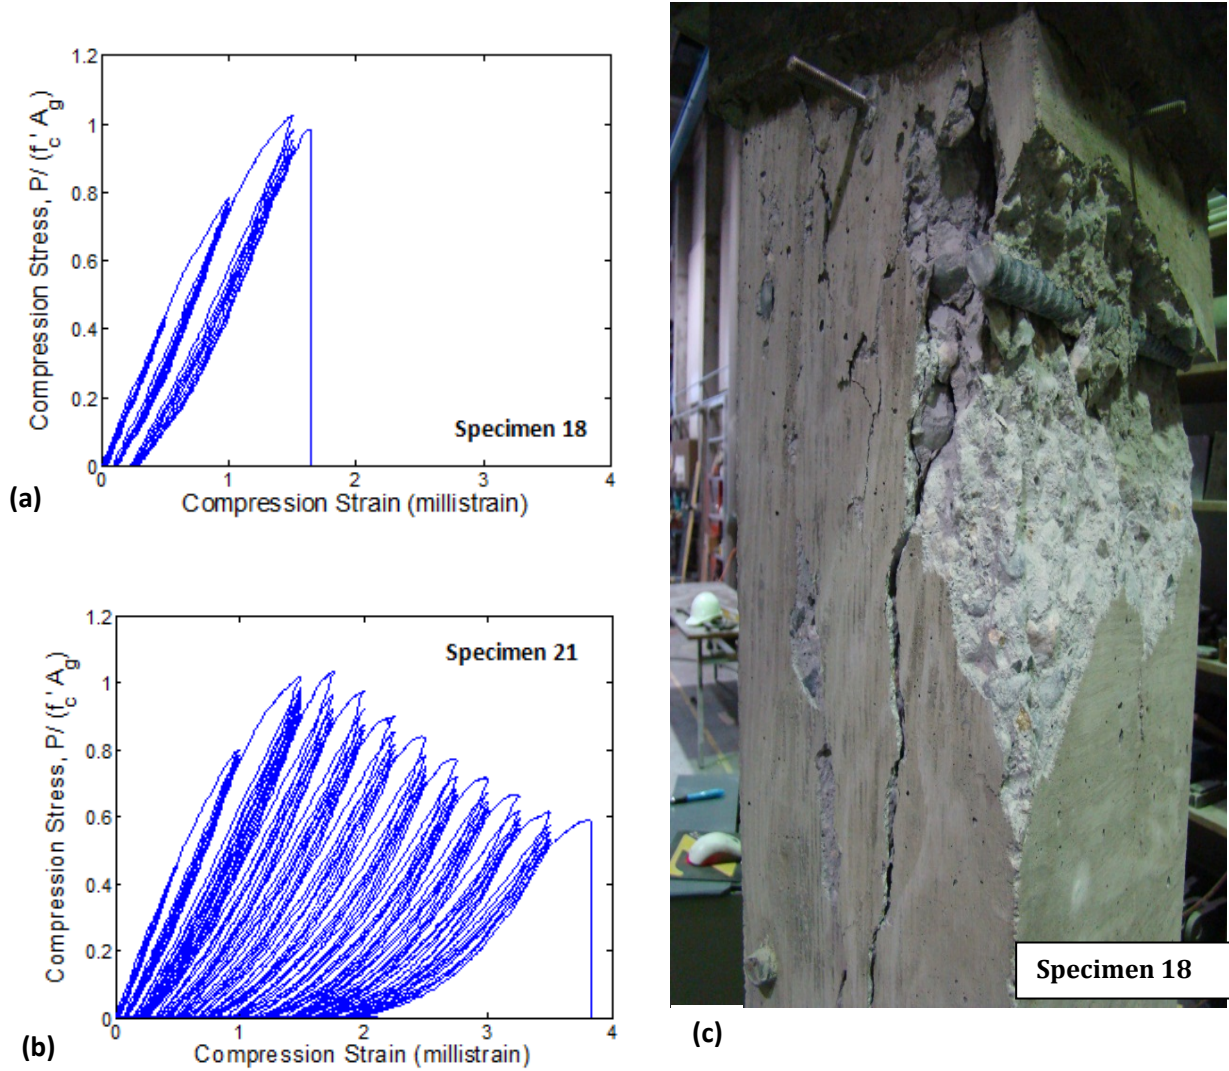
Figure 3. Typical experimental results: (a) Load-deformation response of Specimen 18, (b) Load-deformation response of Specimen 21, (c) Photograph of Specimen 18 after failure.

Figure 3 shows two typical recorded load-deformation relationships. The load is expressed as a ratio of $f_c'A_g$ and the deformation is expressed as the average compression strain measured by the four displacement transducers. Specimen 21 shown in Fig. 3(b) is typical of many specimens that had a strain capacity of at least 0.0035. As described above, the specimen is labelled as a Type 3; but actually had U-shaped horizontal reinforcement that went around three sides of the specimen to simulate an element from the end of a wall. The maximum compression force was applied to the specimen at a strain of about 0.002. As the specimen was pushed to higher compression strains, the maximum compression force during each load cycle reduced and increasing damage was observed.

A longitudinal splitting crack similar to that described by Pfister can be seen in the photograph of the failed wall element without ties in Fig. 3(c).
