Field investigation and model tests on differential settlement of houses due to liquefaction in the Niigata-ken Chuetsu-Oki Earthquake of 2007

K. Isobe & S. Ohtsuka
Nagaoka University of Technology, Japan

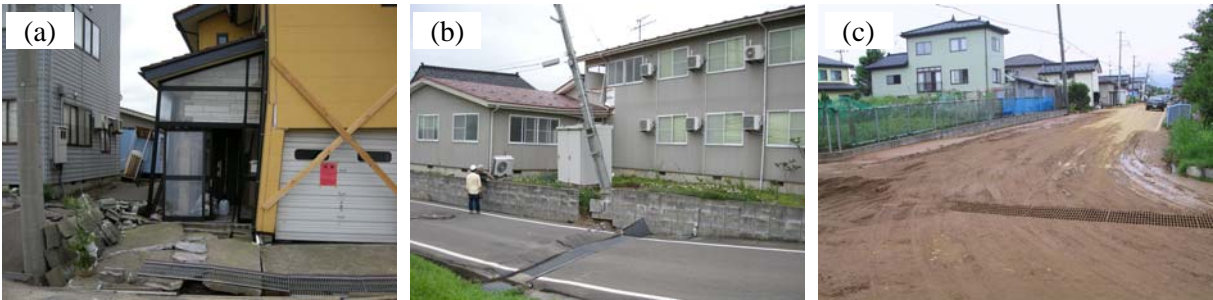
Building Foundations (2008). The most severely damaged structures stood on the stratum boundary located in the northern part of Matsunami, where ground cracks were observed (figures 2.3 (a) and (b)). The maximum differential settlement in the area was more than 200 mm (in the location of the shaded houses in Table 2.1). Signs of liquefaction such as sand boiling were observed in central and eastern areas of the district such as zones C and D (Figure 2.3 (c)). However, differential settlement of damaged houses in these areas was less prominent than that of structures in the northern area. The reasons for this are highlighted by the results of the ground investigation as outlined below.

Figure 2.3. Earthquake damage in Matsunami district; (a) the severest damaged house, (b) damaged houses due to ground crack and (c) signs of liquefaction (sand boiling)

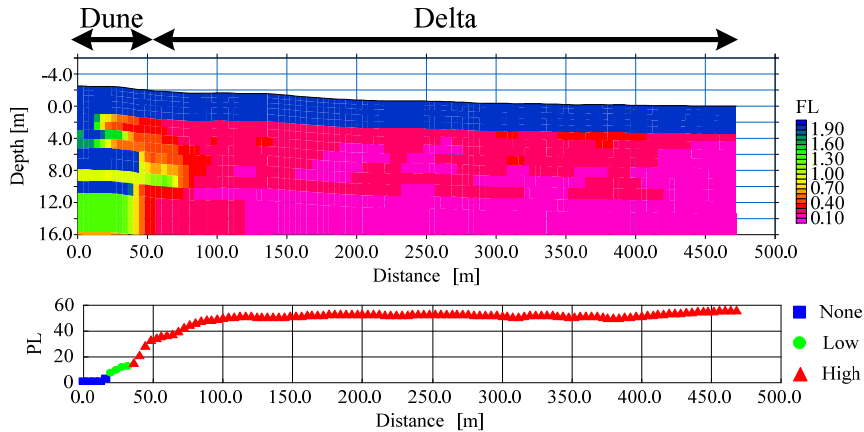
Figure 2.5 shows the results of simple liquefaction judgment such as FL (factor of liquefaction) and PL (potential liquefaction) values calculated using the shear wave velocity on the M-1 line according to reference literature (Andrus et al., 1999; Japan Road Association; 2002). These results indicate that the FL value in the delta area with its loose sand layer was less than 1.0, while the corresponding value in the sand dune area with its dense sand layer was over 1.0. The PL value changed rapidly along the stratum boundary between the sand dune and delta areas. This is considered to be why the severest differential settlement of houses around the stratum boundary was seen in the Matsunami district.

Figure 2.5. Simple liquefaction judgments using surface wave results in Matsunami (M-1 line)

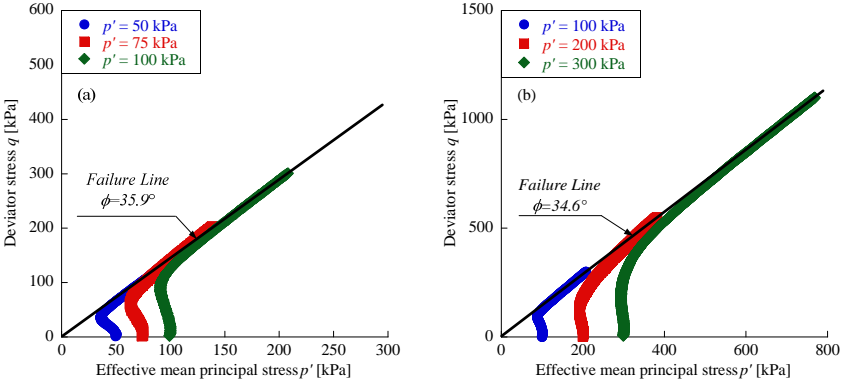
Figures 3.2 (a) and (b) show the effective stress paths of the static CU tri-axial tests for both samples. It can be seen that the angles of shear resistance ϕ' for the undisturbed and reconstituted samples were 35.9 and 34.6 degrees, respectively. These figures indicate typical undrained cyclic behavior of regular loose sand; that is, pore water pressure rises with increasing strain before deviator stress approaches the failure line, and volume expansion is seen after its approach.

Figure 3.2. Effective stress paths of (a) undisturbed and (b) reconstitution sample under static monotonic loading

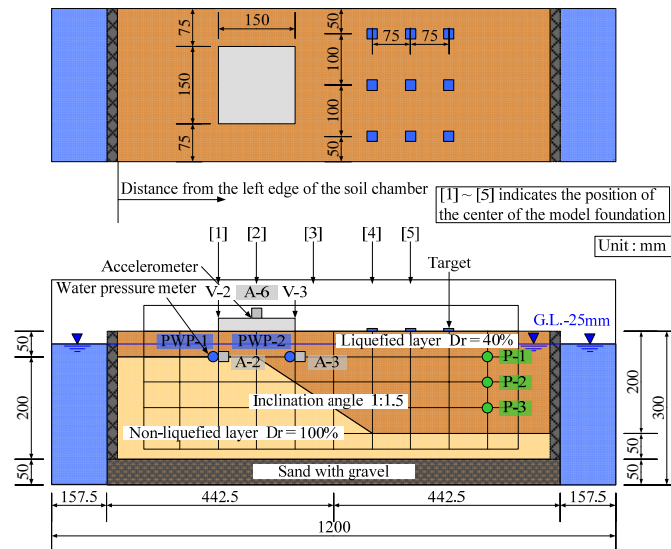
the liquefaction layer and total/differential settlement of houses. Figure 3.5 shows a sectional side view of the model tests. The soil chamber, which measured 300 mm in length, 1,100 mm in width and 400 mm in depth, had water tanks on its left and right sides to supply the model ground with water. Cushioning material was attached to the sidewall surface in order to reduce the influence of reflected wave during shaking. The specifications of the model ground were based on the results of surface wave exploration conducted at the M-1 line in consideration of the similarity ratio. The thicknesses of the liquefied and non-liquefied layers were 200 mm and 100 mm, respectively, and the angle of the slope was 1:1.5 as shown in Figure 3.7. The liquefied layer was modeled by pluviating air-dried particles through water using Kariwa sand with a relative density of 40%, and the non-liquefied layer was modeled via the tamping method using Tohoku silica sand #6 with a relative density of 100%.

The positions of the foundation model were varied from [1] to [5] as shown in Figure 3.5 to survey the influence of liquefied layer thickness imbalance under the foundation. Table 3.6 shows the test cases, the relative density and the thickness of the liquefied layers unbalanced under the model foundation of each case before shaking. Figure 3.6 shows the location of measurement sites for variables such as acceleration, displacement and pore water pressure. As input, 40 cycles of an 8 Hz sinusoidal wave with a slope were used. The target acceleration was 250 gal. Considering the similarity ratio, the weights of the 150 mm x 150 mm square foundation model and the ground contact pressure were set to 7.8×10^{-3} kN and 0.34 kPa, respectively. The data sampling frequency was 1000 Hz.

Figure 3.5. Sectional side view of model tests and the position of the center of the model foundation

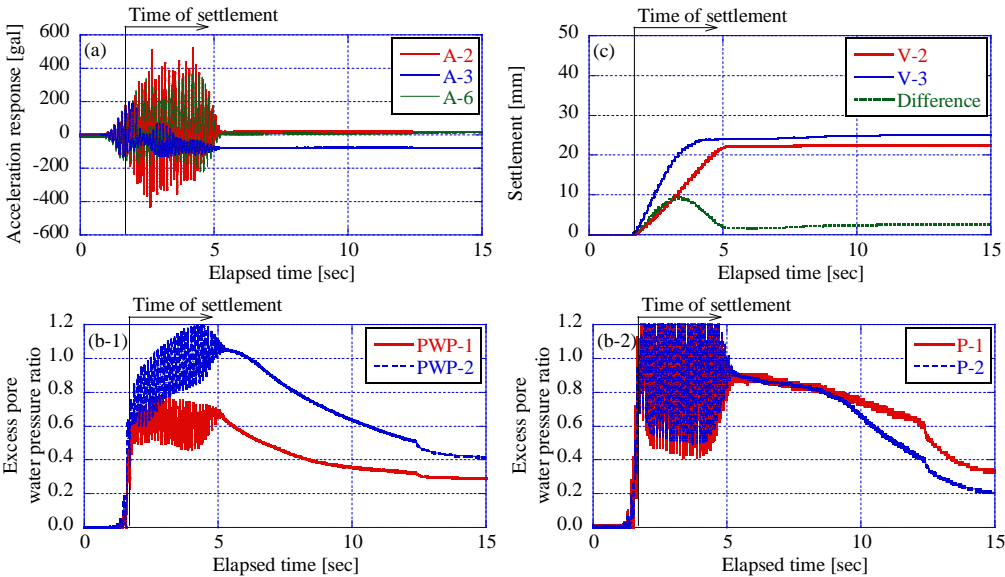
Figure 3.6 shows time histories of the acceleration response, total settlement and differential settlement and the excess pore water pressure ratio for Case A-2, in which the liquefied layer under the model was unbalanced at both edges to represent the conditions of the houses in Zone A of Figure 2.1. Settlement of the model foundation occurred with an excess pore water pressure ratio (defined as the

ratio of excess pore water pressure to initial effective stress) of P-1 and P-2 reaching approximately 1.0. A significant difference in this ratio between PWP-1 and PWP-2 can be seen at the time of settlement. This appears to depend on the boundary condition between the liquefied and non-liquefied layers because no difference in acceleration response between A-2 and A-3 before the time of settlement is observed. Differential settlement arises due to differences in excess pore water pressure, and the phenomenon in Case A-2 can be attributed to such a difference between PWP-1 and PWP-2.

Figure 3.6. Time history of (a) acceleration response, (b) excess pore water pressure ratio and (c) total and differential settlement of Case A-2 in which the model foundation is located on the position [2]
