# Study on A Real 8F Steel Building with Oil Damper Damaged During the 2011 Great East Japan Earthquake

## **SUMMARY:**

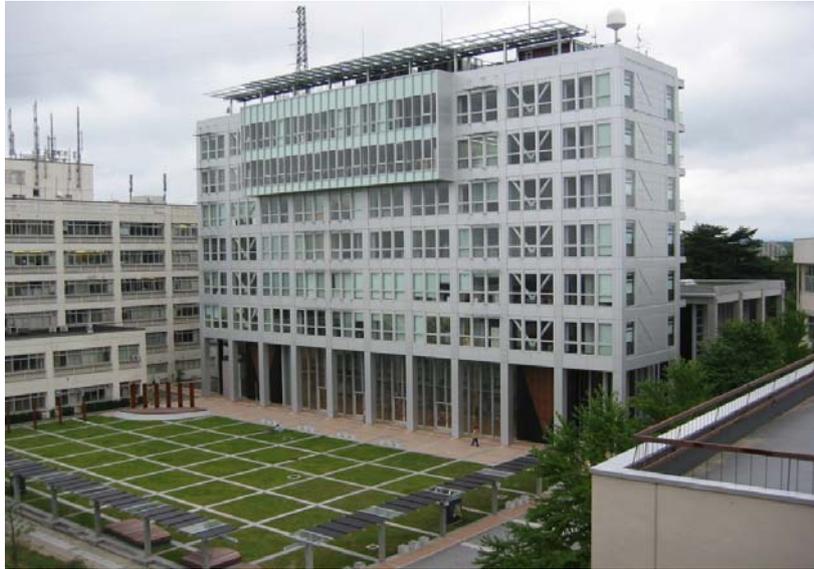
**Figure 1.** The building constructed in 2003

The 8F steel building was constructed in 2003 shown in Figure 1, where the 1st floor and the 2nd floor have been made as one floor to make large space with height of 6m, as you can confirm in the Fig. 1.

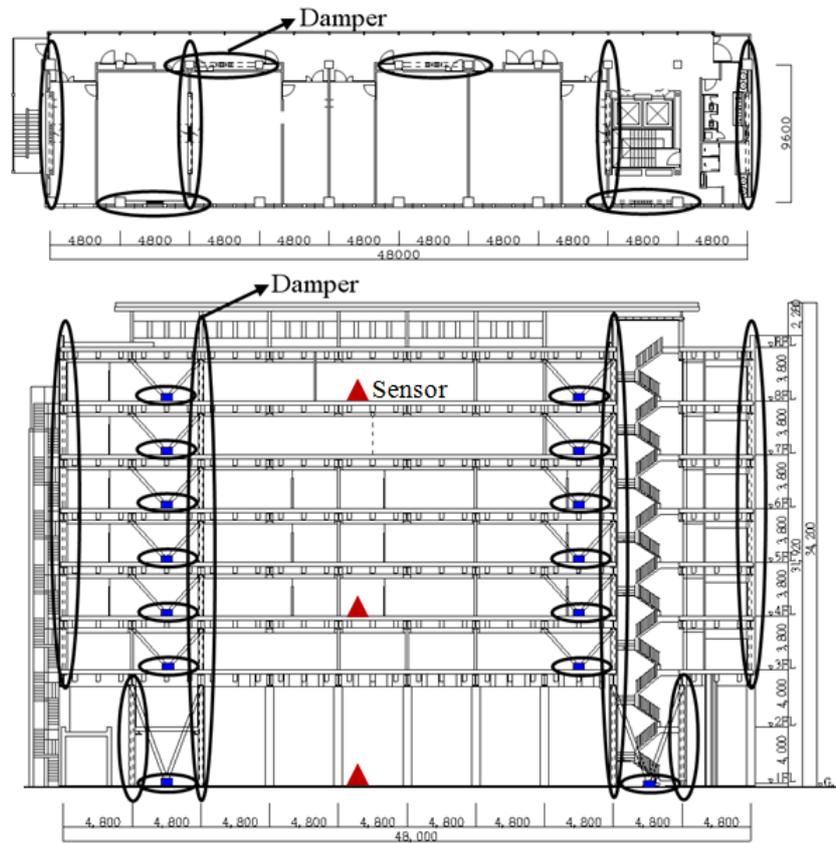
**Figure 2.** The position of dampers

This steel building certainly has been designed to satisfy the Japanese Earthquake Resistance Code for School building without any control equipment. But after designing for the purpose to verify the effectiveness of the newly developed oil damper in this University, also to improve the ability of earthquake resistance, 56 sets of dampers have been installed, with 8 sets on each floor as shown in Figure 2 and Figure 3.

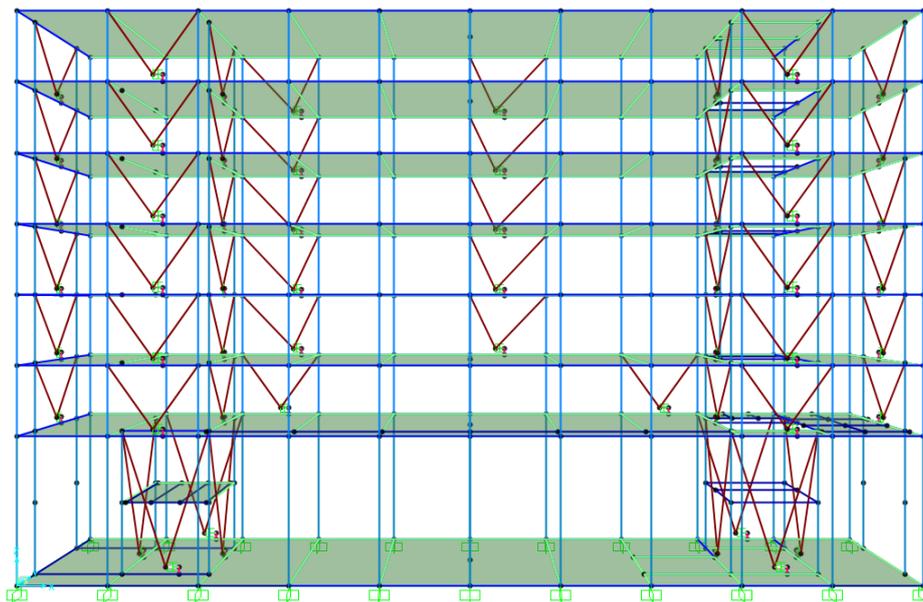
**Figure 3.** The model of building with dampers

For the purpose of calculation, FEM soft Sap2000 has been used to build the simulation model as shown in Figure 3. The sizes of all the steel columns and beams have been modelled follow the design book and the material parameters have been set following of the Japanese Steel Design Code. The joints between columns and beams have been totally fixed. Because of the steel material, the binary plastic-elastic hysteresis loop has been utilized.

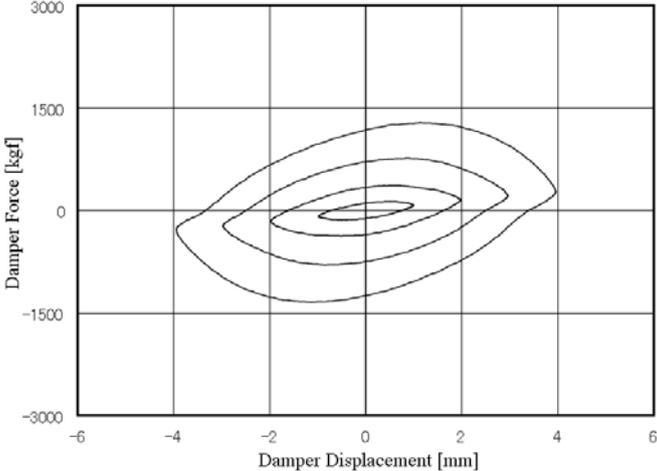
Figure 4. Damper with oil, 1.0Hz excitation, tested in 2003

The oil dampers have been modelled as the damper model in Sap2000 by the data of the test, which is considered to be most suitable to the real case before construction. Before construction of the building, we have finished the test of oil damper where the hysteresis loop is shown in Figure 4.

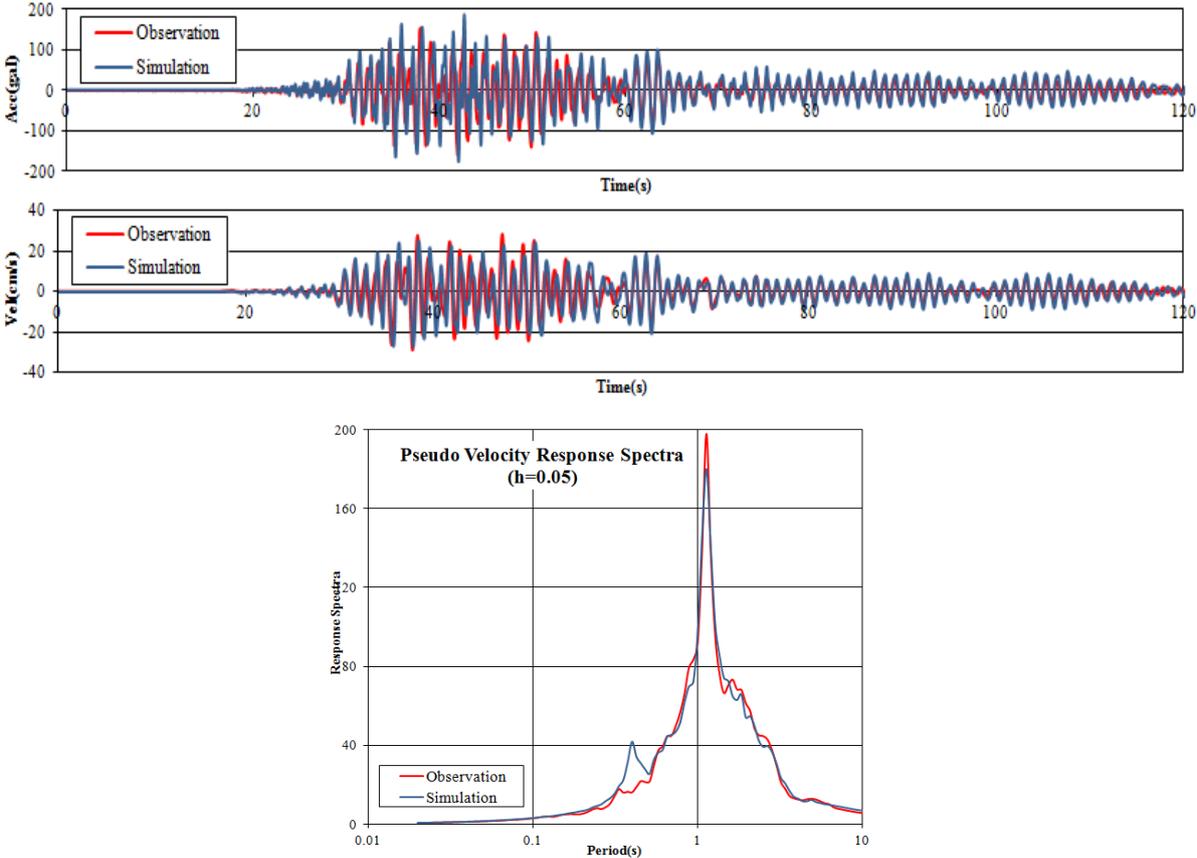
Figure 5. Comparison of the observation and simulation (2003/05/26)

Two Figures in Fig. 5 show the acceleration response and velocity response in time domain and frequency domain respectively for the earthquake of 2003/05/26 in EW direction, where red line is the recorded one and black one is the calculated one. It is clear that the simulation data coincides with the recorded one well.

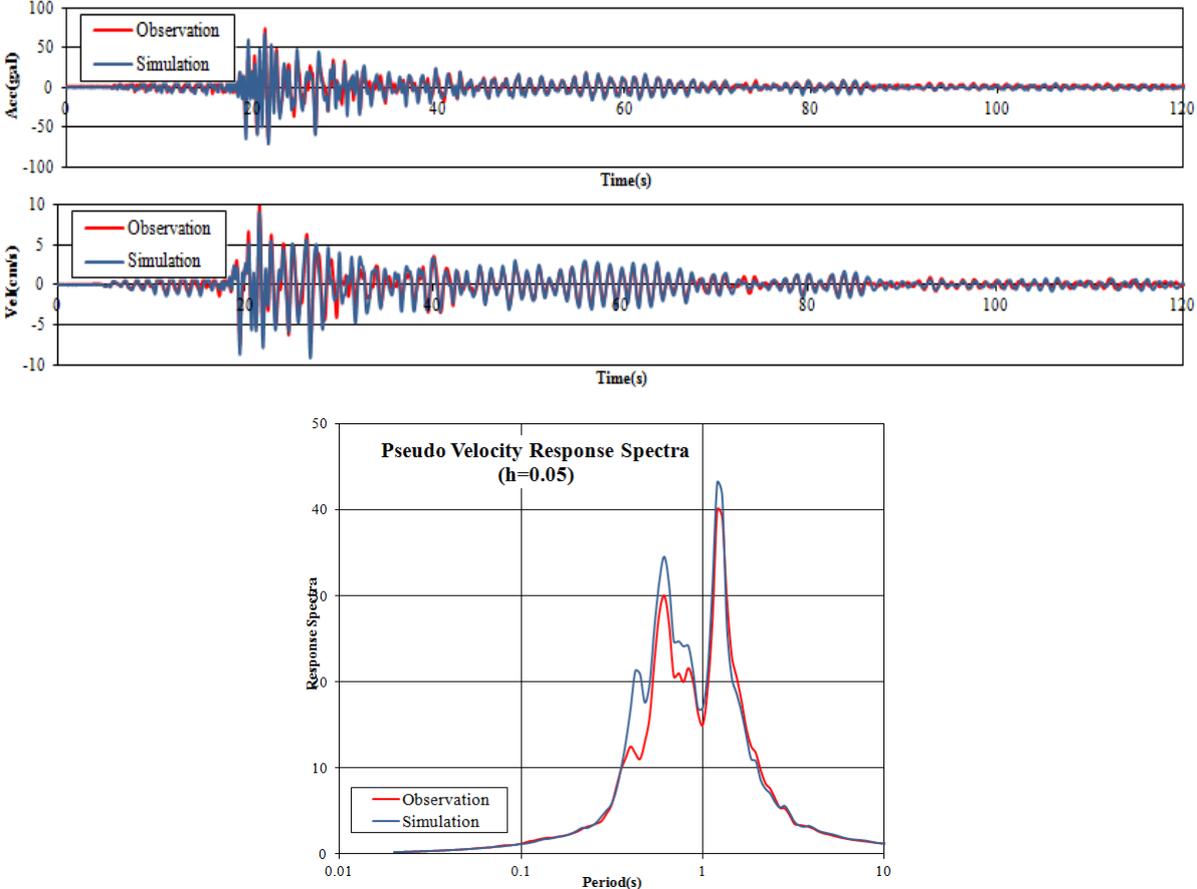
**Figure 6.** Comparison of the observation and simulation (2011/03/09)

The acceleration waves recorded and simulated are shown in Figure 6 in time domain and frequency domain respectively. The transfer functions from 1F to 8F are shown in Figure 7, where it is clear that the transfer functions has been excited about the frequency of 1.13Hz and the maximum magnification is about 4.2 times in EW direction and the frequency of 1.27Hz and the maximum magnification is about 3.8 times in NS direction.

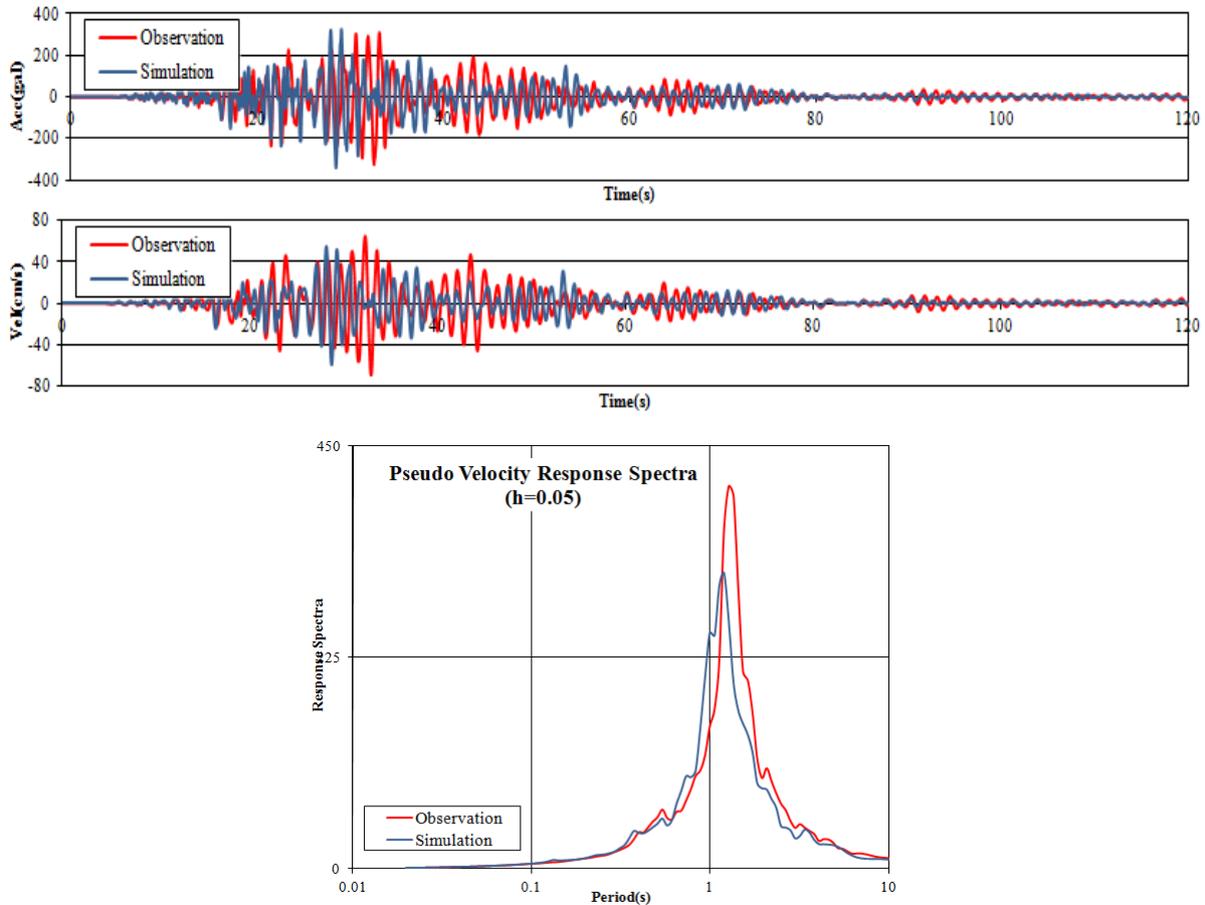
Figure 8. Comparison of the observation and simulation (2011/04/07)

Figure 8 shows the waves recorded and simulated in time domain and frequency domain, and Figure 9 is the transfer function. It is clear that the maximum magnification of observation is larger than the maximum magnification of simulation. It can be seen that some properties of our steel building maybe changed during the 2011 Great East Japan Earthquake.

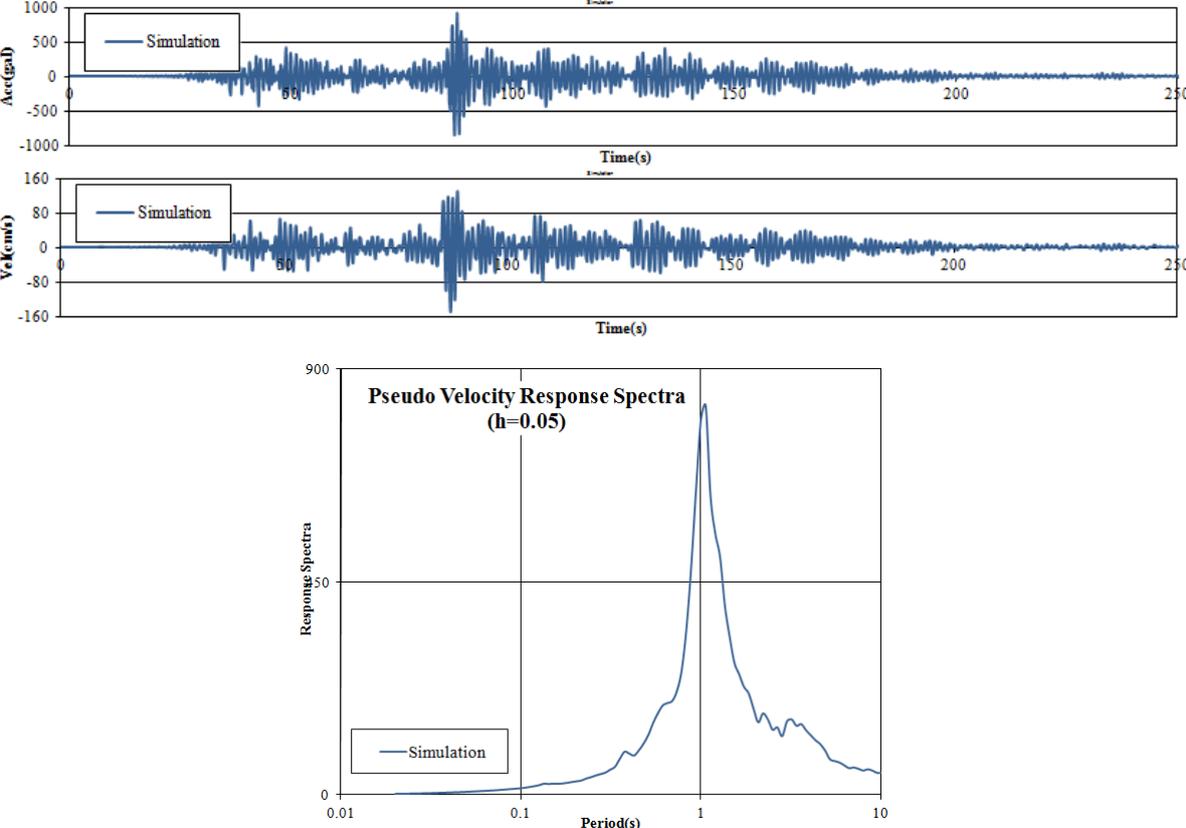
Figure 10. The simulation data (2011/03/11)

The acceleration and velocity waves simulated for the main shock are shown in Figure 10 in time domain and frequency domain respectively and Figure 11 is the transfer function.

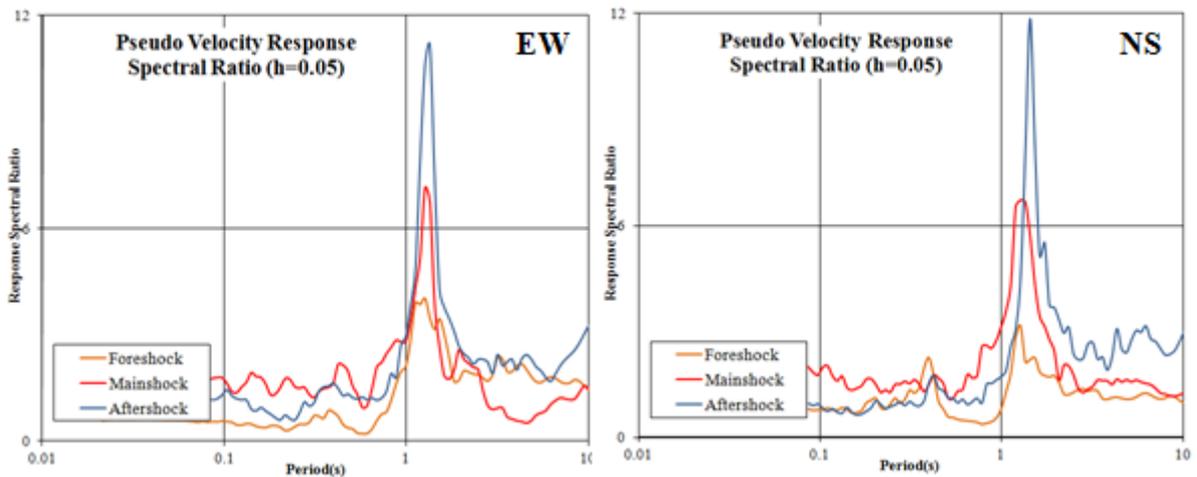
**Figure 12.** Comparison of the transfer function ( $8F/1F$ ) Foreshock, aftershock recorded, main shock simulated

The transfer functions from 1F to 8F are shown in Figure 12 for three earthquakes, where the foreshock is recorded in 20110309, main shock is the simulated one and the aftershock is recorded in 20110407. It is clear that the period of aftershock is larger than the other two because of the absence of the dampers in 1<sup>st</sup> floor. Maximum magnification of the aftershock is obviously takes a big value compared with others. Such fact clearly reveals the effectiveness and the importance of the dampers.

Figure 13 is the simulated results for transfer functions (8F/1F) of foreshock, main shock and aftershock. Comparison of Figure 12 to Figure 13, it is found that the simulated aftershock one do not identify with the foreshock one, which means that after the 311 earthquake the characteristics of the building may changed.

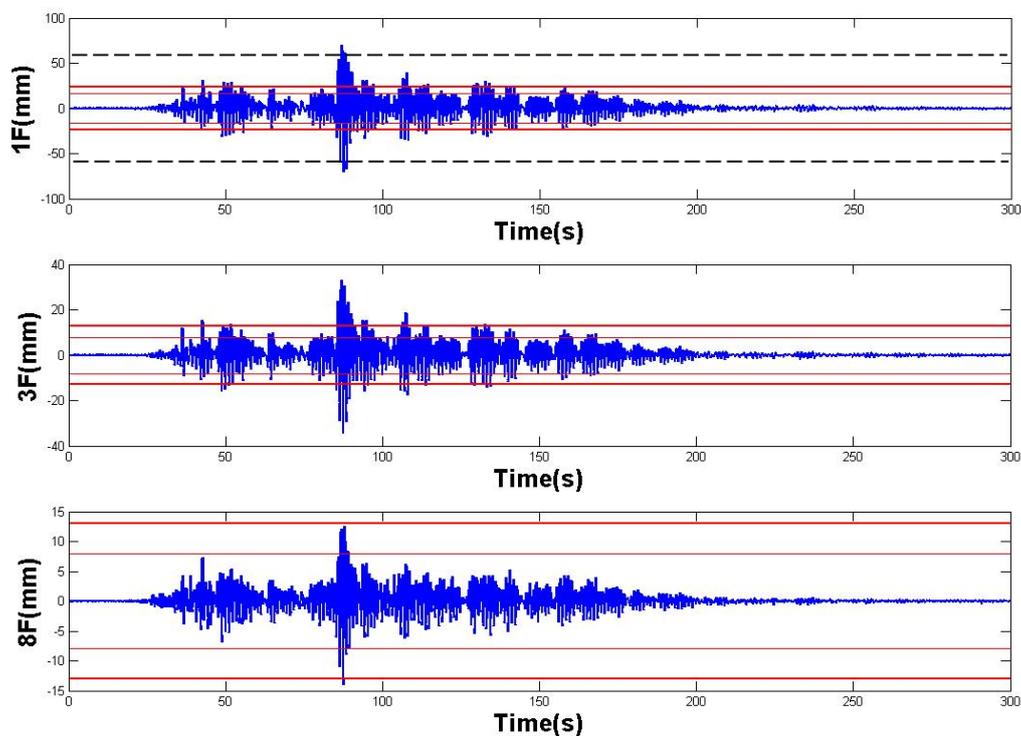
**Figure 14.** Displacement of dampers

Figure 14 shows the simulated displacement of dampers on 1st, 3rd and 8th floor in EW direction in the 311 earthquake. During the earthquake the dampers on 1st floor had been destroyed and the oil leaked out, the dampers on 3rd floor kept undestroyed but leaked the oil out. Following the design book, the designed limit displacement of the damper for 1st floor is 16mm (pink line) and for others is 8mm. In addition to protect the damper, a cushion has also been designed as 8mm (red line) for 1st floor and 5mm for others. Considering the limit situation of the dampers of 3<sup>rd</sup> floor with oil leaded but itself safe, it is reasonable to assume damper destroy limit displacement in such situation, that is if this limit is being exceeded the dampers can be thought to be damaged. Because of different sizes of the dampers, the ratio of maximum displacement to the limit displacement for 3<sup>rd</sup> floor should be confirmed and be used as a standard damage value to also apply to the dampers in the 1<sup>st</sup> floor.

The ratio of maximum displacement to the limit displacement for 3<sup>rd</sup> floor is 2.6. Applying this standard ratio to 1<sup>st</sup> floor, maximum value 62mm is obtained which is shown as broken black line in Figure 14. While this value is exceeded the dampers are suggested to be destroyed. Certainly the 1<sup>st</sup> floor dampers had been destroyed at about 85 second. Such simulation agreed with the fact.

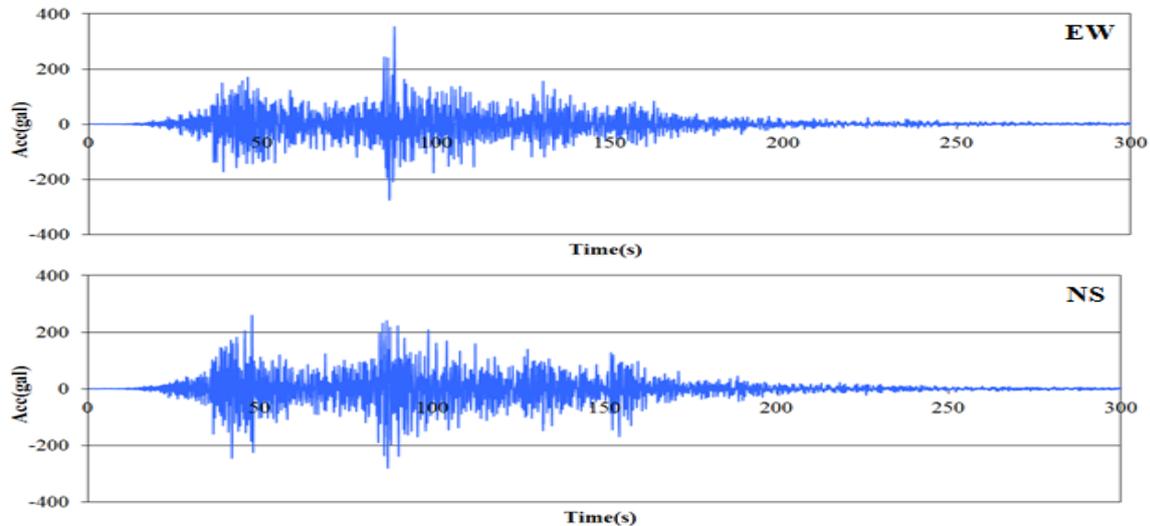
**The Input wave:** the recorded ground motion during 311 Earthquake in Tohoku Institute of Technology, 50m far away from the building.

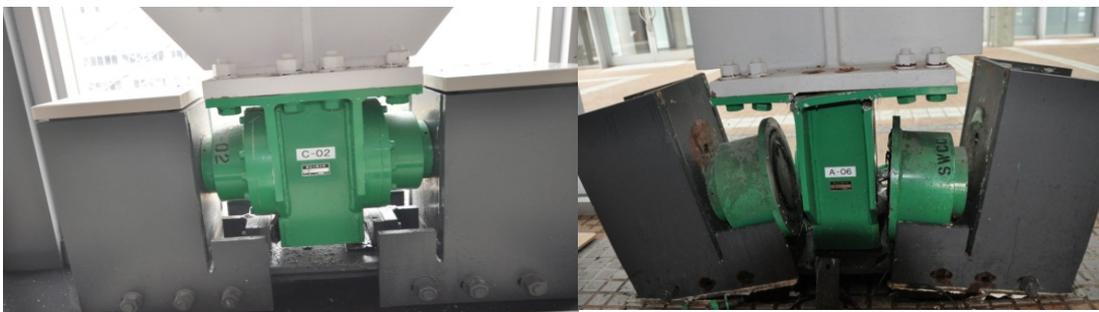
Unfortunately during the 2011 Great East Japan Earthquake (shortly the 311 earthquake in this paper), the 8 sets of dampers on 1st floor had been destroyed and the oil leaked out (Find the figure in the SUPPLEMENTS). Other way the 8 sets of dampers on 3rd floor kept undestroyed but leaked the oil out. Because of power failure during the earthquake the computer stopped recording the data and fortunately, the ground motion about 50m far away near this building was recorded as EW=354 and NS 280 gal. Because even without the oil dampers, this building had been designed to satisfy the Japanese Earthquake Resistance Code for School, this building is still being in use.

**The Destroyed damper:** Damper Destroyed in the earthquake
