Assessment on the Future Seismic Behaviour in Heritage Buildings In San Juan, Argentina

The analysis of most relevant aspects of Obras Sanitarias Sociedad del Estado building, an emblematic institutional building built after this earthquake, are presented in this research. This building suffered considerable damage during the November 1977 earthquake, IMM= VIII at San Juan city. It was necessary to retrofit it. This was done by placing resistant walls.

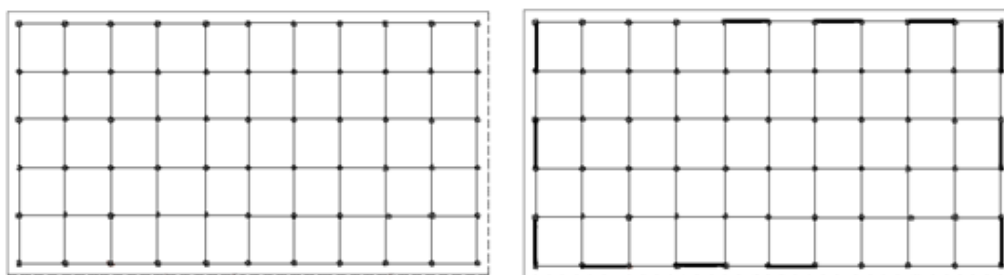
Figure 8 Schematic Plant Building.
Left, Old Structure in Plant - Right, New Structure in Plant, with Consolidation Walls

The damage, see Figure 13, was motivated by its structural design, concerning the tenets of modernism, with a flexible ground floor and compact upper floors that gave a rigidity not contemplated in these stories. Studies by specialists, determined the consolidation immediate. Joined the structural reinforced with 12 concrete walls, each formed by a pack of 5 columns, placed between the columns on the outer sides of the building, increasing floor stiffness. The location of those is shown in the graphic information, Figure 8. Each concrete wall has openings whose purpose is to maintain "if possible" the architectural style of the building.

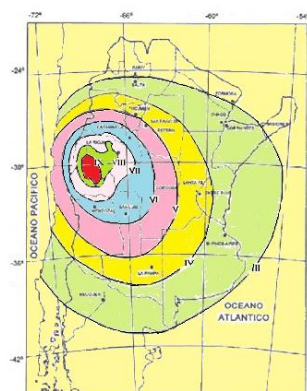
Figure 9 Isoseismics map of the earthquake⁵ on October 27, 1894

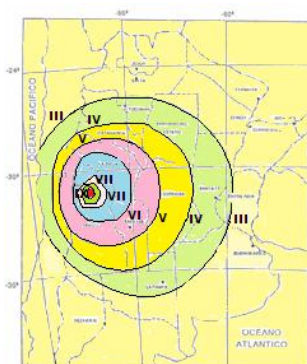
Figure 10 Isoseismics map of the earthquake on January 15, 1944

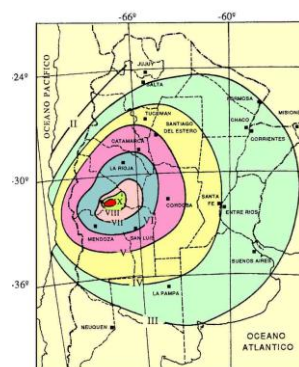
Figure 11 Distribution of intensities of the earthquake on November 23, 1977

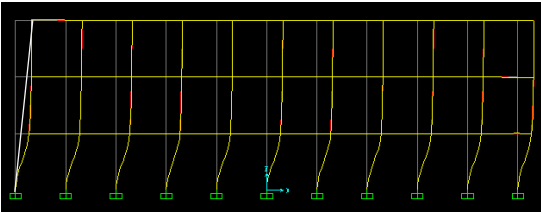
Modal 1 T=0.258602 Eigenvector [0.18465; 0.17777; 0.15624]

- It is noted that the consolidated model best fits the pseudo-static analysis performed to calculate the seismic capacity by standards applicable in the city of San Juan, see the white line drawn on the mode shape of the first mode.
- On the other hand and observing the spectrum of the seismic standard, the demand will be higher for the unconsolidated model, since due to the structure stiffening the demand for the standard will be lower. See design spectrum of the standard Figure 12
- As for the shear stresses, we see that are concentrated in the first floor columns in the flexible model, while the shear stresses are absorbed by the walls in the structural retrofitting model.

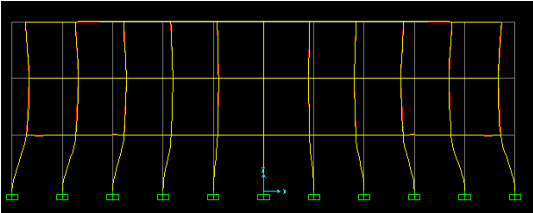
Modal 2 T=0.048111

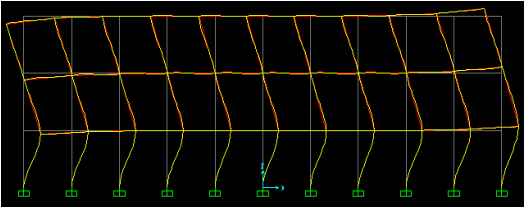
Modal 3 T=0.047549

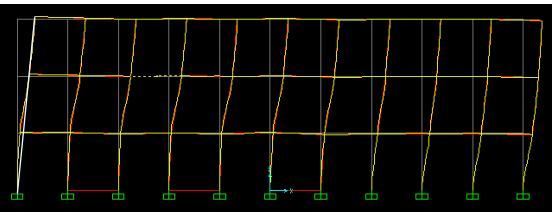
Modal 1 T=0.097700 Eigenvector [0.23401; 0.16226; 0.03453]

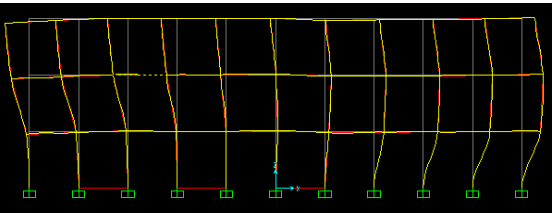
Modal 2 T=0.045156

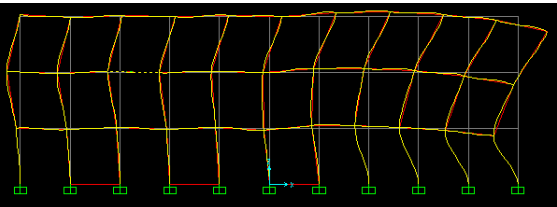
Modal 3 T=0.037510
Shear Stresses in Frames and Concrete Walls and Masonry Walls

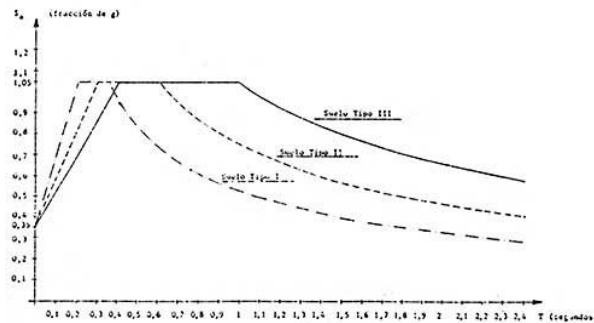
Figure 12 Pseudo elastic spectrum for seismic zone 4 $\xi = 5\%$

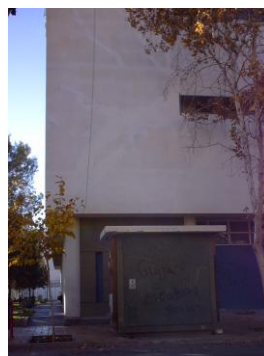
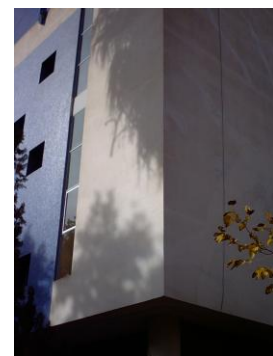
Figure 13 Northwest corner

During the earthquake of November 1977³ the building suffered considerable damage, which leads to decreased resistance capacity⁴. Manifested stress concentrations in the northwest corner of the building, still observed nowadays cracks caused by the earthquake in the wall of the west facade.
