# An Evaluation of Shear Strength of RC Frame with Old Masonry Wall

*Keywords: deteriorated RC frame, old masonry wall, shear test, seismic performance*

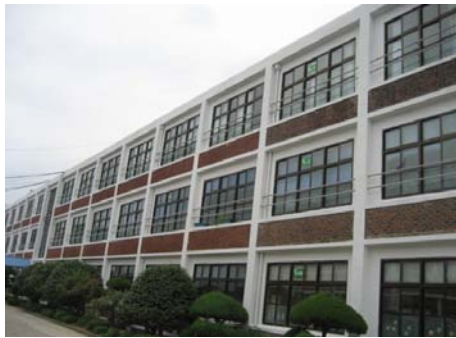
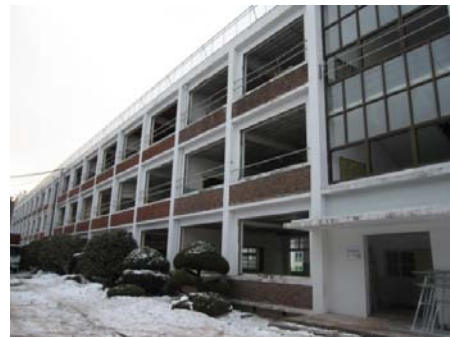
Figure 1. S Elementary School to be dismantled (Gwangju, Korea, 1969)

Usually, school buildings in Korea are low story and a floor plan of one-sided corridor type. In most cases, columns, beams and slabs of the buildings are reinforced concrete structures. Partition walls between classrooms and waist walls are masonry. As shown in Figure 1, the S Elementary School constructed in 1969 is a 3-story reinforced concrete structure, and has a waist wall in the long span direction. For this test, a specimen was taken from a partition wall between classrooms on the ground floor in the S Elementary School of which dismantlement was underway. (Figure 2)

(a) Photo before dismantlement

(b) Photo showing dismantlement (Feb. 2011)

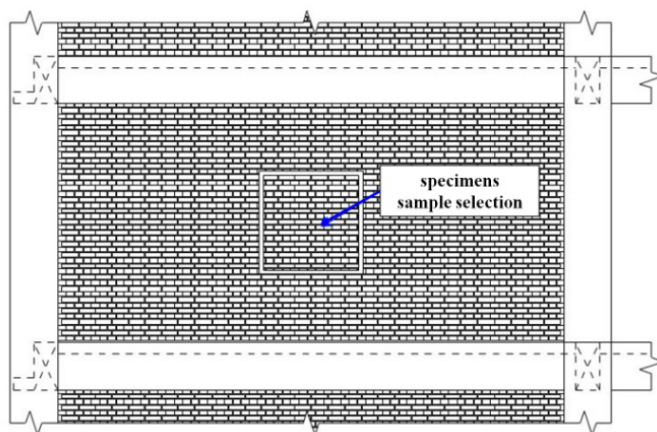
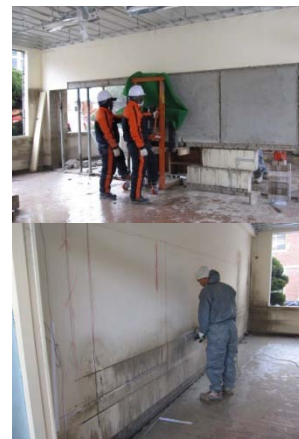
Figure 3. Point of sampling and cutting masonry wall

As shown in Figure 3, the specimen of 1000mm x 1200mm was cut from the masonry partition wall 60cm above the floor, using a concrete cutter. The masonry wall was made in the British 0.5B bricklaying type, and the finishing mortar was in very good condition.

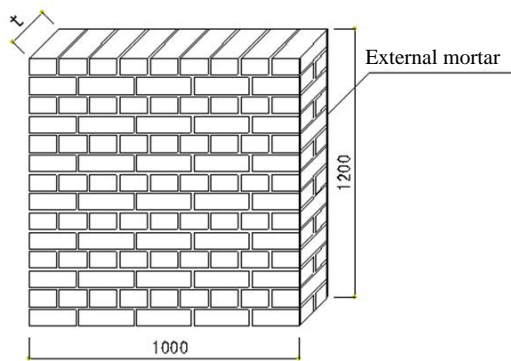
**Figure 4. Sampled masonry wall**

The RC frame specimen for test was produced by using the masonry wall of approximately 1200mm×1000mm×200mm sampled from the S Elementary School. The masonry wall sampled from the wall is shown in Table 5. The No. 1 specimen in the Figure is an RC frame without masonry infill walls. The No.2 specimen is plastered with mortar on the masonry wall, and the No.3 is a specimen in which the finishing mortar was removed from the surface of masonry wall.

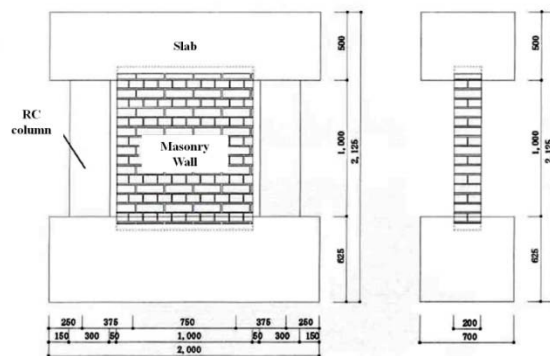
**Figure 5. Specimen**

In precedent studies<sup>[3][4]</sup>, researchers proposed their own method of test to verify the shear capacity of masonry walls. In this test, the sample is taken directly from existing building, in order to produce the original masonry wall conditions as possible with less damage to the specimen as shown in Figure 5. As shown in Figure 7, a clearance of ( $\approx 50$ mm) between the masonry wall and the RC column was

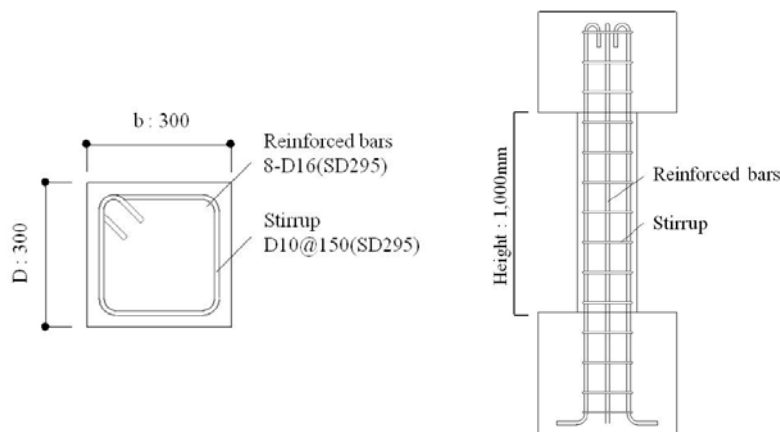
**Figure 6. Reinforcement bar arrangement of RC frame column**

ensured, and the RC column was made not to restrict the masonry wall in loading. The RC column section and the arrangement of reinforcement bars are shown in figure 6.

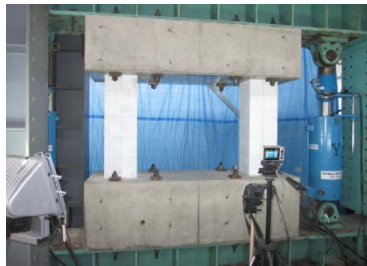
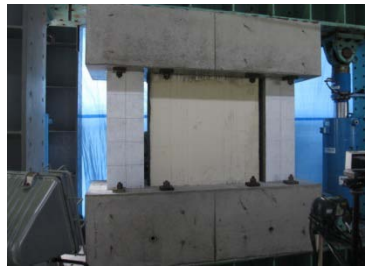
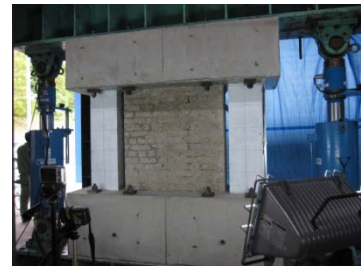
Figure 7. Masonry wall test specimens

a) No.1 specimen

b) No.2 specimen

c) No.3 specimen

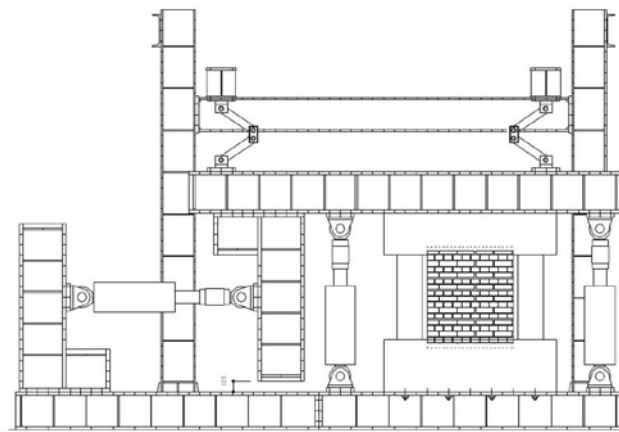
Figure 8. Configuration of actuator

Figure 8 shows the test set up and loading condition. The reverse symmetry loading device was constituted to carry out unidirectional static loading test. A vertical constant load of 36kN was given in a controlled manner with vertically installed actuator which is equivalent to  $0.1bDF_c$  of the RC column. The actuator having a capacity of 500kN was used to apply the lateral load to the specimen in the controlling the displacement. A Pantograph was installed to avoid deformation in the out-of-plane direction of the wall. The loading rate was set up not faster than 1mm/sec for quasi-static test.

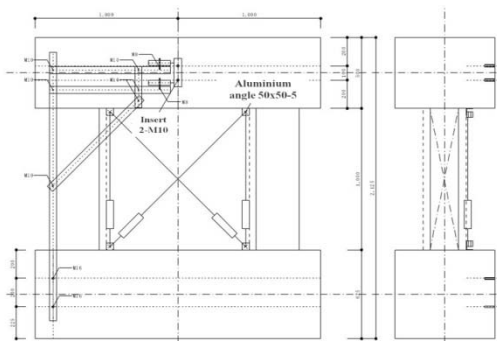
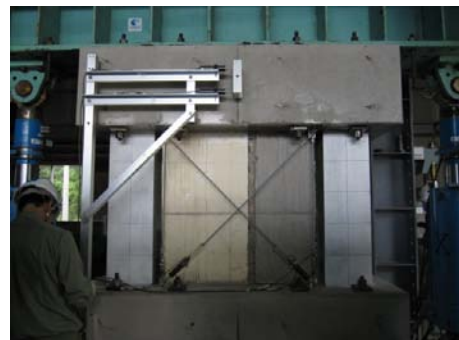
Figure 9. Measurement method

Figure 9 shows the points for measuring displacement. Two actuators were installed on the upper part of concrete beams to measure displacement of the specimen. Four measuring device are installed diagonally and vertically to measure bending and shear deformation respectively as shown in figure 9. Load was measured at 3 points arranged at the end of the actuator installed laterally and at the upper end of vertically installed actuators.

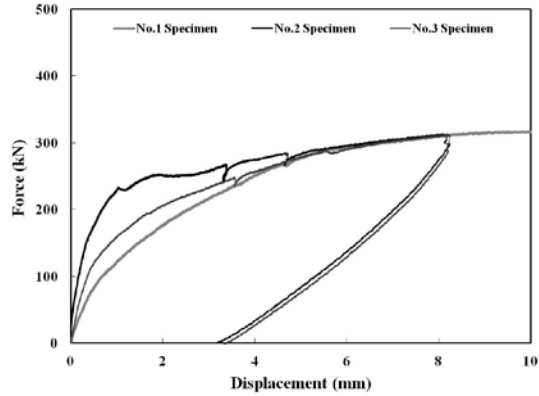
Figure 10 Load-displacement r/n of masonry wall specimen

Figures 10-13 show the relationships of load obtained from unidirectional lateral load under a constant axial force and displacement of each specimen under consideration. As shown in Figure 10, the initial stiffness and initial strength of No.2 (RC column + masonry wall with finishing mortar) > No.3 (RC column + masonry wall without finishing mortar) > No.1 (RC column). Final shear strength of all three specimens was approximately 315kN which is the maximum shear strength. It is considered that the masonry wall lost its capacity from the inter-story drift angle of approximately 1/200(5mm) so that it behaves only with the strength of the RC column. Figure 11 shows theoretical and test shear strength with respect to load-displacement of No.1 specimen (RC column). The No.1 specimen showed the calculated shear strength ( $Q_{su}$ ) of the reinforced concrete column on the basis of KBC2009 and AIJ standard, which is approximately the same as the test result. However, the calculated bending strength ( $Q_{mu}$ ) of the reinforced concrete column on the basis of AIJ standard showed a significant difference. The result calculated in 2.3 showed precedent rupture in bending, but the No. 1 specimen exhibited shear rupture (Figure 15.(a)). The result revealed that the calculated shear strength was even closer to the calculated strength of the column. ★ in Figure 11 is a normal indicator in which cracks occur in a masonry wall to represent RC column strength where inter-story drift angle is 1/500 so as to examine the strength of a masonry structure.<sup>[3]</sup>

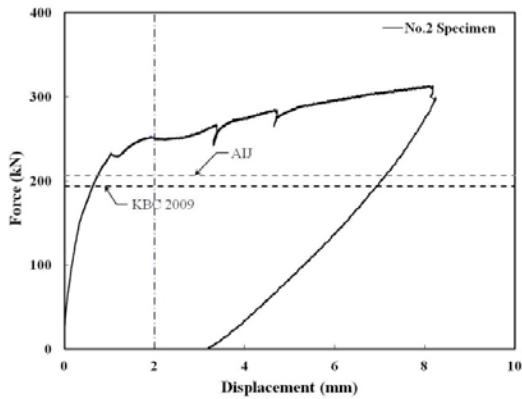
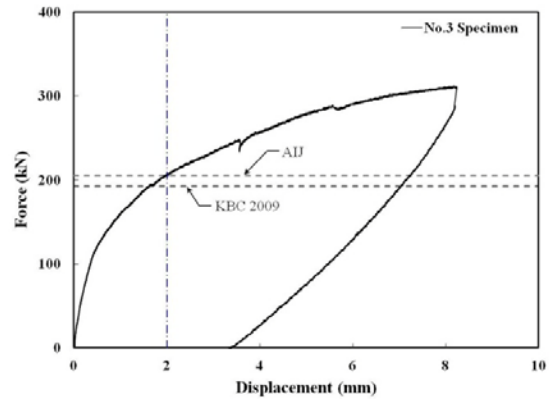
Figure 12. Load-displacement curves of each specimen

(a) No.2 Specimen

(b) No.3 Specimen

Figure 12 shows the comparison of the test result of load-displacement curves in the case of the masonry wall with and without the finishing mortar as well as with the calculated shear strength based on the inter-story drift angle of 1/500. Here, the test result of RC column shear strength and the calculated masonry wall for both standards at a drift angle of 1/500 was obtained.

The No. 2 specimen exhibited the calculated strength with the standard of KBC2009 and AIJ, lower than the test result. The reason is because the thickness of finishing motor is considered in calculating the wall area during calculation of masonry wall strength by each standard, but the finishing mortar strength is not considered.

Meanwhile, the No.3 specimen without finishing mortar showed the calculated masonry wall strength with the AIJ standard almost the same as the test value. On the contrary, the theoretical value was slightly smaller than the test value for KBC2009 standard.

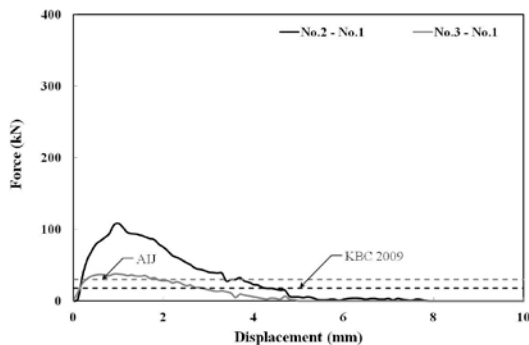
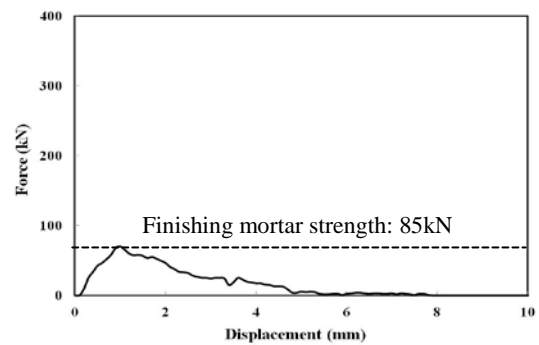
Figure 13. Load-displacement curves of masonry wall and finishing mortar

(a) Masonry wall strength

(b) Finishing mortar strength

The comparison of all test specimens is shown in figure 13. In this figure, the strength measured is only the strength of the masonry wall. Figure 14 shows the difference of strength of finishing mortar the test results of No.2 specimen and No.3 specimen. The finishing mortar strength is maximum at the inter-story drift angle of 1/1000(1mm), after which cracks occurred, and most of shear strength was lost at the inter-story drift angle of 1/200 as shown in Figure 13. (b). Therefore, it is seen that a significant proportion of the shear strength of the masonry wall came from the shear strength of the finishing mortar.

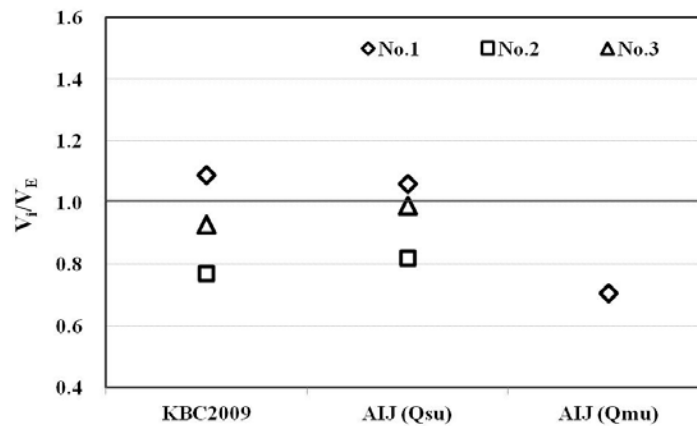
**Figure 14. Comparison of test result and calculated strength by each country standard**

Figure 14 shows the comparison of the theoretically calculated strength in each country standard and the maximum value from the test result (the inter-story drift angle is 1/500 in No.2 and No.3). In No. 1, it is seen that the RC frame strength is over evaluated in the KBC2009 standard. However, for the masonry wall for No.3, the test result and the calculated value according to AIJ standard was almost the same but for KBC2009 the calculated value was slightly smaller.

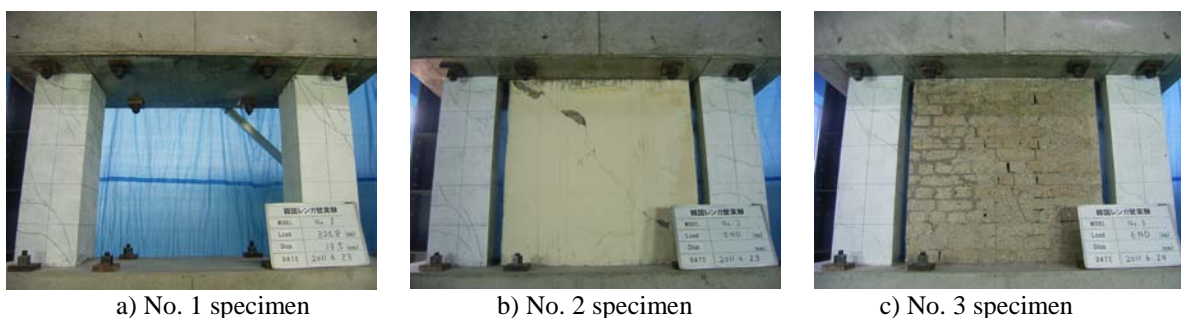
**Figure 15. Rupture of masonry walls**

Figure 15 shows final failure mode of each specimen. For No. 1, specimen cracks at the head and the bottom of the RC column as shown in figure 15 a). The masonry wall specimens of No. 2 and No. 3 the cracks starts in the masonry wall right after loading, and the cracks gradually extended to result in shear failure as shown in figure 15 b) and c) respectively.

- 1) Right after loading, the specimen exhibited shear cracks on the brick wall. The cracks gradually

extended to result in final shear failure.
