Seismic Strengthening of Deficient RC Buildings Using Post-Tensioned Metal Straps: An experimental Investigation

This paper presents some of the preliminary results of the European research project BANDIT (SERIES Programme). The project investigates experimentally the efficiency of Post-Tensioned Metal Straps (PTMS) strengthening at improving the seismic performance of a seismically deficient full-scale two-storey RC building tested on a shaking table. To simulate typical deficient buildings, the reinforcement of columns and beam-column joints were poorly detailed. The first two test stages performed on the BANDIT building are summarised here. In Stage 1, the bare building was tested to produce damage and evaluate its basic performance. After the initial tests, the damaged building was repaired and subsequently strengthened using PTMS. In Stage 2 the building was re-tested to examine the efficiency of the PTMS technique. The results show that the PTMS strengthening improved substantially the seismic performance of the deficient building.

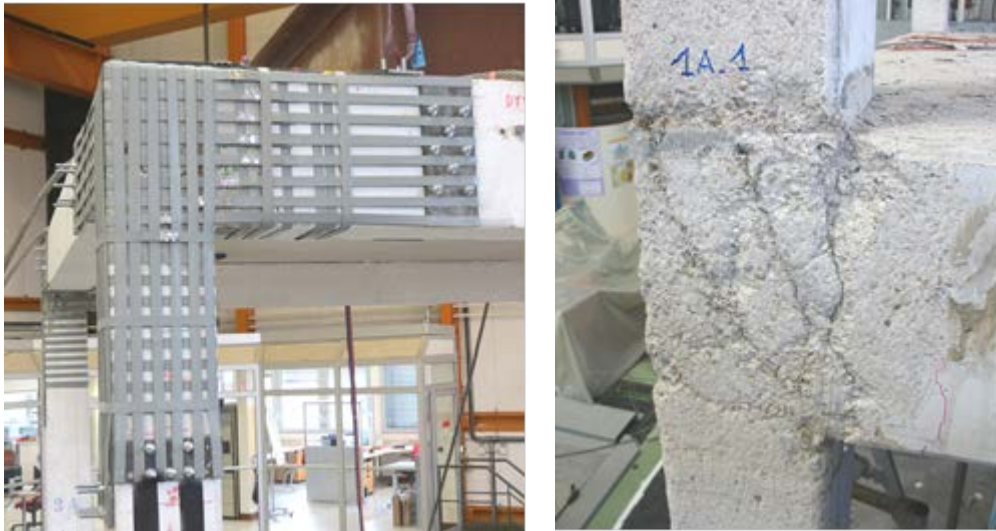
Although only limited local damage in the columns was visible during the tests (see Figure 8a), the drop in frequency suggested that more significant damage had taken place. After the tests were halted, a thorough inspection of the building was carried out and no apparent damage of the PTMS strengthening or steel plates was visible, with only some of the longitudinal straps (parallel to the columns axes) showing evidence of minor buckling at the 1st floor beam-column joints. The removal of the straps revealed significant damage in the beam-column joints, particularly at joints 1A-1, 1A-2, 2A-1 and 2A-2 (see Figure 8b). The test results show that whilst the level of damage produced in Stage 1 was critical for the building, damage was effectively controlled during Stage 2 and the global stability of the building was never compromised.

Figure 8. (a) View of joint 1A-2 during tests in Stage 2; and (b) joint 1A-1 after removing the PTMS

The experimental results also show that during Stage 1, the inadequate reinforcement detailing led to premature failure of the 2nd floor before the capacity of the 1st floor joints was fully mobilised. This was confirmed by the limited diagonal cracking observed at the 1st floor joints after the removal of the PTMS. Conversely, in Stage 2 the PTMS intervention increased significantly the shear strength of the 2nd floor joints and controlled better their structural deterioration. Accordingly, seismic forces redistributed among the building's members and the 1st floor joints were subjected to higher seismic force demands, which in turn produced severe damage (see Figure 8b). This suggests that the PTMS strengthening allowed a better exploitation of the available member strengths over the building height.
