Seismic resilience of existing masonry building

SUMMARY:

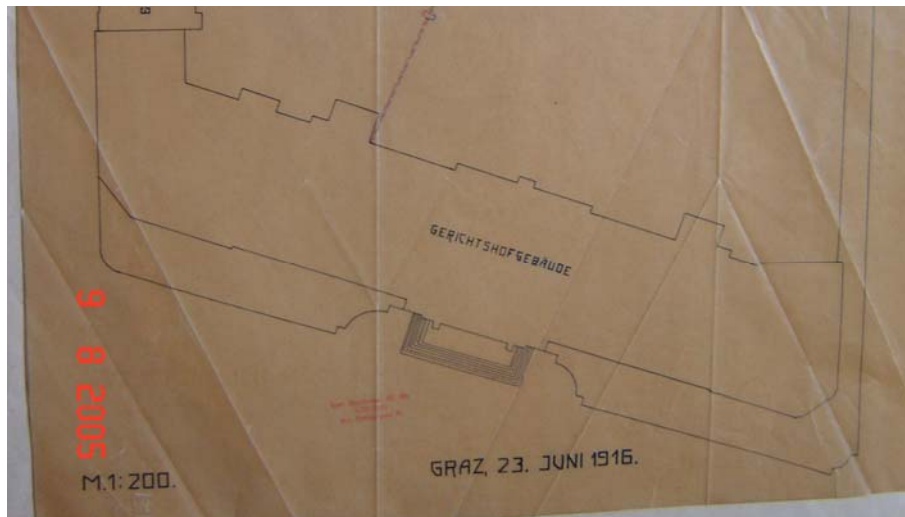
Figure 1. Photo of a historical layout of the Municipality court

The layout of the building is majorly shaped rectangular-wise, but with 2 shorter wings on its end under an angle to the main building structure. The ground floor layout is dominated in the middle point of the building with the entrance foyer with three-way stairs which are connecting the building vertically from the basement to the 1st floor. The layout of the building is also marked with a long hallway stretched out through the whole length of the building situated in the middle of the building transversally. On the second floor is the main court room, which is an impressive 2 stories high room with relief decorations on the wall in the Baroque style (see **Fig. 1** and **Fig. 2**).

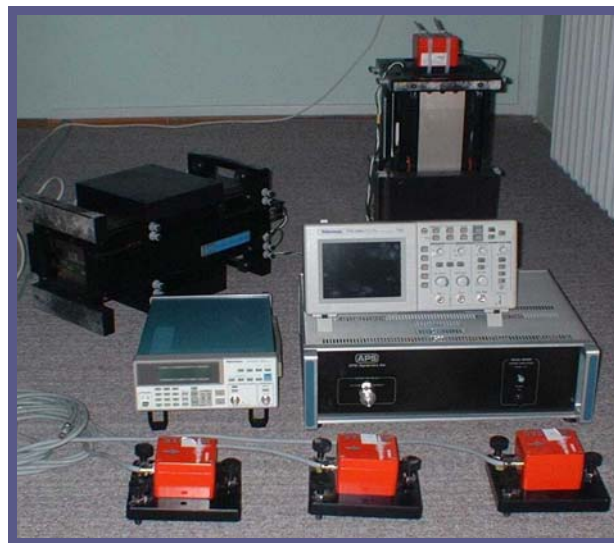
Figure 4. Accelerometers for the building screening

At first the vibrations of the floors were screened in order to get an insight of the floor constructions, and afterwards the dynamical screening of the whole object was conducted. The vibrations screenings were conducted with accelerometers (see **Fig. 4**) specifically designed to screen the velocities of the vibrations in areas from 0.007 μm to 100mm/sec for frequencies from 0 to 315 Hz.
