# Seismic Capacity Evaluation of an Instrumented Damaged School Building Strengthened with Acrylic Walls

This paper evaluates the seismic capacity of the preserved Damaged South Classroom (DSC) building at the 921 Earthquake Museum of Taiwan (921EMT). The site of the 921EMT was a schoolyard before the 1999 Taiwan Chi-Chi Earthquake. For exhibition purposes, numerous acrylic walls were used to strengthen the DSC building, making it a unique retrofit case with seismic concerns. This study applies nonlinear static analysis and the capacity spectrum method to evaluate the seismic capacity of the existing structure. In contrast to the conventional approach in which some building parameters and response spectra are based on design codes, this study utilizes real dynamic parameters extracted from seismic measurements of the DSC building. Results show that the analyzed ground acceleration capacity is 0.5-0.6g in longitudinal direction and 0.8-1.0g in transverse direction. Although the weakness of the structure remains the same as before, its capacity is higher than the demand of the Taiwan seismic specification.

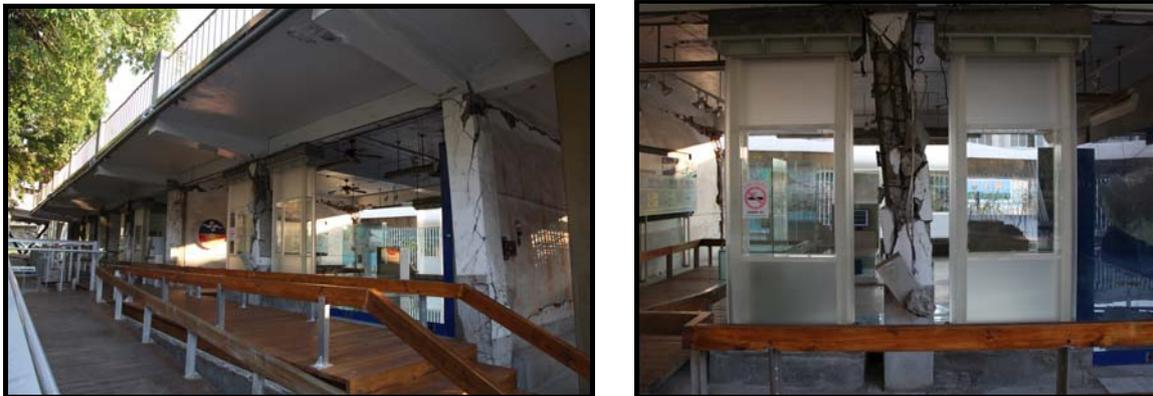
**Figure 1.** Damaged South Classroom in 921 Earthquake Museum of Taiwan  
(Left: view from northwest; Right: AW retrofit)

The original DSC building, which is only five meters from the Chelungpu fault, encountered serious column damage along the corridor (in the x-direction) during the 1999 Chi-Chi Earthquake. The exhibition structure is a one-story building with a base size of 35m × 11m. Weight bearing, earthquake resistance, and damage display are the basic demands to this building. To achieve these goals, fourteen AWs were installed beside the damaged columns as the vertical and horizontal resisting elements, as shown in Figure 1.

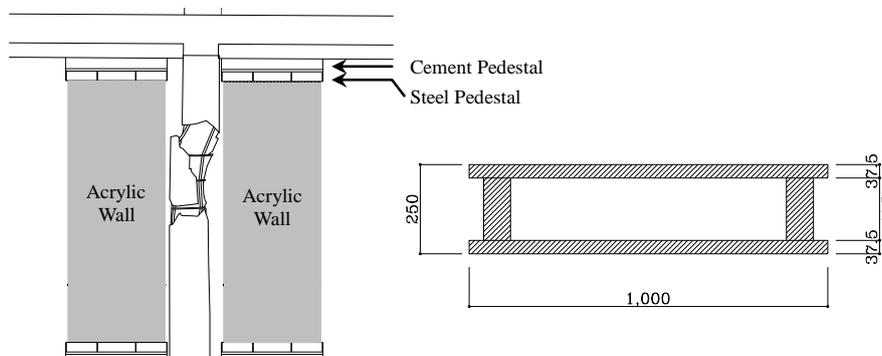
**Figure 2.** Configuration of AW retrofit

The AW is of box section composed of four acrylic plates (Figure 2). Each AW was installed between the beam and the ground with a steel-cement pedestal at each end joint. The weakest interface under lateral loads is the epoxy adhesive layer between the steel and the AW. The design shear strength of the adhesive is 100 kgf/cm<sup>2</sup>.

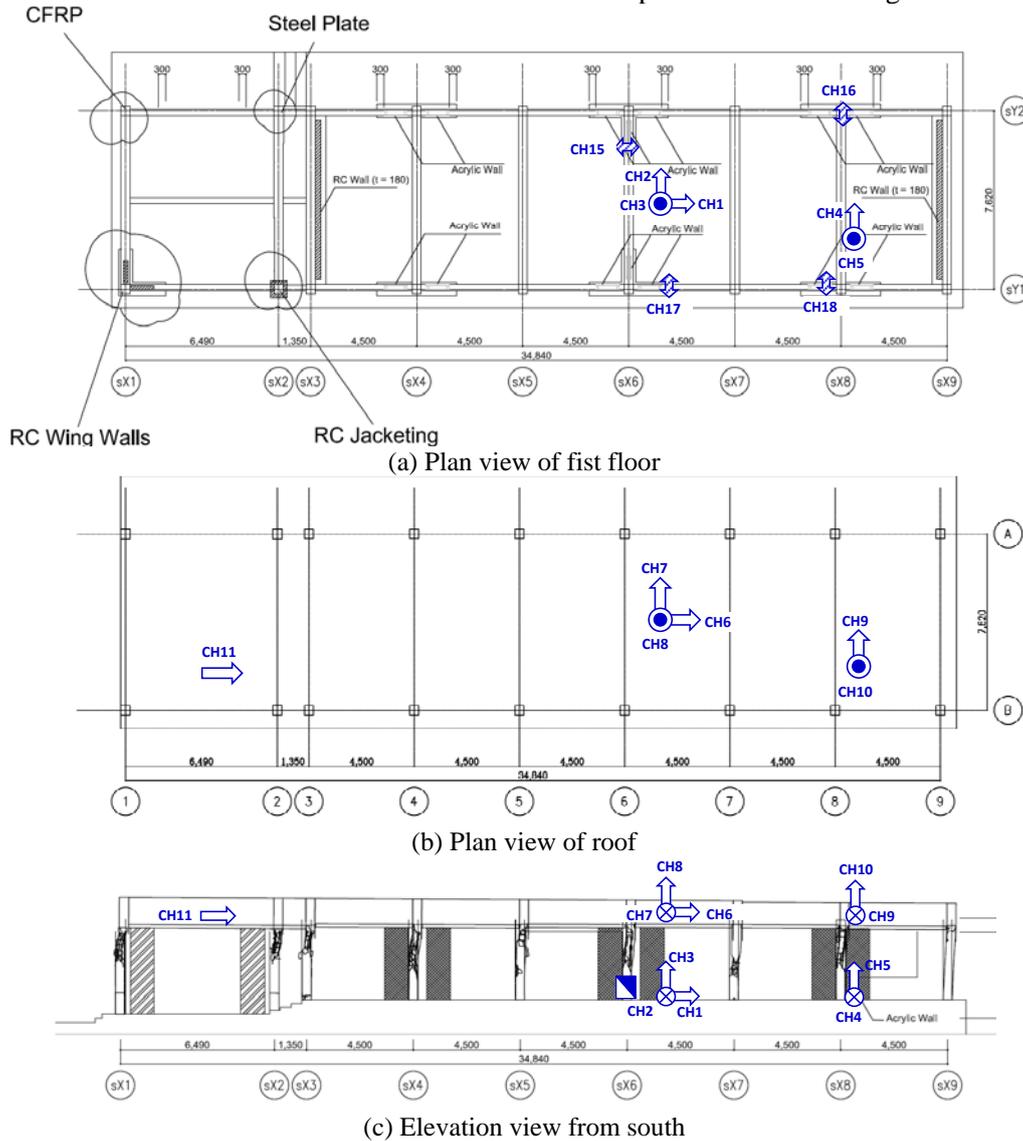
**Figure 3.** Sensor array deployment layout (measured positive direction:  $\Rightarrow$ : to the right;  $\odot$ : out from the paper;  $\otimes$ : into the paper;  $\Leftrightarrow$ : displacement transducer measured axis)

The instrumentation project for the DSC building was completed in December 2010. Fifteen sensors including five uni-axial accelerometers at two locations on the ground floor, five uni-axial velocity sensors and one accelerometer at three locations on the roof, and four displacement sensors on four different AWs, were installed. Figure 3 presents the location, measured direction, and channel label of each sensor. Figure 4 shows the three sensor types. The velocity sensor on the roof is highly sensitive and can record ambient vibrations of high signal-to-noise ratio. Notably, each displacement transducer was installed horizontally to measure the gap distance between two wide acrylic plates. It is expected that the middle of the AWs will encounter contraction and expansion under loadings.

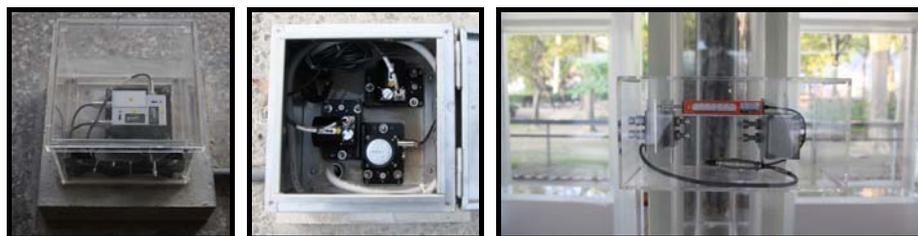
**Figure 4.** From left to right: accelerometers, velocity sensors, displacement transducer

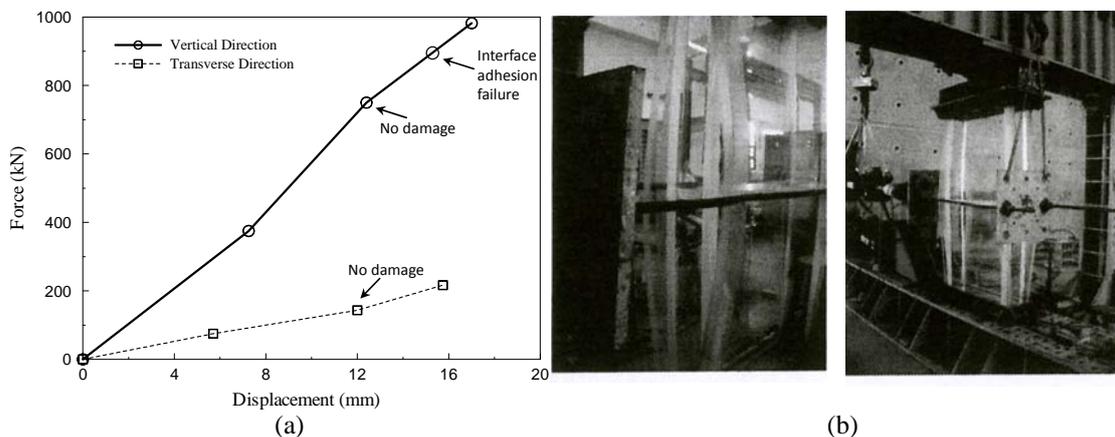
**Figure 5.** (a) Tested force-displacement relationship of the prototype AW; (b) Pictures of the test

Before the manufacture of the AWs, a prototype with a steel connection at each end was designed and tested in a lab. Vertical load and lateral load were respectively applied, and the resulting force-displacement relationships are shown in Figure 5(a). Figure 5(b) shows the buckling of the AW. The behavior of the prototype is nearly linear and the shear strength is one-fifth of the axial strength. Some mechanical properties are presented in Table 1.

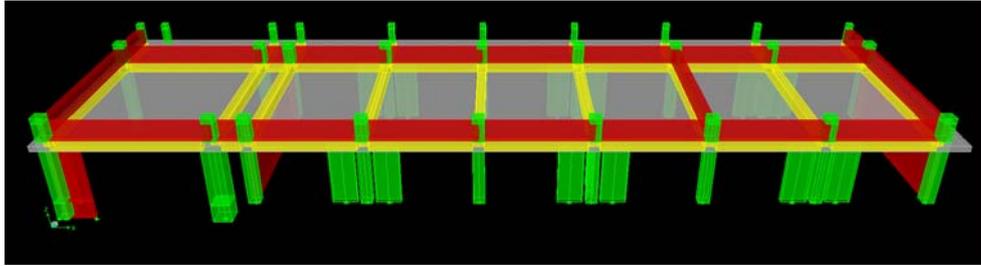
**Figure 6.** 3D view of the ETABS model of the DSC building

Figure 6 illustrates the ETABS model. The roof slab of the building was assigned as a rigid diaphragm to consider the compactness between the beam and the slab. By performing modal analysis, the first three modal frequencies and mode shapes were obtained, as shown in Table 2. Apparently, though the building has been strengthened, the softest axis is still the roof motion along the corridor (x-translation) as that of its undamaged state, but the first modal frequency is 13% higher than the fundamental frequency suggested by the Taiwan seismic code ( $1/0.07h^{3/4} = 1/0.07(2.87)^{3/4} = 6.48$  Hz), which means the stiffness is approximately 25% higher than a general building.

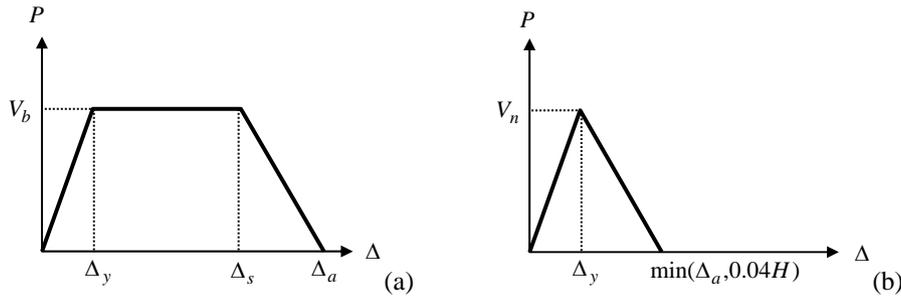
**Figure 7.** Lateral force-displacement curve of a nonlinear hinge with (a) bending-type or (b) shear-type damage for an RC column

In conducting nonlinear analysis, the ductility of structural components was considered. The nonlinear characteristic of a structural component was given by assigning nonlinear hinges according to its damage mechanism. Typically, the damage of a column can be dominated by bending or shearing. Two ends of a column may encounter bending-mode failure, whereas the other sections usually exhibit shear-mode failure. Therefore, in the ETABS model, a bending-type hinge was set at each end and a shear-type hinge was set in the middle of a column to determine the nonlinear characteristics. For the beams, only bending-type hinges at two ends were set because the beams are not of deep section. The lateral force-displacement relationships shown in Figure 7 were assumed in this study. Figure 8 shows the corresponding nonlinear hinge settings in the ETABS model (Chung et al., 2009).

Figures 7 and 8 show that the displacements of yielding  $\Delta_y$ , shear failure  $\Delta_s$ , and axial failure  $\Delta_a$  are unknown. Chung et al. (2009) suggested that

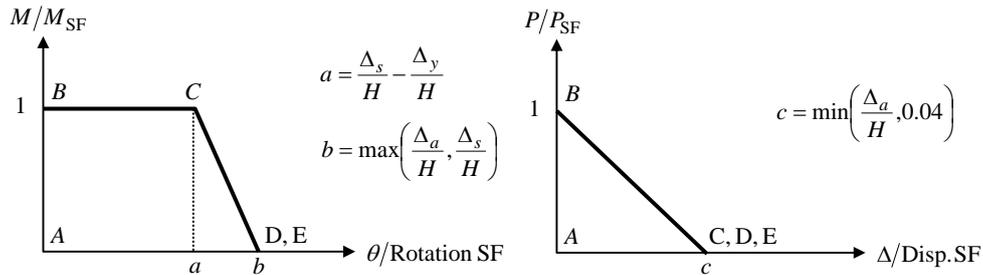
**Figure 8.** Nonlinear hinge property of (a) bending-type and (b) shear-type used for the RC columns

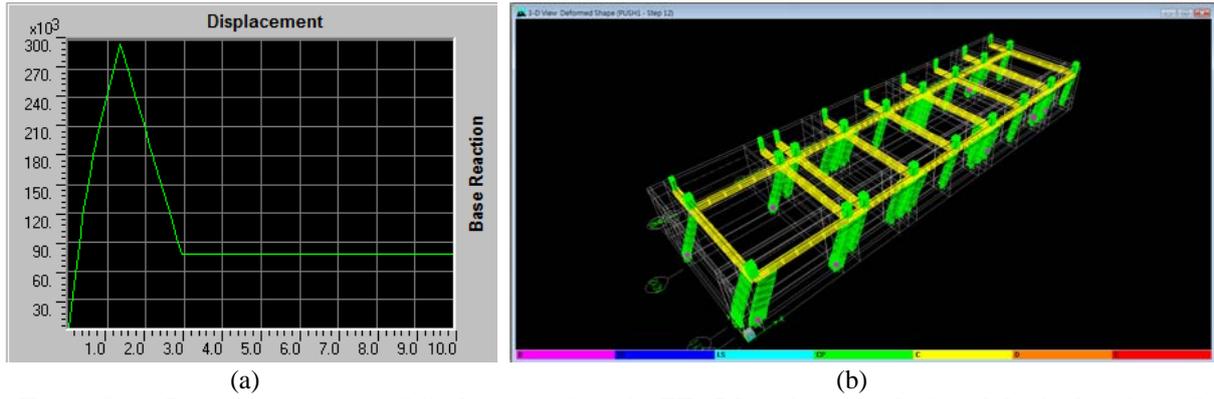
**Figure 9.** (a) Base shear versus roof displacement from the ETABS pushover analysis and (b) the locations of nonlinear hinges at the state of maximal shear

After setting the parameters of the nonlinear hinges, pushover analysis was performed. The force was applied at the mass center of the roof, and the observed displacement point was set at the same point. The obtained base shear versus roof displacement curve is shown in Figure 9(a). Figure 9(b) shows the state where the first nonlinear hinge on the AW was formed.

The capacity curve in Figure 9 shows that before the base shear reaches the maximal value, the behavior of the DSC building is nearly linear; after that, the base shear is significantly reduced, which shows that almost all of the AWs encounter shear failure simultaneously and the low ductility property dominates the seismic capacity of the building. After the failure of AWs, the seismic resistance of the building is maintained solely by the four retrofitted columns.

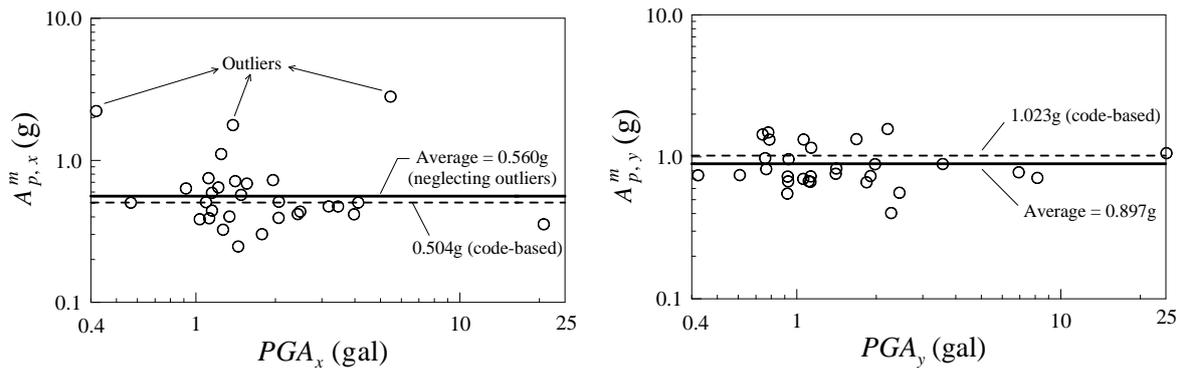
**Figure 10.** Ground acceleration capacities of the DSC building along the x- and y-directions, utilizing the ground acceleration measurements

In addition, this study collected the x- and y-direction ground acceleration time histories from 30 seismic events to create the response spectra of a 5% damping ratio for the DSC building site. The ground acceleration capacities along the two horizontal directions based on each event were then obtained using Eq. (4.10), as shown in Figure 10. The average  $A_{p,x}^m$  (0.560g; neglecting three outliers) and  $A_{p,y}^m$  (0.897g) in Figure 10 exhibit an approximately 11-12% difference from the seismic code-based ground acceleration capacities ( $A_{p,x} = 0.504 g$  and  $A_{p,y} = 1.023 g$ ). This implies that the seismic code spectrum shape can approximately describe the real site effect of the DSC building.

Considering the design code demand, the short period acceleration spectral value of the DSC building site in the Taiwan design code is,  $S_{DS} = 0.984$ . This building is a public building; hence, the importance factor is  $I = 1.25$ . The design ground acceleration is  $A_g = (0.4S_{DS})I = 0.492 g$ . This shows that the ground acceleration capacity ( $A_{p,x} = 0.504 g$  or  $A_{p,x}^m = 0.560 g$ ) of the DSC building satisfies the demand of seismic design specifications.
