The Seismic Performance of a Post-tensioned LVL Building During the 2011 Canterbury Earthquake Sequence

T. Smith, D. Carradine, S. Pampanin

University of Canterbury, Christchurch, New Zealand

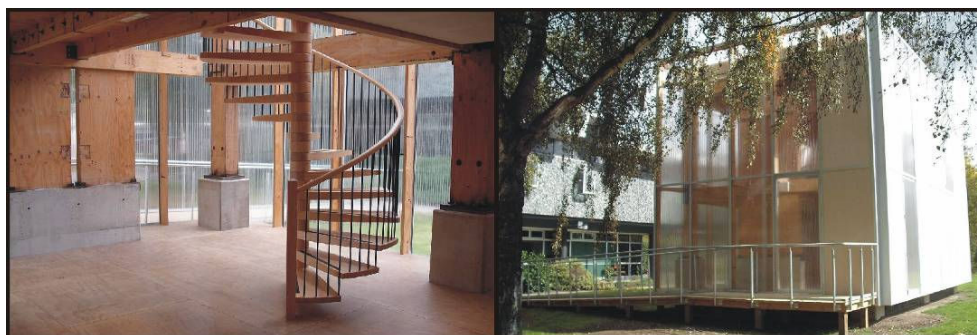
Figure 1.2. The Expan Office Structure for STIC

To transform the experimental building into a new office building, most components of the existing experimental structure were to be fully utilised. In total over 90% of the structural components were able to be reused (Smith et al. 2011), however due to the original purpose as a 2/3 scale test specimen, some changes had to be made. The building was designed before the September 2010 earthquake therefore, the codes in place at the time (NZS 1170.5:2004 2004) were used in design (Z for Canterbury = 0.22). The building was estimated to have a fundamental period of 0.34 seconds and was given an Importance Level of 2 and due to the temporary nature of the building a 10 year design life was assumed ($R_{ULS} = 0.75$).

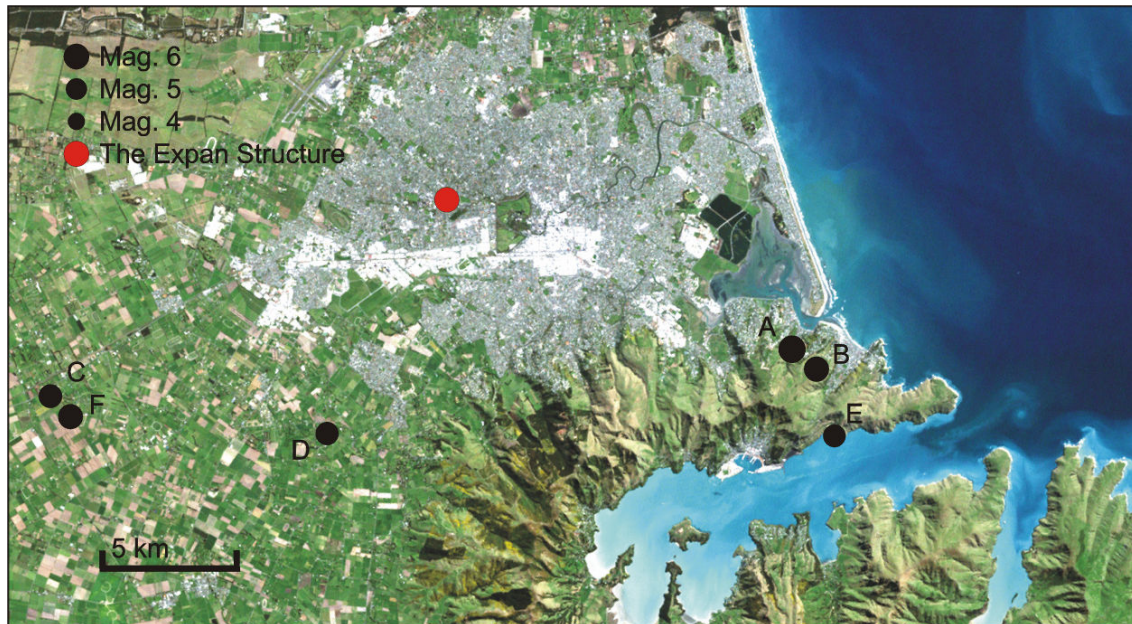
Following the installation of the instrumentation, trigger thresholds have been surpassed over 1000 times leading to a significant database of records available to the current research. In this paper a selection of 6 records have been chosen based on the largest acceleration measured at the second storey of the building between the installation of the instrumentation and the 1st of October 2011. Information regarding the selected records is presented in Table 2.1 and shown in Figure 2.2.

Figure 2.2. Studied Earthquakes in Relation to Expan Structure (NASA Satellite Image)

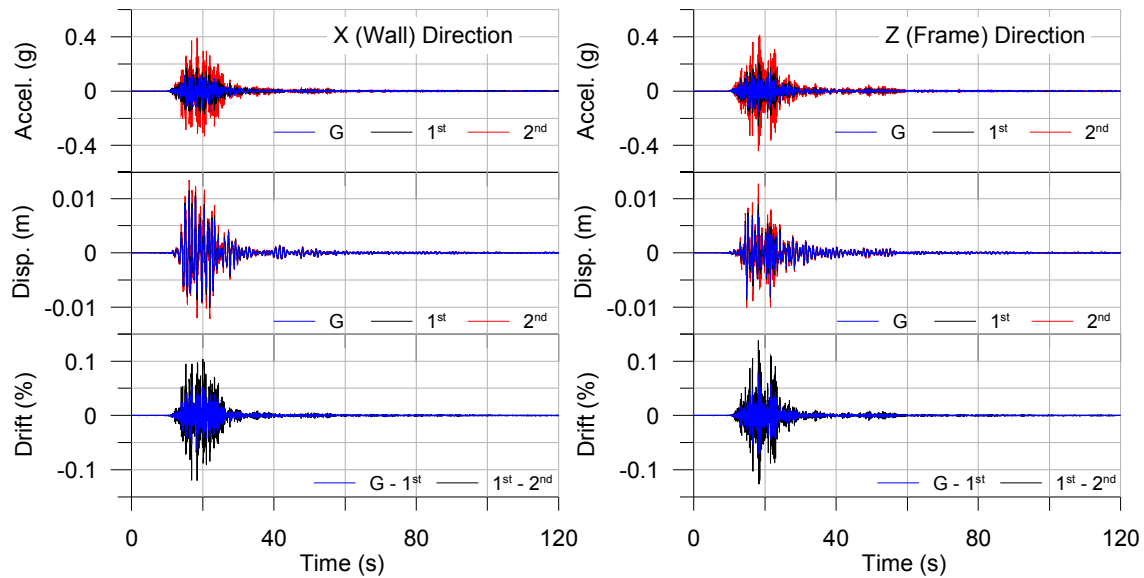
The first study made of the data involved the evaluation of the individual time history responses. One of the principle objectives of this was to ensure instrumentation was functioning properly and to study the way in which accelerations were transmitted up the structure. Figure 3.1 shows the acceleration, displacement and drift recorded during Earthquake A.

Figure 3.1. Time History Response In X (Wall) And Z (Frame) Direction In Terms Of: Acceleration, Displacement And Drift

From the figure showing the acceleration time-history it can be seen that a significant increase in acceleration occurred from the base of the structure to the 2nd floor (roof) with this effect being larger in the Z (frame) direction. Maximum interstorey drifts recorded were not significant enough to observe the elastic non-linear behaviour which is characteristic of this type of construction system. Interstorey drifts were not constant throughout the structure with larger values occurring at the second level. This is likely due to the large concrete plinths and effectively fixed base connection which were used as shown in Figure 2.1.

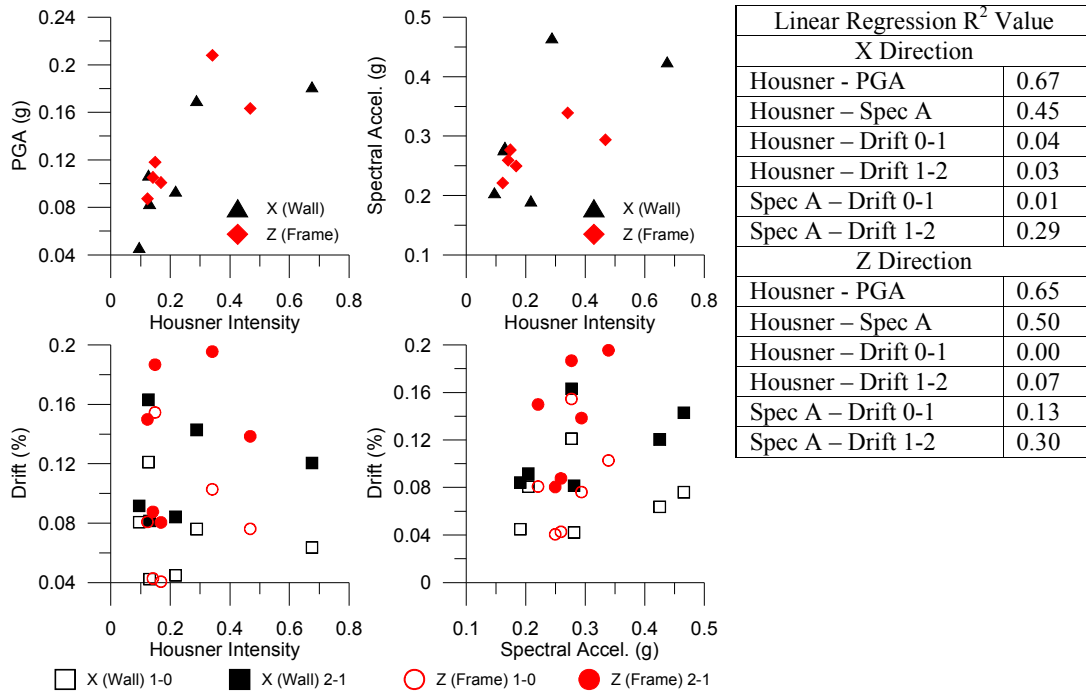
During the examination of the results obtained from the 6 acceleration records being studied several key parameters which are commonly used in structural dynamic analysis have been calculated and compared. These parameters were: Peak Ground Acceleration (PGA), interstorey drift, spectral acceleration at the fundamental period of $T = 0.18$ seconds and the Housner Intensity. Often used as an indicator for structural damage, the Housner Intensity is evaluated as the area under the velocity spectrum between a given period range (Housner 1952). Comparisons between a selection of these parameters are shown in Figure 3.3 along with a table showing the calculated linear regression analysis values.

Figure 3.3. Comparison Between: PGA, Spectral Acceleration, Drift And Housner Intensity and Drift and Spectral Acceleration

As shown Figure 3.3 minimal correlation was found for the 5 cases studied between the Housner intensity and both PGA and Spectral acceleration. No relation was seen however between the Housner Intensity and interstorey drift. The final comparison made was between the spectral acceleration and interstorey drift which also shows no correlation.

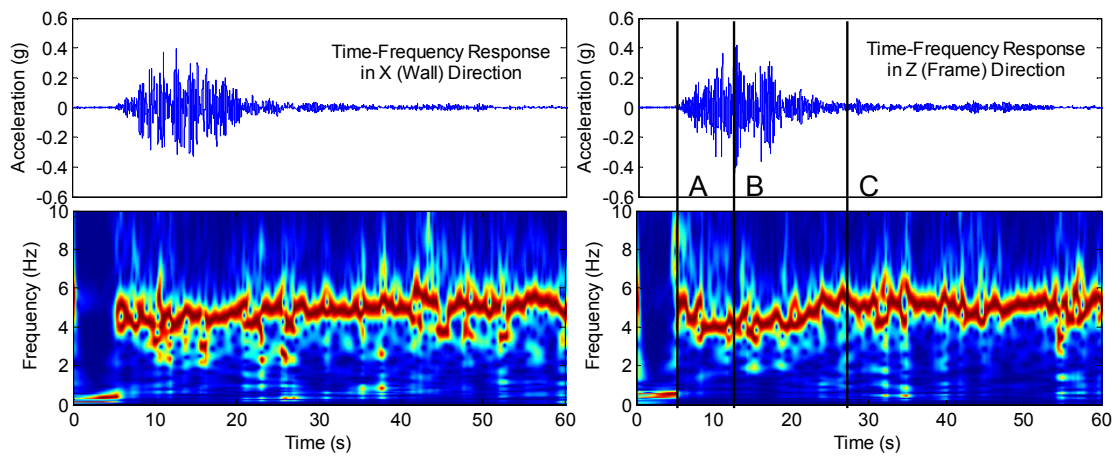
Where: t = time, f = frequency and τ = a parameter that controls the position of a Gaussian window along the time axis. This method of analysis has been used on the selected records with the results of the analysis of Earthquake A top floor acceleration shown in Figure 3.4.

Figure 3.4. S-Transform of Earthquake A in X and Z direction given Time Frequency Response

The fundamental frequency of the building in both directions is approximately 5.5 Hz which gives a fundamental period of 0.18 seconds. This is lower than the estimated value which was used in design ($T = 0.34$ s). The closeness of the two values indicates that probably a torsional mode is governing the system response. This is possible and may be arising from the large section of floor which was removed in order to allow for the stairs (Figure 3.4).

From Figure 3.4 the relationship between building frequency and drift is shown clearly with the frequency drop from its stationary value of 5.5 Hz to a value of approximately 4 Hz during the maximum excursions of the structure in terms of drift. This is further illustrated in Figure 3.5 which shows the instantaneous base shear versus displacement response at the instants A, B and C in the Z (frame) direction as shown in Figure 3.4. These instances represent the record before, during and post event (A, B and C, respectively). Although the scale of the y axis In Figure 3.5 differs, the ratio between the x and y axis has been maintained.
