Experimental characterization of Pombalino “frontal” wall cyclic behaviour

Ana Maria Gonçalves, Joao Gomes Ferreira, Luis Guerreiro, Fernando Branco

Instituto Superior Técnico, Lisboa, Portugal

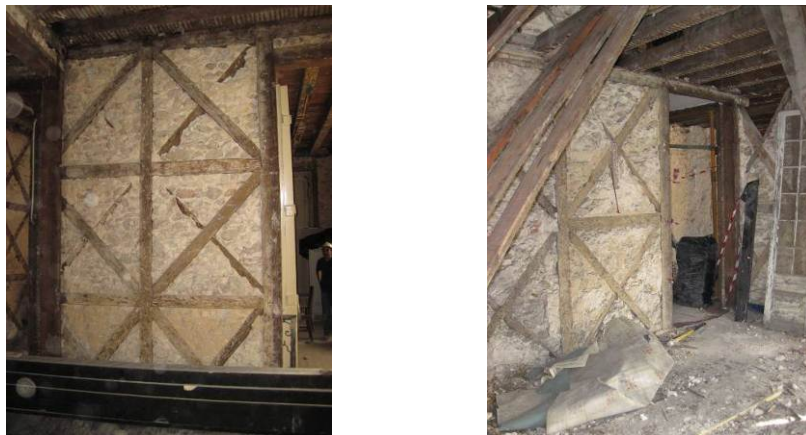
Figure 1. Frontal wall in “pombalino” Building (Gonçalves, *et al.* 2011)

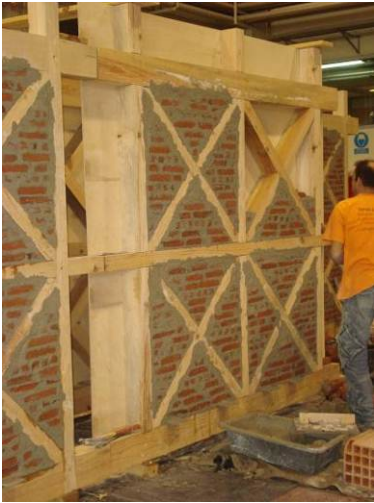
The choice of the type of masonry was very important since there are several types of infill, including mortar with bricks or mortar with tiles or even mortar mixed with small stones. In this study, mortars with bricks (Figure 4) were used. The masonry consists of bricks and cement-lime-sand mortar with a volume ratio of 1:2:6 (hydrated lime (air): portland cement 32.5 N : sand). Although ancient mortars

Figure 4. Masonry wall fabrication

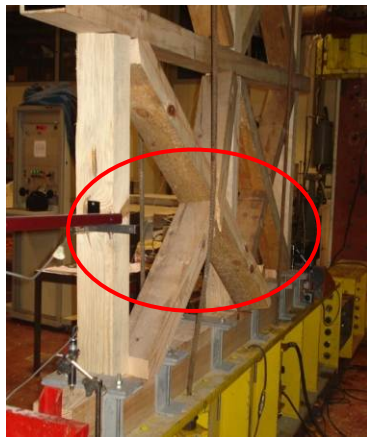
The load was increasing with the imposed displacement until the rupture of the diagonal associated with lateral instability. Figure 10 shows the failure modes of timber frames.

a) Failure by buckling of diagonal for TF1

b) Failure by buckling of diagonal for TF2

Figure 10. Failure mode of timber frames

As expected, masonry walls exhibited higher stiffness than timber frames, 2000 kN/m and 600kN/m respectively. Masonry infill is important to the stiffness and especially to the strength of the whole module. The masonry infill also influences the collapse mode, for example by preventing the lateral instability of the compressed diagonal.

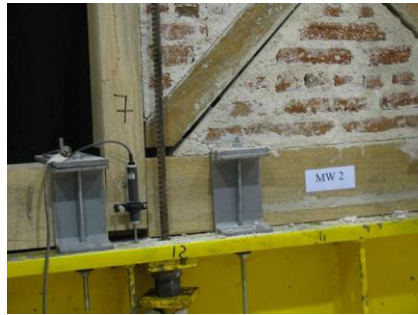
The vertical lift of the bottom beam occurred during the wall test. Besides, a separation of the vertical timber beams from the bottom beam was observed as an effect of a rocking movement that was not eliminated, becoming more significant with the increase of the overall deformation (Figure 12).

Figure 12. Vertical lift of bottom beam and vertical member.

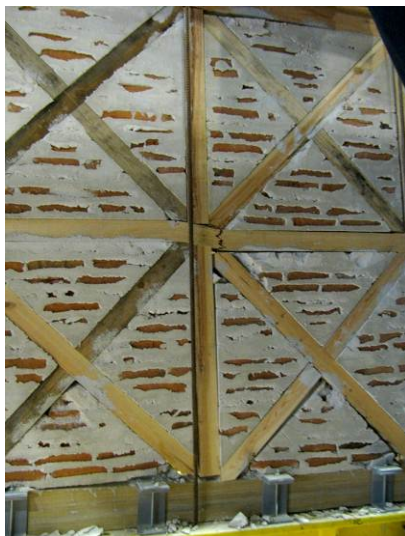
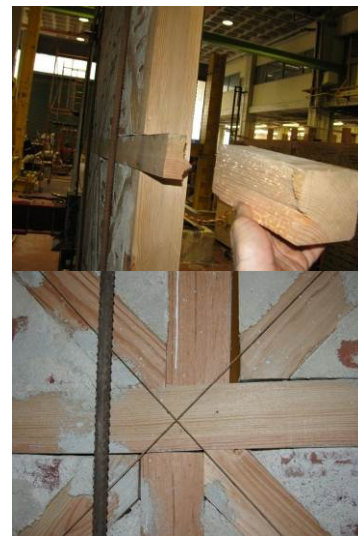
Figure 15 shows the failure modes of the walls. Rupture in MW1 is associated with compression of the diagonals that caused the shear failure of the intermediate beam. In the case of the model MW2 the wall had an early rupture by cutting parallel of the timber fibres at one end of the intermediate beam.

a) Failure by shear failure of intermediate timber beam for MW1

b) Failure by parallel shear of intermediate timber beam for MW2

Figure 15. Failure mode of masonry wall
