Seismic retrofitting of Pombalino “frontal” walls

Ana Maria Gonçalves, João G. Ferreira, L. Guerreiro, F. Branco
Instituto Superior Técnico, Lisboa, Portugal

SUMMARY:

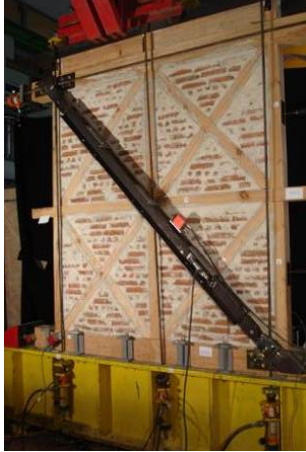
Figure 1. Walls MW4/5 with damper

The damper was composed by a steel rod (8 mm diameter 55.5 cm length), laterally restrained by steel plates and profiles, according to the scheme presented on Figure 3. The rod has been fixed to a guiding bar, in which it can move freely, preventing the occurrence of bending out of the plane. The guiding bar has been welded in profiles UNP 100 (Figures 1 and 2).

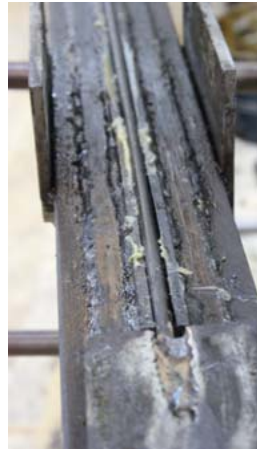
Figure 2. Guides, the rod and plate

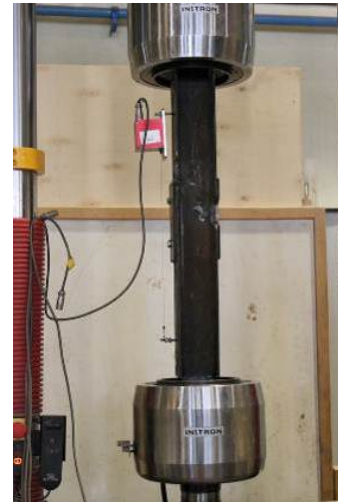
Figure 5. Damper test

In order to obtain the mechanical properties of the damper, such as strength, elastic moduli and energy dissipation, cyclic tests were carried out in a universal Instron testing machine, at a load speed of 0.05mm/s (Figures 4 and 5). The results of the cyclic tests are presented on Figure 4 showing a good energy dissipation capacity. Observed an asymmetric behaviour in Figure 4, the maximum force of the damper is 25 kN, in tension, and 35 kN on compression. This difference is due to the construction of the damper, and the (controlled) buckling of the damper, what causes touch in the guides and increased force.

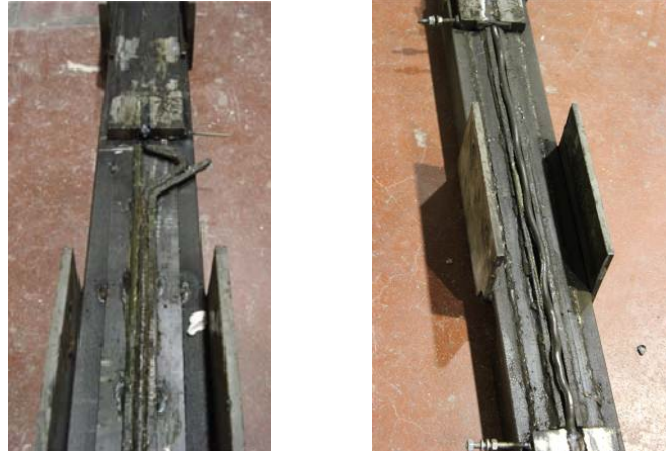
Figure 8 shows the welding failure in the test element MW4, compression (Figure 8a) and the (controlled) buckling of the damper in the test element MW5 (Figure 8b).

a) Rupture of the welding rod guide in MW4 b) Instability of the rod damper in test MW5

Figure 8. Rupture and instability of the damper

Also in Figure 7 (right) it was observed energy dissipation on the first cycles of wall model MW4. During the test the guiding system welding collapsed and, as a consequence, the rod buckled. After the buckling of the rod no more energy dissipation occurred (Figure 8a).

The energy dissipation in the MW5 wall occurs both in tension and compression, as observed in Figure 7 (right). It is noticeable that the maximum displacement of the damper is 22 mm, in tension, and 15 mm on compression, due to the localized buckling which the rod shows under compression (Figure 8b). This results in better energy dissipation in tension than in compression phase.

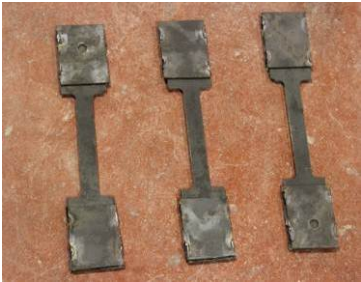
Figure 11. Specimens

In order to obtain the mechanic properties of the studied material, such as strength and elastic moduli, tests were performed on specimens according to the NP EN 10 002-1 (Figure 11). The tests were carried out in a universal Instron testing machine, at a load speed of 0.05 mm/s (displacement between grips). The stress-strain profile of the plate is presented in Figure 12.

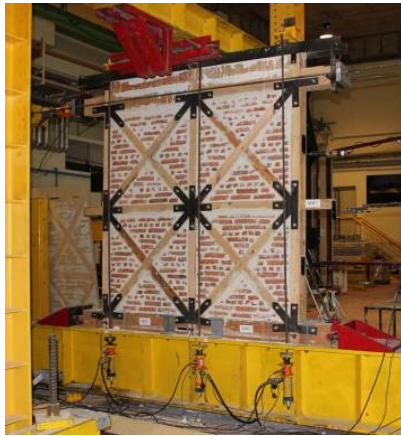
Figure 13. Walls MW6/7

a) Photo of Wall MW6

b) Schematic drawing of walls (MW6/7) instrumentation

Figure 13 represents the location and orientation of the forces/displacement measured by instrumentation of the walls MW6 /7.

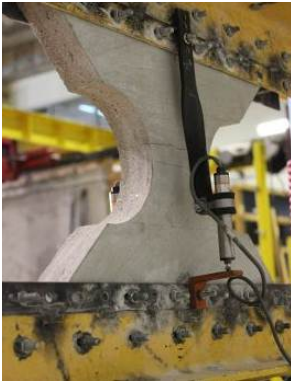
Figure 17. Failure mode

In order to obtain the mechanic properties of the studied material, such as strengths and elastic moduli, tensile tests were carried out on specimens with nominal dimensions of 500 x 450 x 50 mm (Figures 16/17). Tests were carried out in a universal Instron testing machine, at a load speed of 0.05 mm/s (displacement between grips). The stress-strain profile of the plate is presented in Figure 18, whose analysis shows that a 2.4 MPa (RA1) and a 1.8 MPa (RA2) was obtained for the Stress.

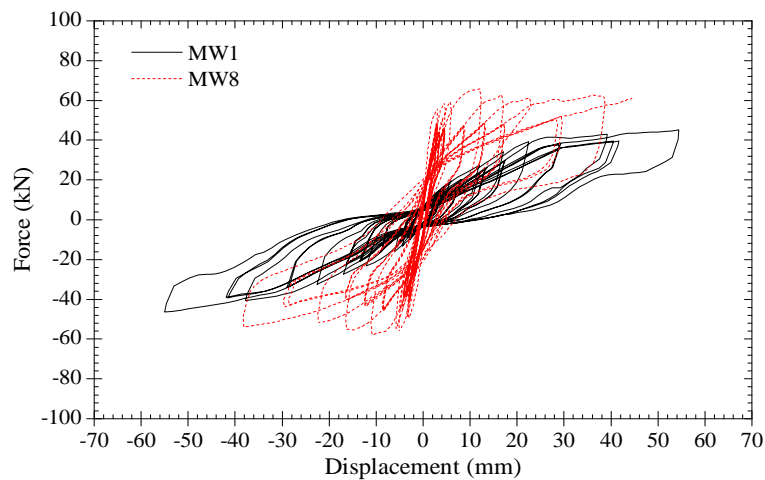
In the hysteresis' curves of tests MW1 and MW8, respectively unreinforced wall and wall with render reinforced with a steel mesh, shown in Figure 20, it is observed that the wall with reinforced rendering has an increased stiffness in the first cycles, until 10 mm of displacement. After that, the force remains constant because some cracking in the reinforced rendering starts to appear, leading to the loss of stiffness, but even though with higher capacity of energy dissipation.

The load-displacement diagrams show that for a 40 mm displacement of the force applied, there is approximately 60 kN and 40 kN to the reinforced wall and simple wall, respectively. The results show that this type of reinforcement is less efficient when compared to other reinforcements studied herein. The collapse mechanism of the wall with reinforced render results in a cut at the base, with a non-efficient use of the reinforcement system.

Figure 20. Curves hysteresis in walls MW8 and MW1

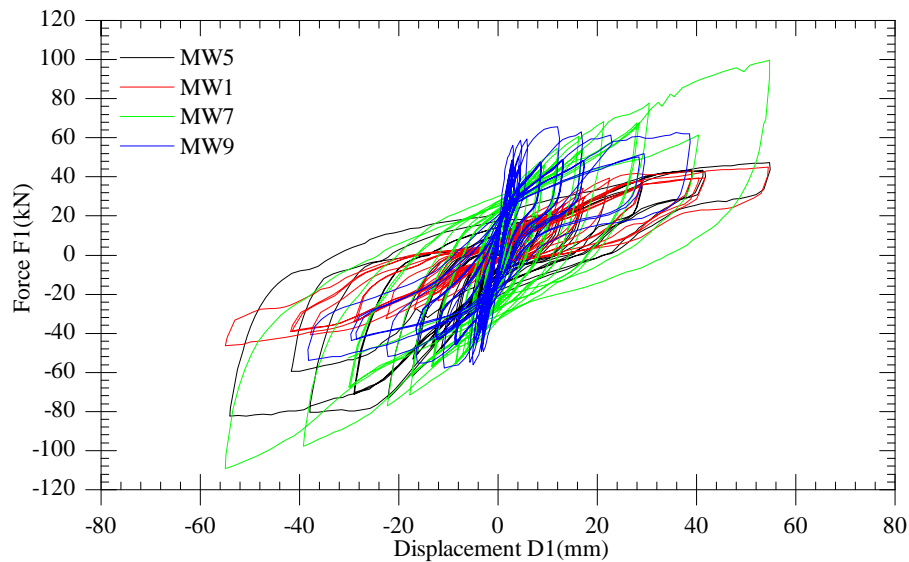
- According to the force-displacement curves, all reinforcement provided a higher ability to dissipate seismic energy, with an increase in their stiffness (Figure 21);
- The damper (MW5) had a good behaviour in tension but in the compression cycles some instability was observed, which leads to the conclusion that this system is difficult to implement when performing the rehabilitation;
- The walls with reinforcing plates (MW6 and MW7) showed the best behaviour in dissipating energy in the tension-compression cycles;

Figure 21. Curves hysteresis in walls MW1/5/7/8

- The reinforcement with rendering system (MW8) led to an increase in stiffness of the wall, up to 10 mm of displacement. Then, the reinforcement started to crack at relatively constant load;
- The application of steel plates was the reinforcing technique that induced the best behaviour, with higher energy dissipation and the hysteretic cycle symmetry.
