Effectiveness of Seismic Improvement of Monumental Heritage

C. Chesi, M.A. Parisi

4. CASE STUDY: THE MADONNA DI MONTE CHURCH

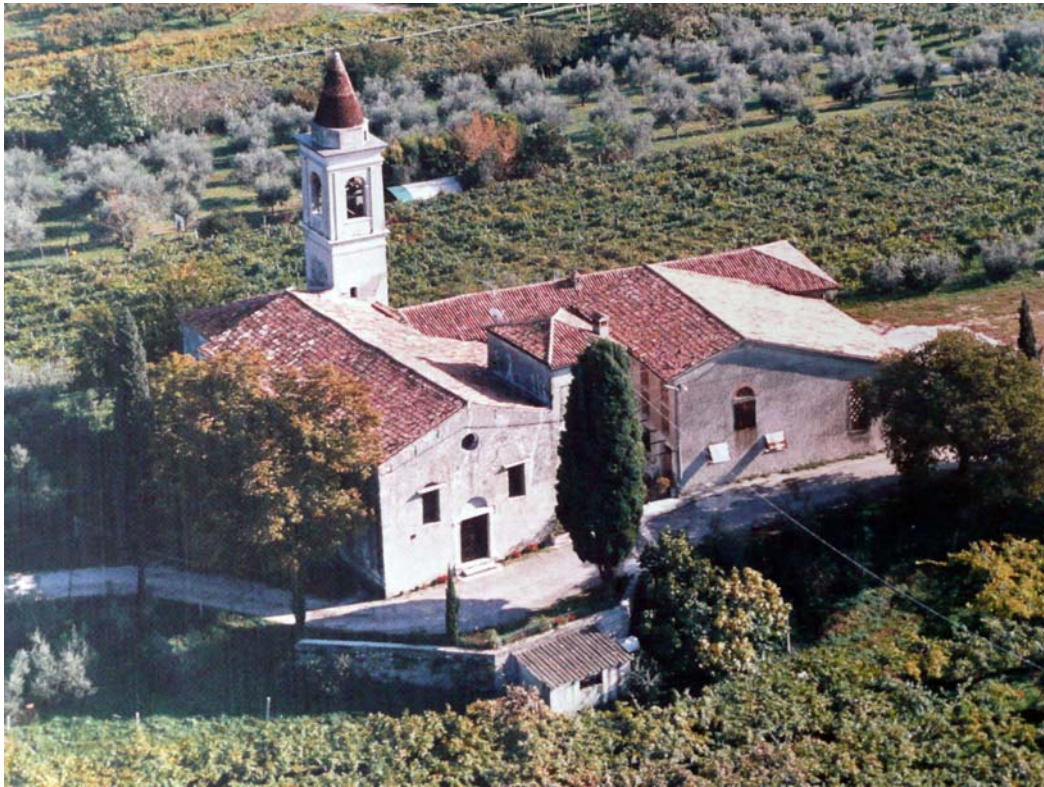
Figure 1. Madonna di Monte – Global view

The case examined concerns a church located on a hill crest in the subalpine region of northern Italy, in a low-to-moderate seismic area (Fig.1). The stone masonry building dates back to the 13th century and is classified as protected cultural heritage. In Italy, seismic strengthening or improvement of an

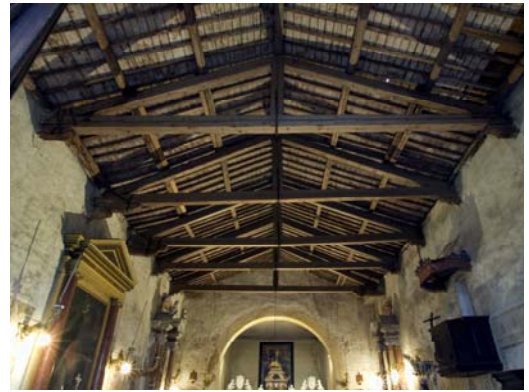
2. Transversal response of the nave: the presence of this mechanism is revealed by the lateral wall rotation and by the slenderness of these walls.
Seismic protection elements: adjacent structural units.
Vulnerability indicators: slender walls.
Improvement interventions: better connection with adjacent structural units.
3. Triumphal arch: a possible collapse mechanism is related to a system of cracks.
Seismic protection elements: massive lateral walls plus a steel tie.
Vulnerability indicators: interaction with the bell tower.
Improvement interventions: additional steel ties and more effective connection to the bell tower.

Figure 3. Mechanism n. 2

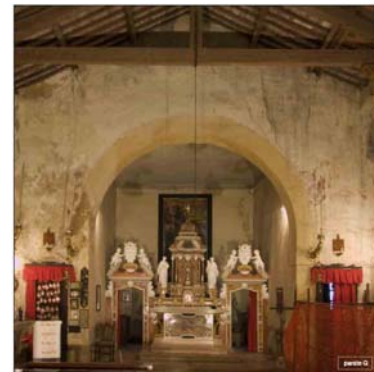
Figure 4. Mechanism n. 3

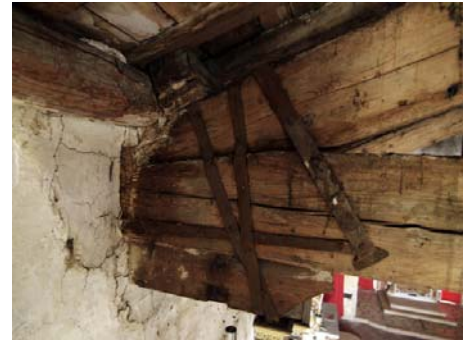
5. Roof and nave lateral walls: cracks are present at the connection of the timber roof structure with the walls, where relative sliding can be observed.
 Seismic protection elements: effective connection of the roof structure well built into the walls.
 Vulnerability indicators: thrust from the roof to the wall.
 Improvement interventions: light ring beams at the top of walls, better connection of the roof timber structure to the walls, pent bracing, better connections between the roof elements.

Figure 6. Mechanism n. 5

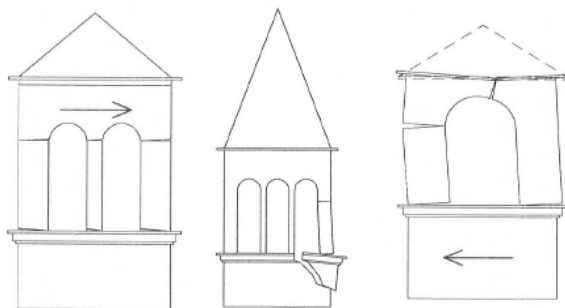
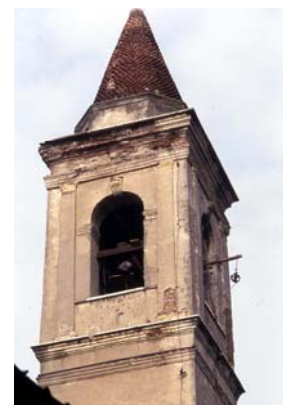
8. Bell tower: vertical cracks are visible.

Seismic protection elements: previously inserted steel ties.

Vulnerability indicators: lack of symmetry at the foundation level.

Figure 8. Mechanisms n. 9
