Seismic Vulnerability of Buildings in the Municipality of Chacao Metropolitan Area of Caracas, Venezuela.

SUMMARY:

The study shows the seismic vulnerability results of the buildings higher than three stories at Los Palos Grandes, and essential buildings of the Municipality of Chacao, metropolitan area of Caracas, Venezuela. The survey includes the visual inspection in each of 231 buildings to identify construction year, stories, materials, plant and elevation scheme, structural system, structural deficiencies, etc., classifying the buildings according to its structural typology, and seismic vulnerability. Likewise the survey of medical facilities is included, educational centers and government buildings.

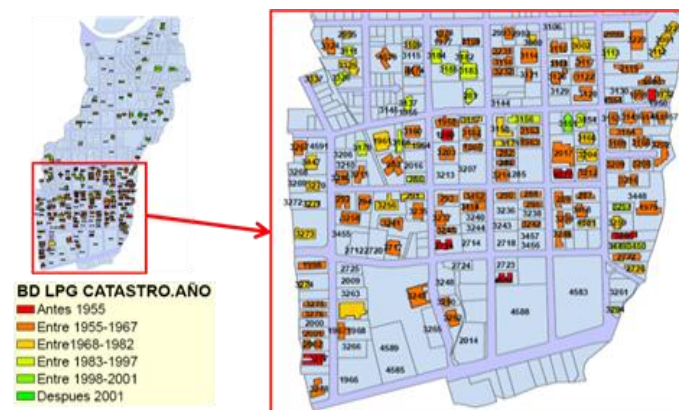
After integration with the GIS platform for the study results, a set of thematic maps was generated permitting to illustrate the distribution of the buildings for each element during recorded the inspection, as well as related statistics. For example, Figure1: “Distribution of buildings by year” is one of tematics maps.

Figure 1: Distribution of buildings by year of construction

The processing in the GIS platform allows a series of thematic maps which illustrate the distribution of buildings by their height, year of construction, structural system, plant and elevation scheme, etc.

52.2% were built before year 1967, 21.9% built between 1967 and 1982, 21.3% built between 1982 and 1998 and barely 4.5% built since 1998 .
